HUNTINGTON LAKES SECTION 4
BUILDING 33

BUILDINGS STRUCTURAL MILESTONE INSPECTION REPORT

FEBRUARY 2024

Re: Milestone Inspections
Huntington Lakes Section Four
7341 Amberly Lane – Building 33
Delray Beach, Florida 33446

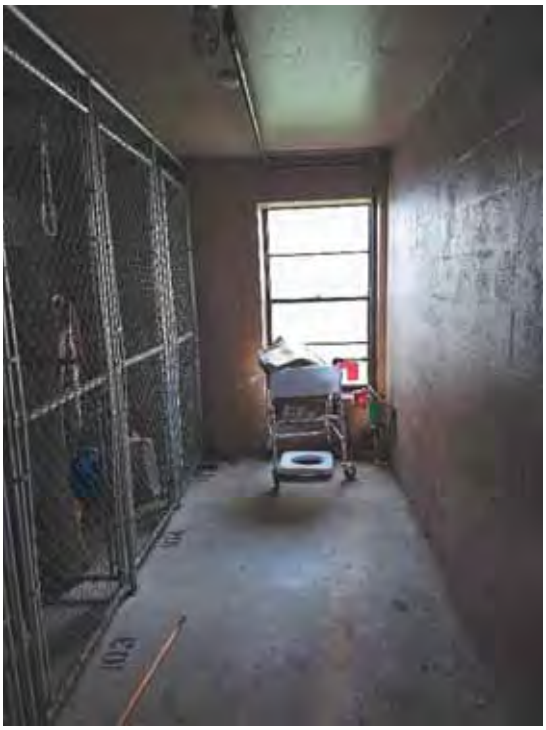
Figure 7: Typical unit-owner storage rooms at the ends of the catwalks

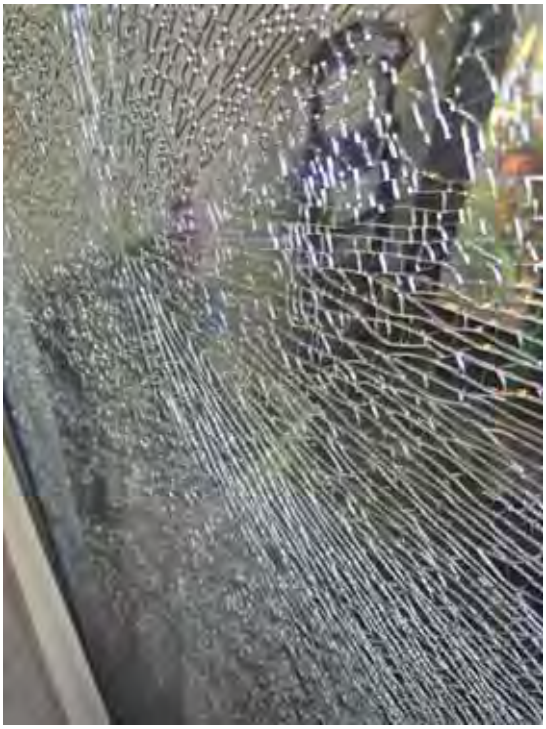
Figure 30: Damaged glazing

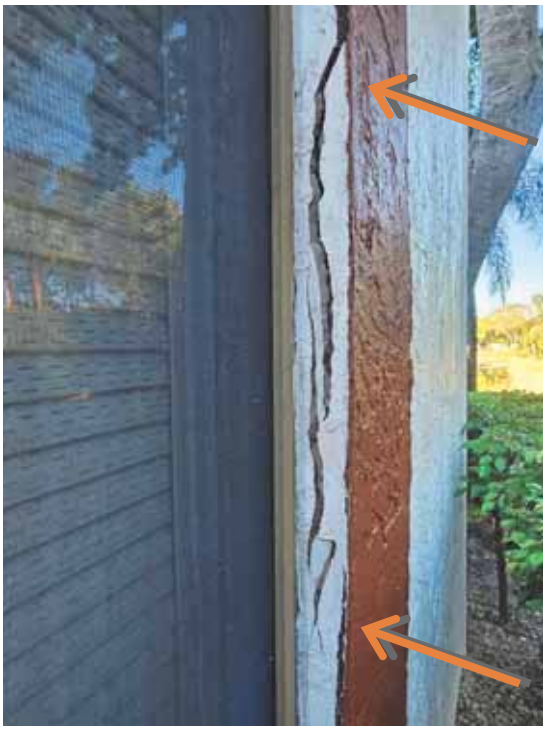
13. Some areas of column spalling were observed at the catwalks.
14. Paint bubbling and delamination was observed occasionally.
15. In general, the stair tower structures, and stair systems were in moderate condition. Some areas of column spalling were observed at the sitar tower structures.

Figure 41: Column spall at building exterior

1. Concrete spalling should be repaired according to engineering specifications at the balconies, building envelope, roof, and catwalk. Any shutters, sunshades, railings, windows, or doors impeding the proper repair of the concrete will need to be removed. When removing doors and windows, temporary weather walls will need to be constructed to protect the interior of the unit. Proof of installation permits will need to be provided by unit owners for the reinstallation of existing enclosures. Due to their age, screen enclosure reinstallation may not be possible, and railing replacement might be required.

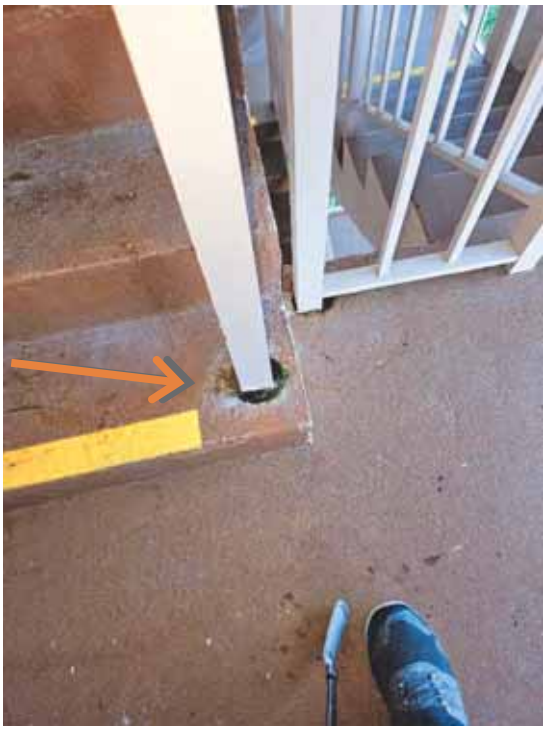
Figure 45: Recessed post pocket at stairwell railing

7. Rail post pocket grout should be chipped out and replaced where it is damaged at the catwalks. The picket railing should be repaired and resecured at a minimum if full replacement is not required. Railing repairs might require mechanically fastened brackets or post sleeves to be installed where sections have detached or corroded. Dangerously loose railings should be temporarily secured if repairs are not immediately performed.

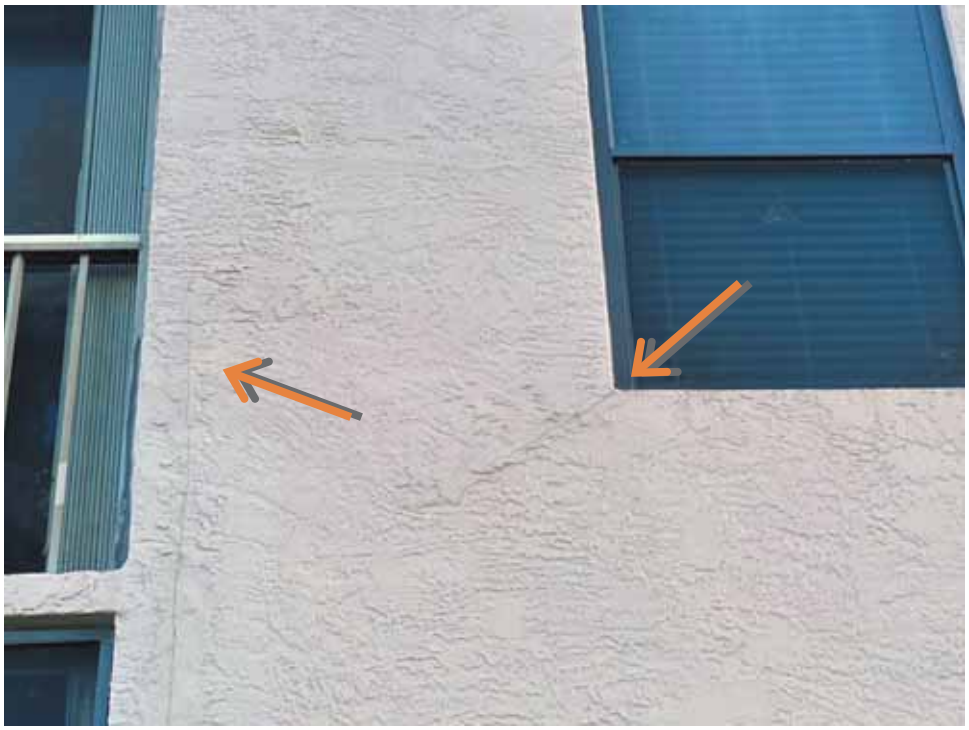
12. Many areas of stucco delamination and stucco cracking were observed on the masonry walls but were often found on the slab edges. Rust spots were also observed along some of the slab edges.

Figure 51: Stucco cracks

8. The Association should plan to replace the existing balcony enclosures and picket railings with new code-compliant railings.
9. Delaminated stucco should be removed from any concrete or masonry surfaces. New stucco should be applied to match existing. Cracks in the stucco on vertical and horizontal surfaces should be sealed. If cracks exceed 1/16” in width, the cracks should be routed in a “V” shape before sealing. Cracking between poured concrete elements and concrete blocks might require mesh reinforcement to prevent future cracking.
