HUNTINGTON LAKES SECTION 4
BUILDING 36

BUILDINGS STRUCTURAL MILESTONE
INSPECTION REPORT

FEBRUARY 2024

Re: Milestone Inspections
Huntington Lakes Section Four
7281 Amberly Lane – Building 36
Delray Beach, Florida 33446

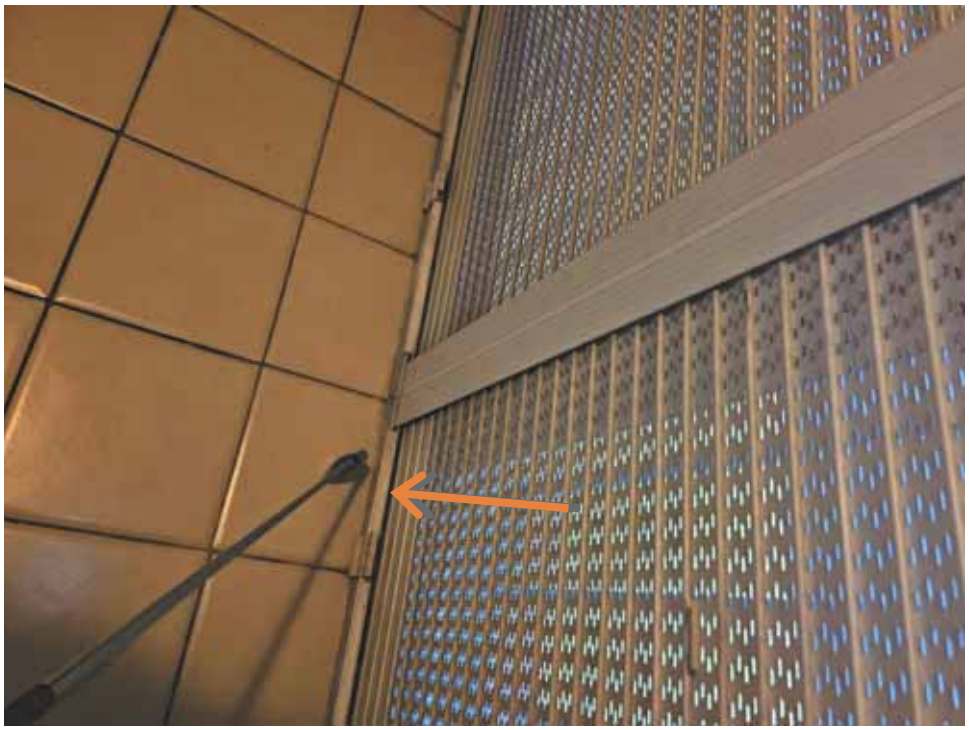
Figure 33: Water and debris trapped between screen frame, sunshade frame, and horizontal sliding plexiglass frame

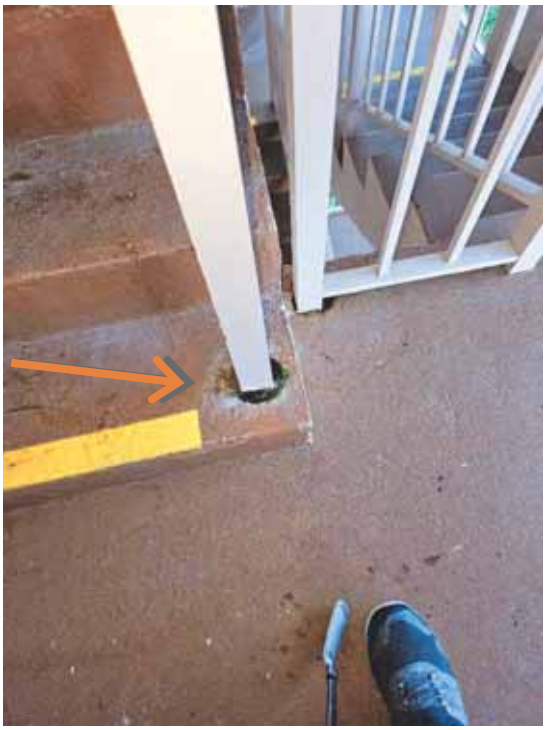
Figure 44: Concrete spall at stairwell

1. Concrete spalling should be repaired according to engineering specifications at the balconies, building envelope, roof, and catwalk. Any shutters, sunshades, railings, windows, or doors impeding the proper repair of the concrete will need to be removed. When removing doors and windows, temporary weather walls will need to be constructed to protect the interior of the unit. Proof of installation permits will need to be provided by unit owners for the reinstallation of existing enclosures. Due to their age, screen enclosure reinstallation may not be possible, and railing replacement might be required.

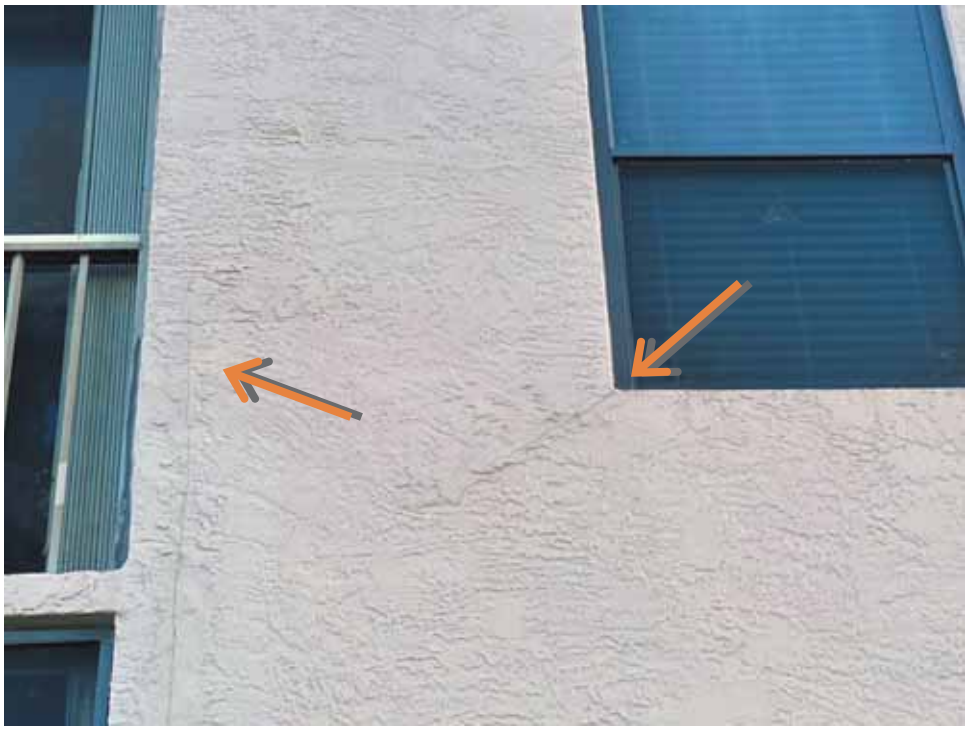
Figure 50: Failing previous repair at exterior wall
