Windstorm Mitigation Inspection

7351 AMBERLY LN, DELRAY BEACH FL 33446

NAME:	HUNTINGTON LAKES SECTION FOUR			Inspection Date:	05/01/2024
ADDRESS:	7351 AMBERLY LN, DELRAY BEACH FL 33446			COUNTY:	PALM BEACH
TEL:	YR BUILT: 1987	STORIES	1	AGENT:	
EMAIL:		POLICY#

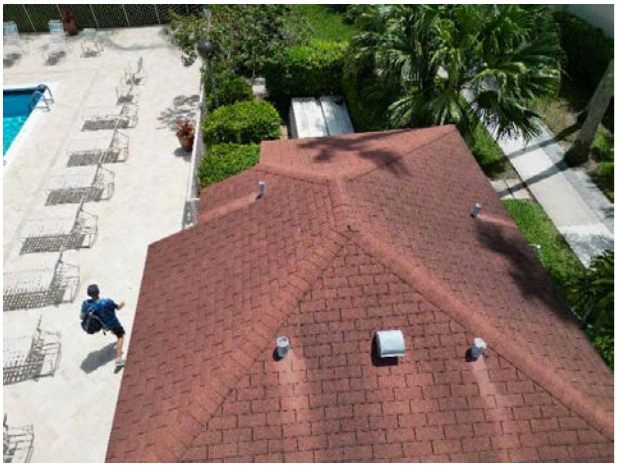
ROOF COVERING

No hurricane protection...No roof permit info located on buildfax/city site, HOA responsible for providing documentation if needed by carrier
