HUNTINGTON LAKES SECTION 4
BUILDING 29

BUILDINGS STRUCTURAL PHASE TWO
MILESTONE INSPECTION REPORT

SEPTEMBER 2024

Re: Milestone Inspections – Phase Two
Huntington Lakes Section Four
7280 Amberly Lane – Building 29
Delray Beach, Florida 33446

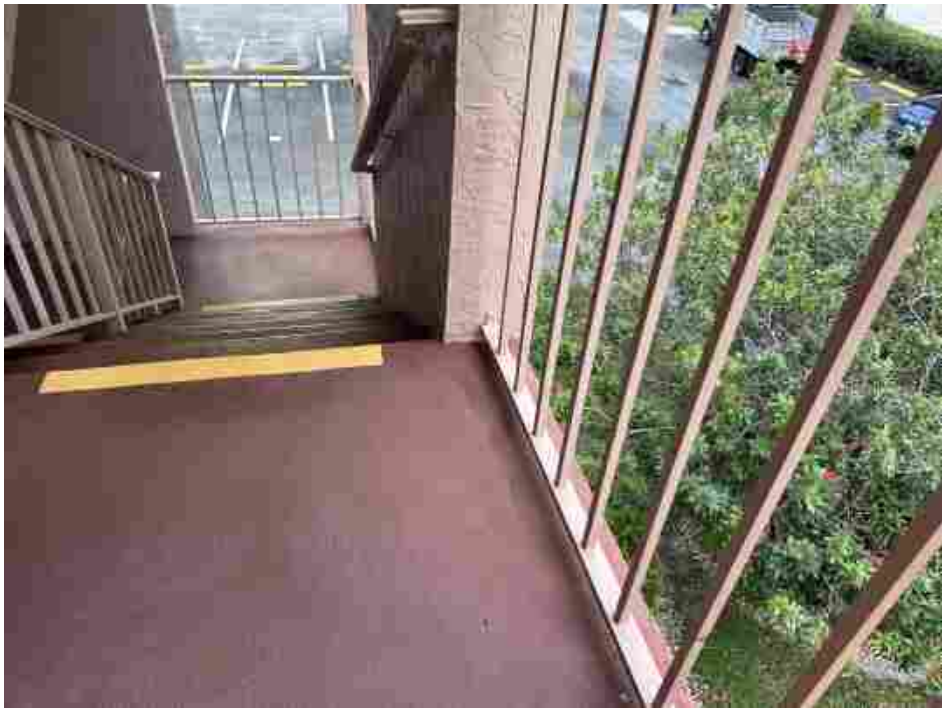
Figure 5: Typical simply supported catwalks on a 4-story building with concrete columns and picket railings (Similar to Buildings 33 through 36)

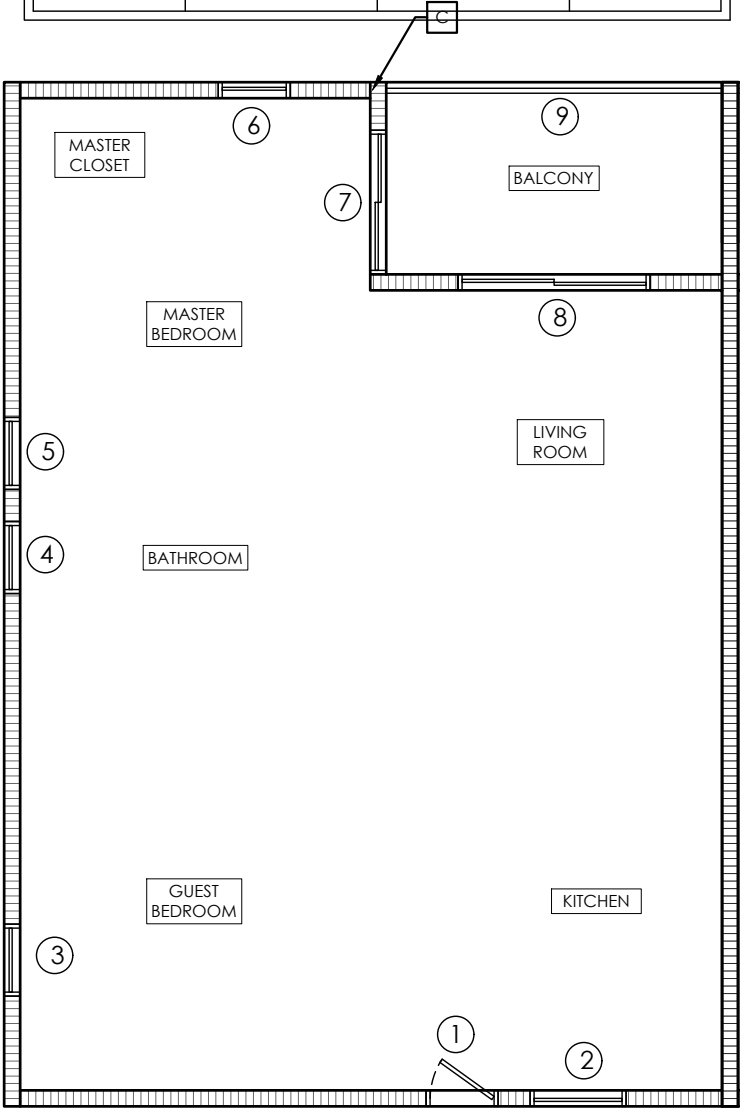
DESCRIPTION	SYM	EST, QTY.
EDGE REPAIR	E	
PARTIAL DECK REPAIR	D	
OVERHEAD REPAIR	O	2 SF
THRU DECK REPAIR	T	
STRESS CRACK REPAIR	R	
HOLLOW TILE	HT	
BEAM REPAIR	B	
COLUMN REPAIR	C	1 CF
DELAMINATED STUCCO REPAIR	S	
STUCCO CRACK REPAIR	SC	
RUST SPOTS	RS	
MISSING ELECTRICAL COVER PLATE	EC	
ABANDON FASTENER/HOLES	F

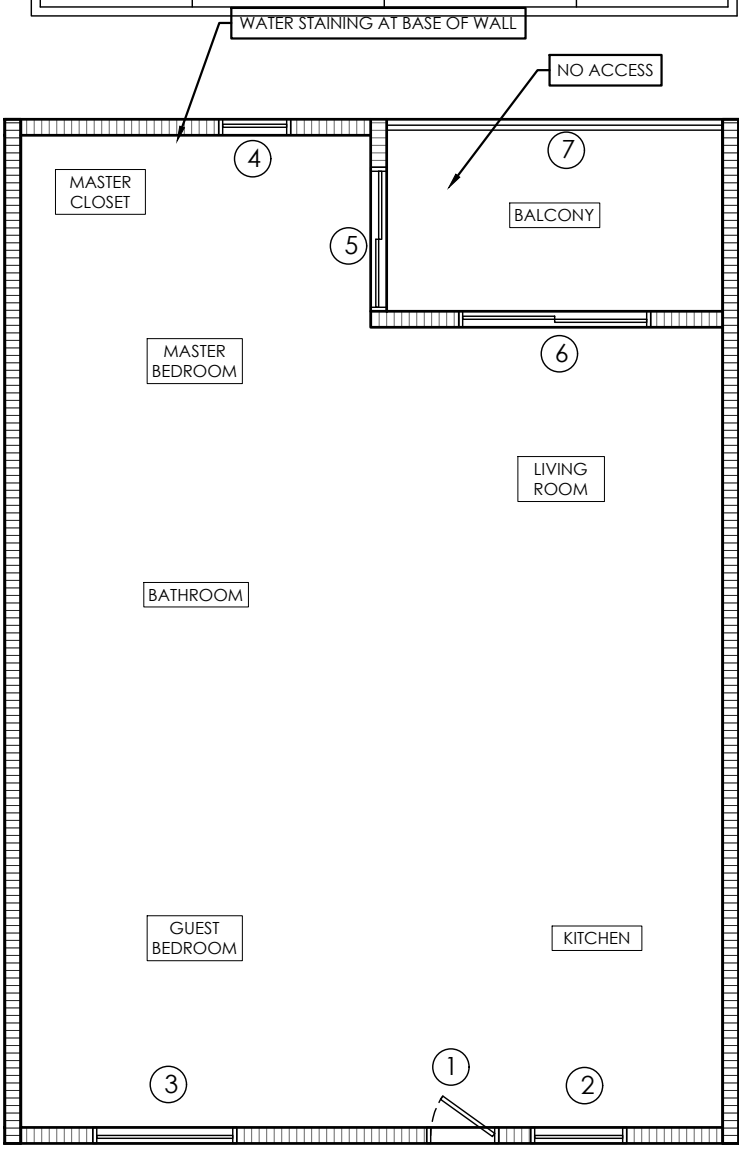
DESCRIPTION	SYM	EST, QTY.
EDGE REPAIR	E	
PARTIAL DECK REPAIR	D	
OVERHEAD REPAIR	O	
THRU DECK REPAIR	T	
STRESS CRACK REPAIR	R	
HOLLOW TILE	HT	
BEAM REPAIR	B	
COLUMN REPAIR	C	2 CF
DELAMINATED STUCCO REPAIR	S	
STUCCO CRACK REPAIR	SC	
RUST SPOTS	RS	
MISSING ELECTRICAL COVER PLATE	EC	
ABANDON FASTENER/HOLES	F

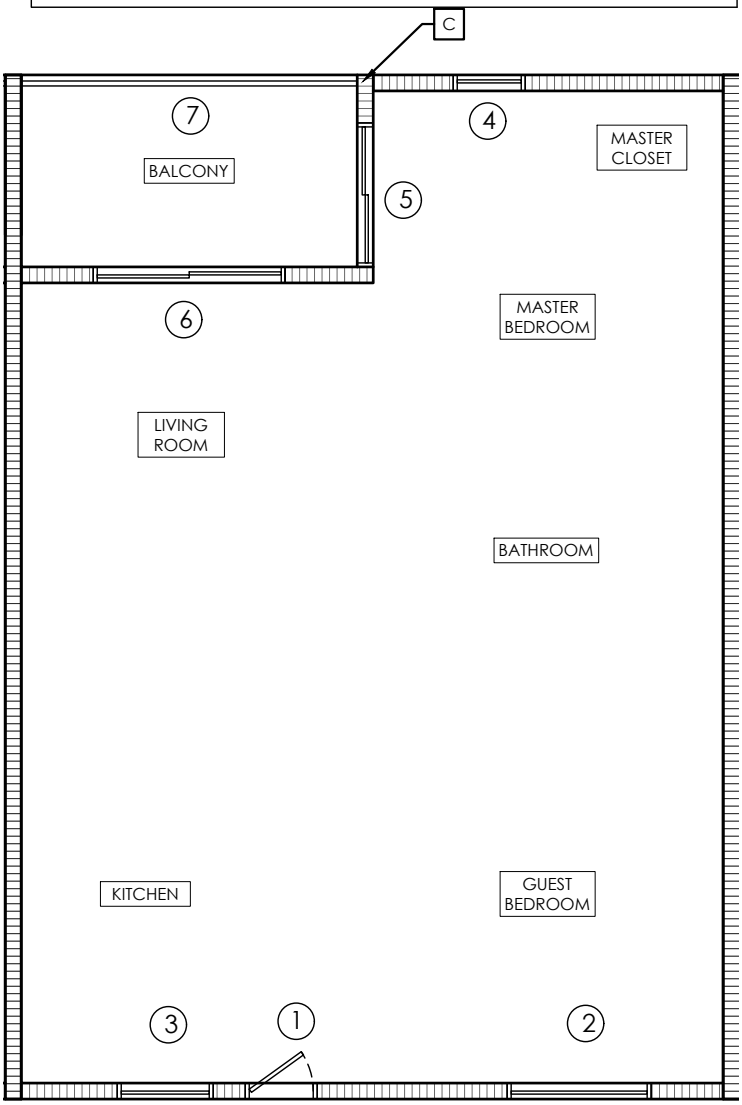
DESCRIPTION	SYM	EST, QTY.
EDGE REPAIR	E	
PARTIAL DECK REPAIR	D	
OVERHEAD REPAIR	O	
THRU DECK REPAIR	T	
STRESS CRACK REPAIR	R	
HOLLOW TILE	HT	
BEAM REPAIR	B	
COLUMN REPAIR	C	3 CF
DELAMINATED STUCCO REPAIR	S	
STUCCO CRACK REPAIR	SC	
RUST SPOTS	RS	
MISSING ELECTRICAL COVER PLATE	EC	1 EA
ABANDON FASTENER/HOLES	F	4 EA

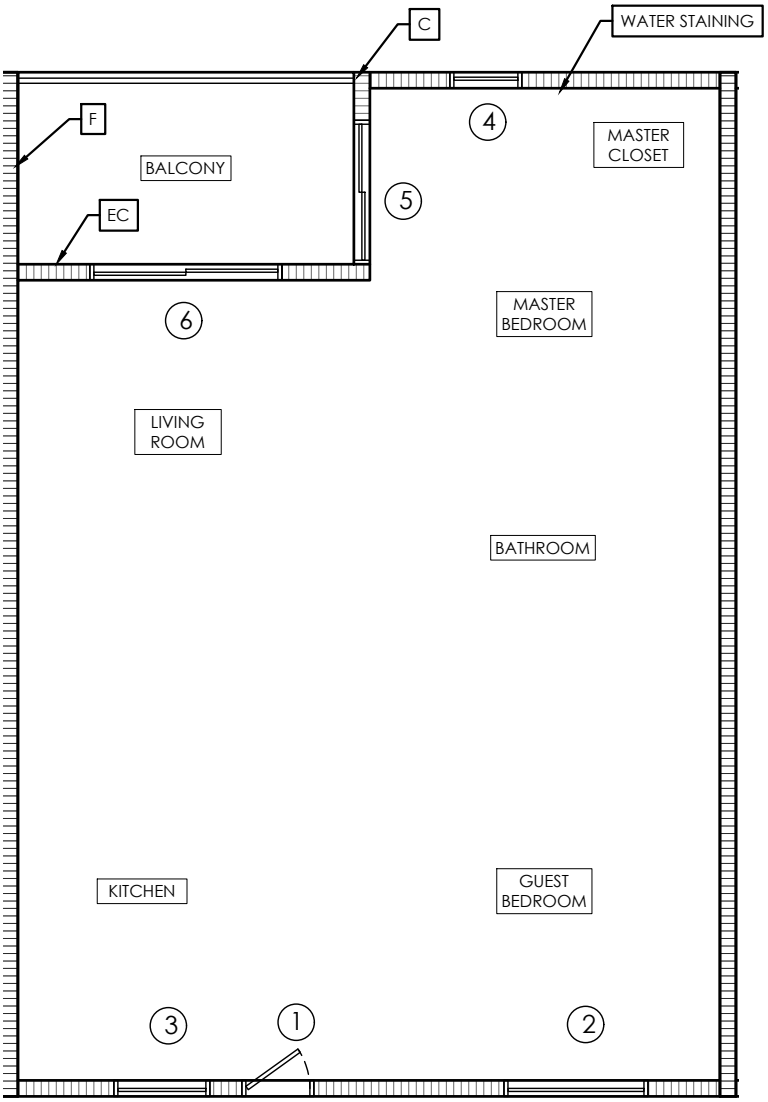
DESCRIPTION	SYM	EST, QTY.
EDGE REPAIR	E	
PARTIAL DECK REPAIR	D	
OVERHEAD REPAIR	O	
THRU DECK REPAIR	T	
STRESS CRACK REPAIR	R	
HOLLOW TILE	HT	
BEAM REPAIR	B	
COLUMN REPAIR	C	10 CF
DELAMINATED STUCCO REPAIR	S	
STUCCO CRACK REPAIR	SC	
RUST SPOTS	RS	
MISSING ELECTRICAL COVER PLATE	EC	
ABANDON FASTENER/HOLES	F	2 EA

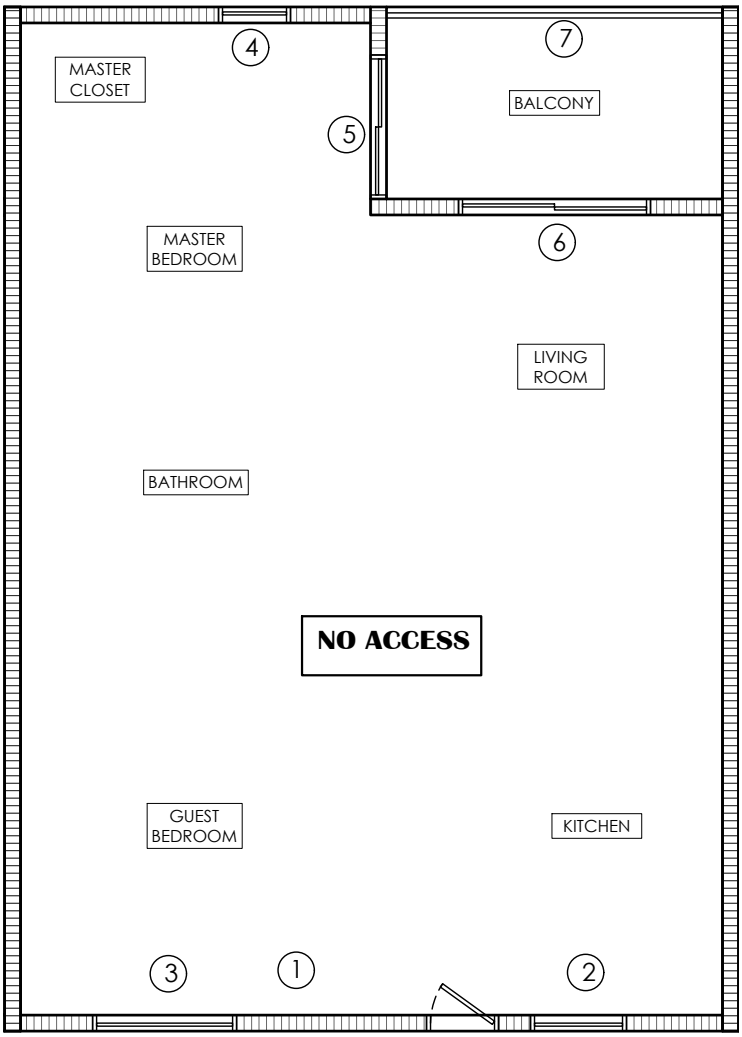
DESCRIPTION	SYM	EST, QTY.
EDGE REPAIR	E	
PARTIAL DECK REPAIR	D	
OVERHEAD REPAIR	O	
THRU DECK REPAIR	T	
STRESS CRACK REPAIR	R	
HOLLOW TILE	HT	
BEAM REPAIR	B	
COLUMN REPAIR	C	4 CF
DELAMINATED STUCCO REPAIR	S	
STUCCO CRACK REPAIR	SC	
RUST SPOTS	RS	
MISSING ELECTRICAL COVER PLATE	EC	
ABANDON FASTENER/HOLES	F	8 EA

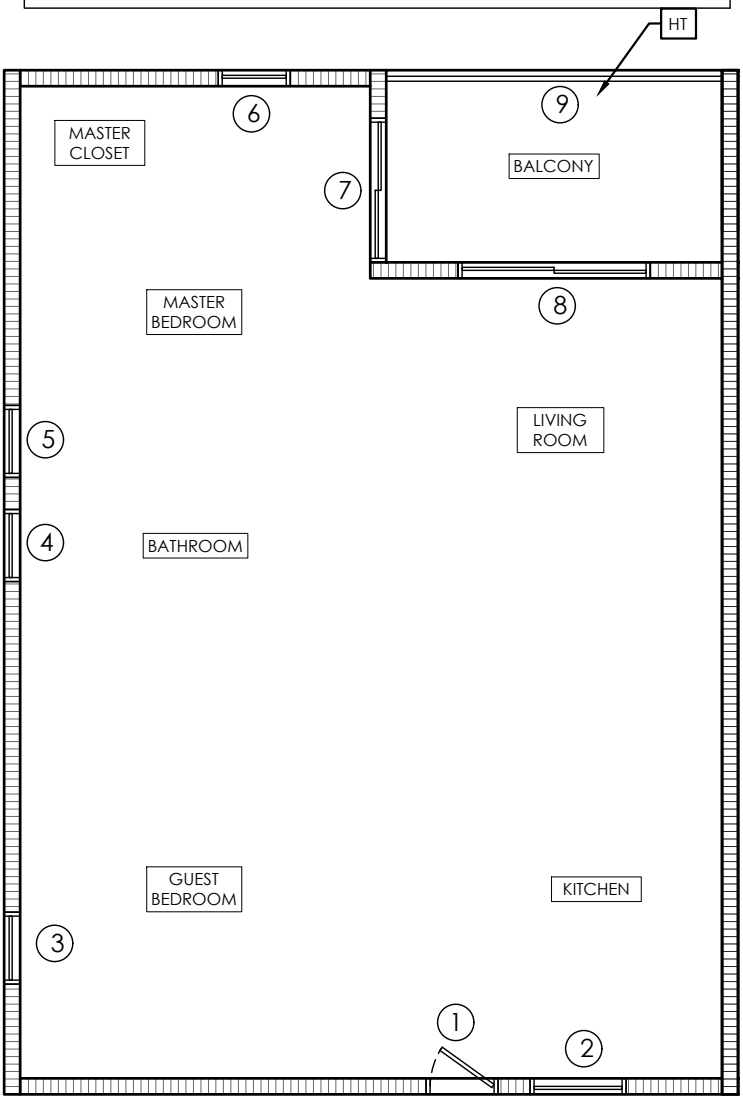
DESCRIPTION	SYM	EST, QTY.
EDGE REPAIR	E	
PARTIAL DECK REPAIR	D	
OVERHEAD REPAIR	O	1 SF
THRU DECK REPAIR	T	
STRESS CRACK REPAIR	R	
HOLLOW TILE	HT	3 SF
BEAM REPAIR	B	
COLUMN REPAIR	C	1 CF
DELAMINATED STUCCO REPAIR	S	
STUCCO CRACK REPAIR	SC	
RUST SPOTS	RS	
MISSING ELECTRICAL COVER PLATE	EC	
ABANDON FASTENER/HOLES	F	21 EA

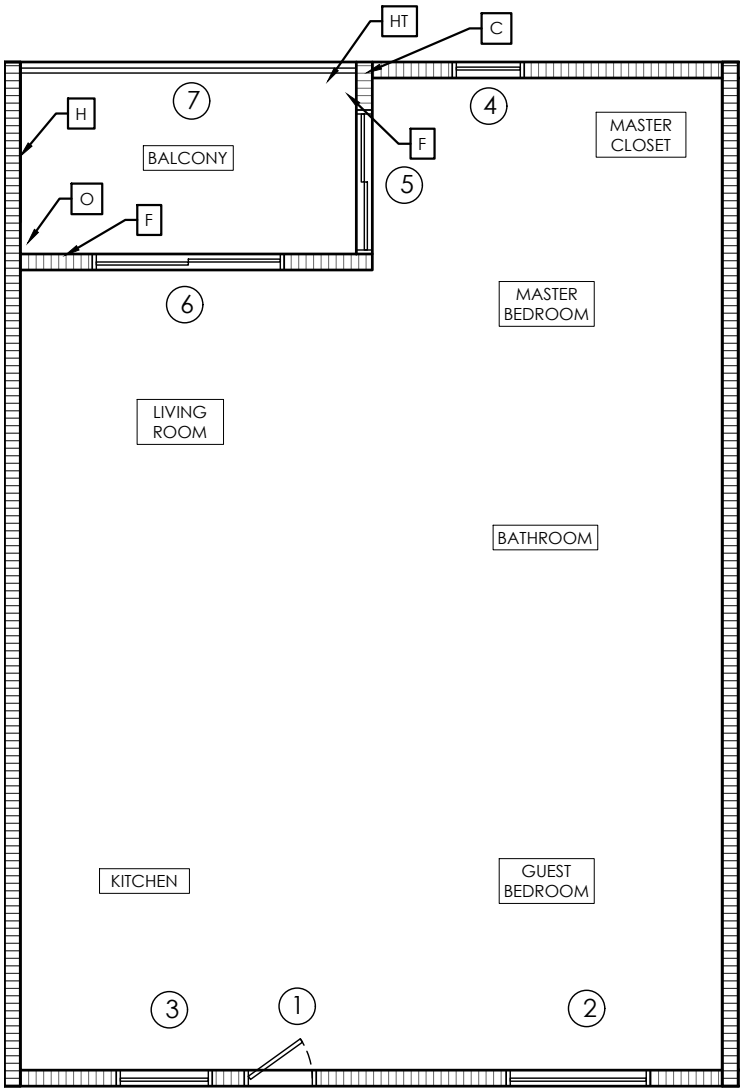
DESCRIPTION	SYM	EST. QTY.
EDGE REPAIR	E	
PARTIAL DECK REPAIR	D	
OVERHEAD REPAIR	O	
THRU DECK REPAIR	T	
STRESS CRACK REPAIR	R	
HOLLOW TILE	HT	
BEAM REPAIR	B	
COLUMN REPAIR	C	2 CF
DELAMINATED STUCCO REPAIR	S	
STUCCO CRACK REPAIR	SC	
RUST SPOTS	RS	
MISSING ELECTRICAL COVER PLATE	EC	
ABANDON FASTENER/HOLES	F

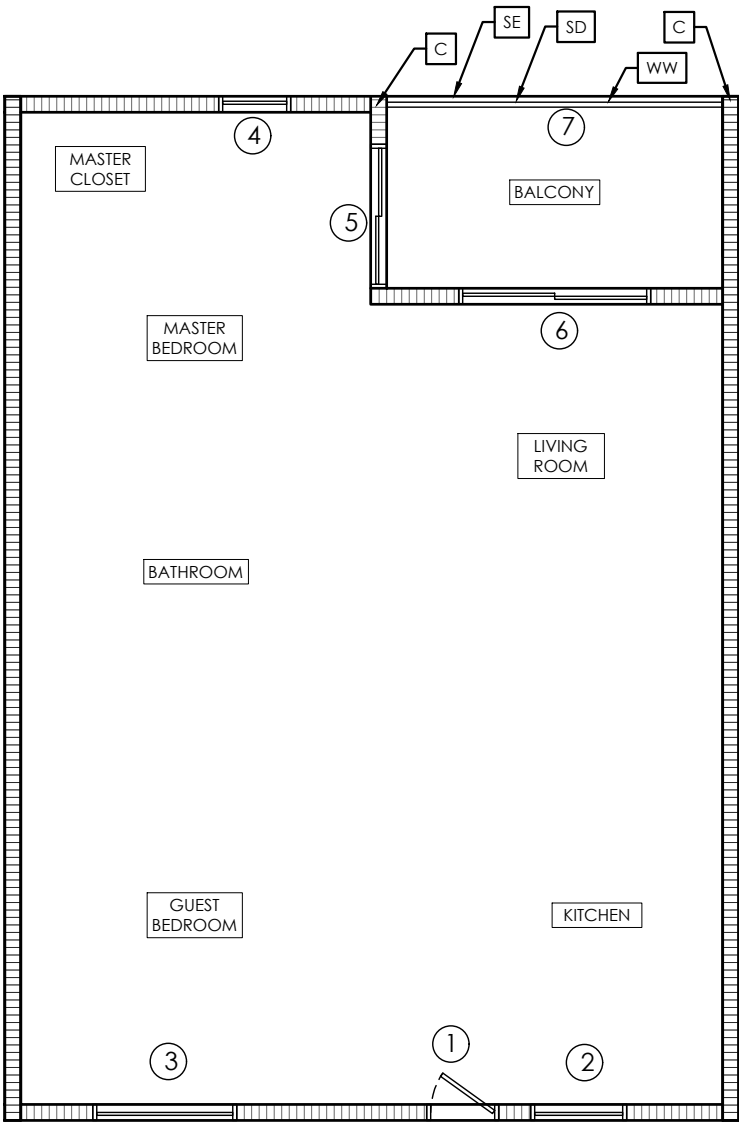
DESCRIPTION	SYM	EST, QTY.
EDGE REPAIR	E	
PARTIAL DECK REPAIR	D	
OVERHEAD REPAIR	O	
THRU DECK REPAIR	T	
STRESS CRACK REPAIR	R	
HOLLOW TILE	HT	
BEAM REPAIR	B	
COLUMN REPAIR	C	2 CF
DELAMINATED STUCCO REPAIR	S	
STUCCO CRACK REPAIR	SC	
RUST SPOTS	RS	
MISSING ELECTRICAL COVER PLATE	EC	
ABANDON FASTENER/HOLES	F

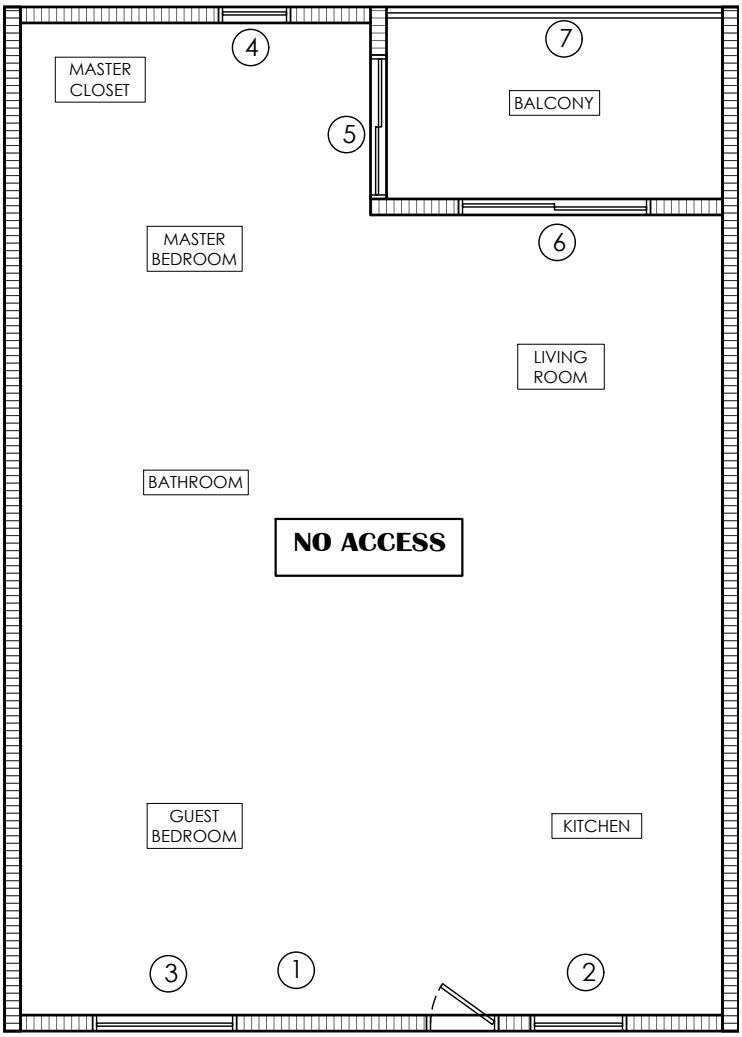
DESCRIPTION	SYM	EST, QTY.
EDGE REPAIR	E	
PARTIAL DECK REPAIR	D	
OVERHEAD REPAIR	O	
THRU DECK REPAIR	T	
STRESS CRACK REPAIR	R	
HOLLOW TILE	HT	
BEAM REPAIR	B	
COLUMN REPAIR	C	2 CF
DELAMINATED STUCCO REPAIR	S	
STUCCO CRACK REPAIR	SC	
RUST SPOTS	RS	
MISSING ELECTRICAL COVER PLATE	EC	
ABANDON FASTENER/HOLES	F	2 EA

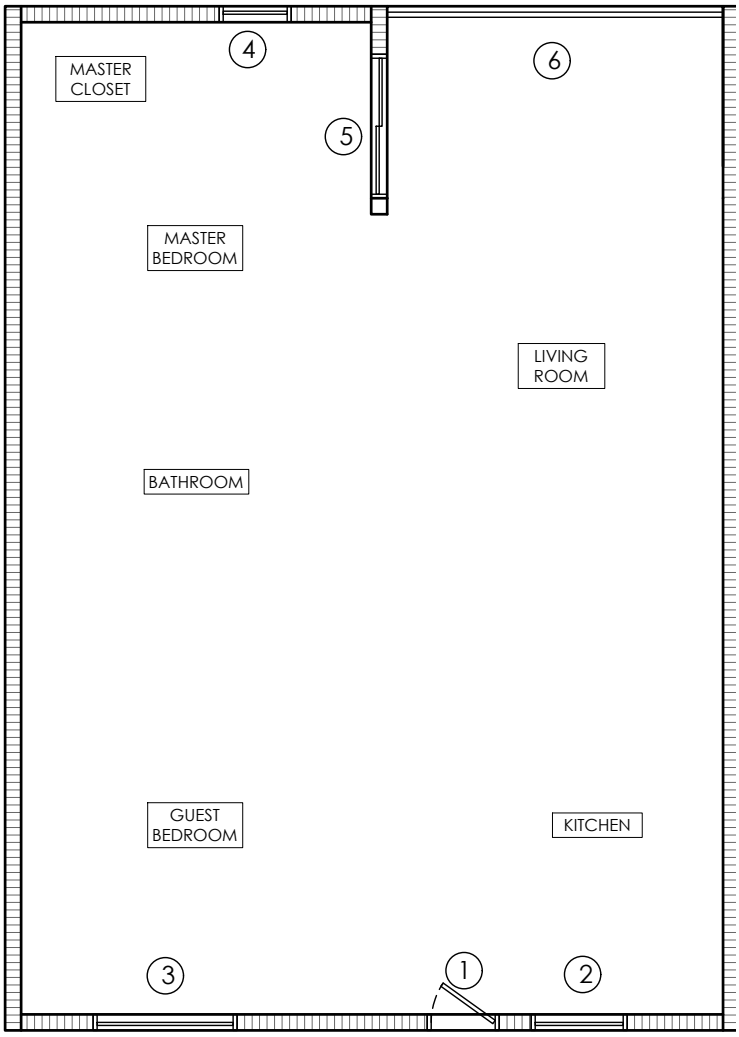
DESCRIPTION	SYM	EST, QTY.
EDGE REPAIR	E	
PARTIAL DECK REPAIR	D	
OVERHEAD REPAIR	O	
THRU DECK REPAIR	T	
STRESS CRACK REPAIR	R	
HOLLOW TILE	HT	
BEAM REPAIR	B	
COLUMN REPAIR	C	2 CF
DELAMINATED STUCCO REPAIR	S	
STUCCO CRACK REPAIR	SC	
RUST SPOTS	RS	
MISSING ELECTRICAL COVER PLATE	EC	
ABANDON FASTENER/HOLES	F	3 EA

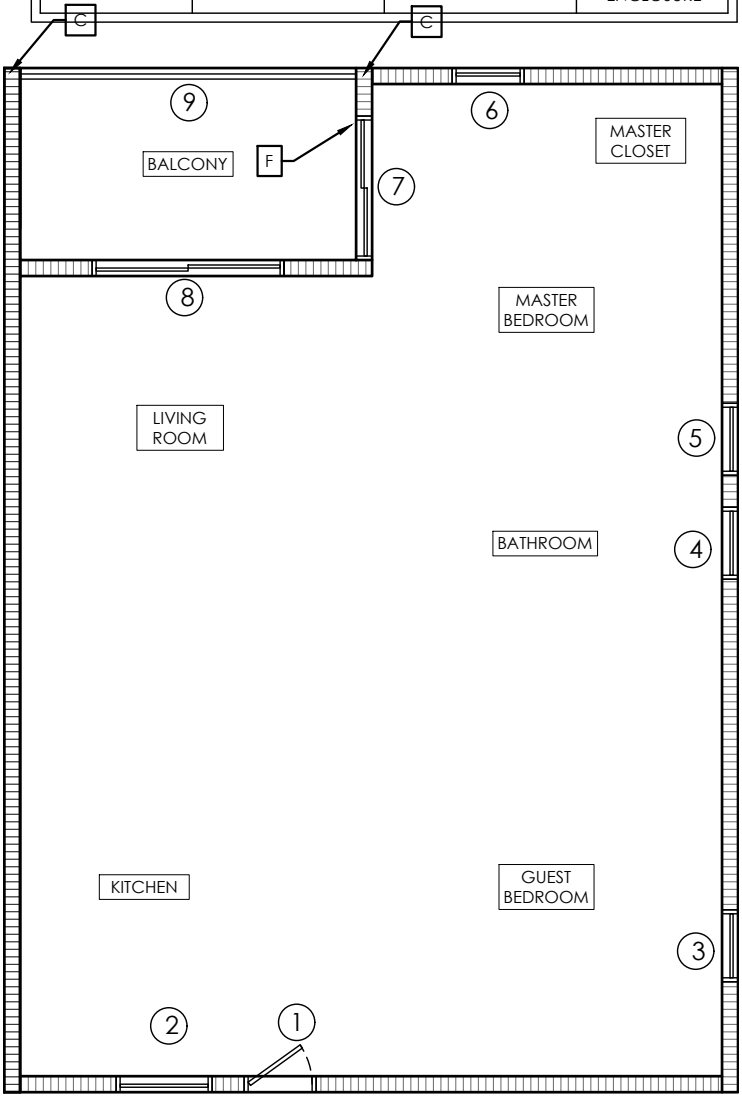
DESCRIPTION	SYM	EST, QTY.
EDGE REPAIR	E	
PARTIAL DECK REPAIR	D	
OVERHEAD REPAIR	O	
THRU DECK REPAIR	T	
STRESS CRACK REPAIR	R	
HOLLOW TILE	HT	
BEAM REPAIR	B	
COLUMN REPAIR	C	1 CF
DELAMINATED STUCCO REPAIR	S	
STUCCO CRACK REPAIR	SC	
RUST SPOTS	RS	
MISSING ELECTRICAL COVER PLATE	EC	
ABANDON FASTENER/HOLES	F	2 EA

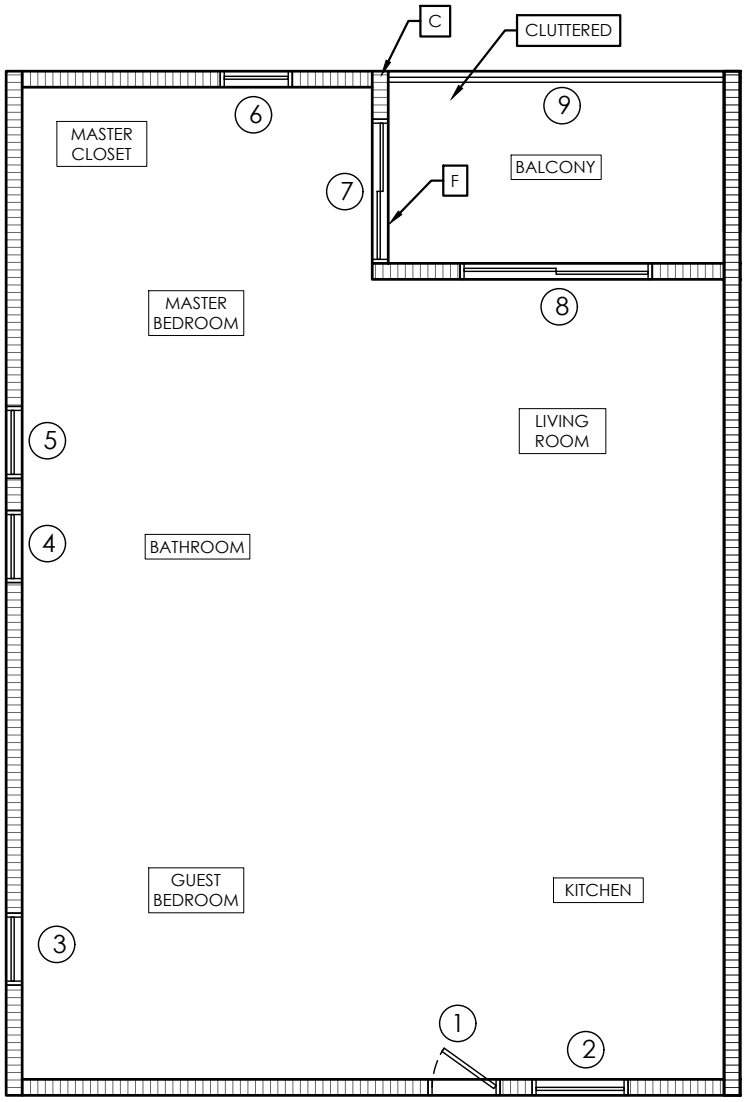
DESCRIPTION	SYM	EST. QTY.
EDGE REPAIR	E	
PARTIAL DECK REPAIR	D	
OVERHEAD REPAIR	O	2 SF
THRU DECK REPAIR	T	
STRESS CRACK REPAIR	R	
HOLLOW TILE	HT	8 SF
BEAM REPAIR	B	
COLUMN REPAIR	C	1 CF
DELAMINATED STUCCO REPAIR	S	
STUCCO CRACK REPAIR	SC	
RUST SPOTS	RS	
MISSING ELECTRICAL COVER PLATE	EC	
ABANDON FASTENER/HOLES	F	6 EA

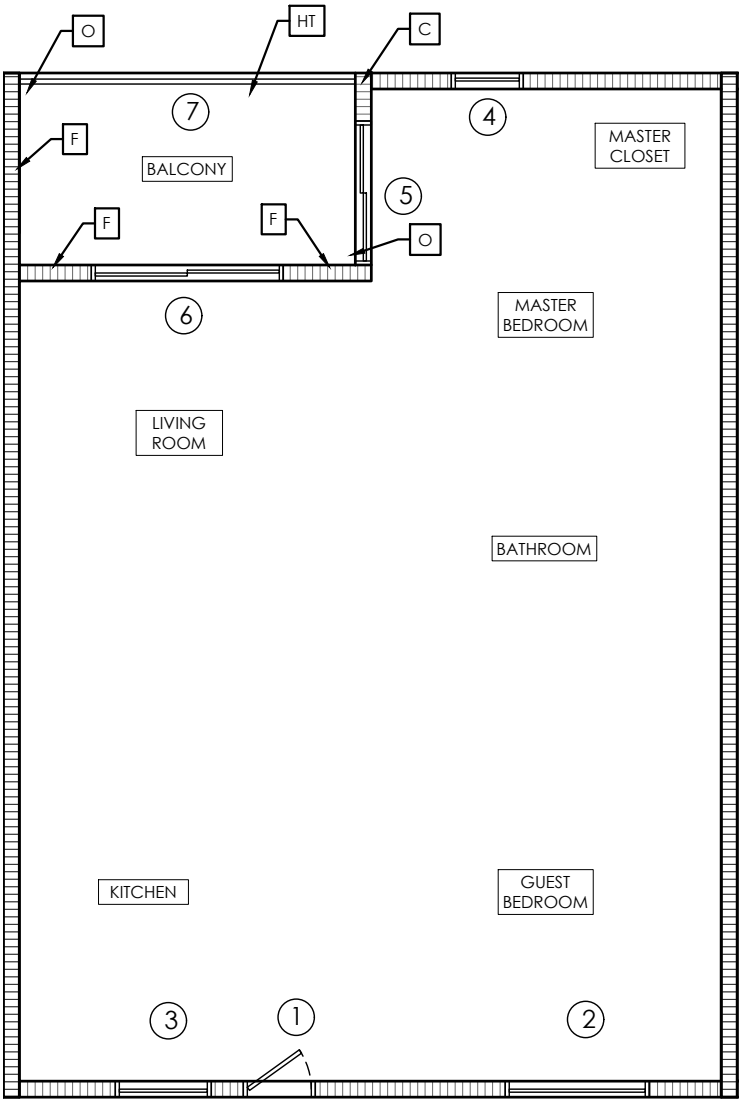
DESCRIPTION	SYM	EST, QTY.
EDGE REPAIR	E	
PARTIAL DECK REPAIR	D	
OVERHEAD REPAIR	O	
THRU DECK REPAIR	T	
STRESS CRACK REPAIR	R	
HOLLOW TILE	HT	
BEAM REPAIR	B	
COLUMN REPAIR	C	1 CF
DELAMINATED STUCCO REPAIR	S	
STUCCO CRACK REPAIR	SC	
RUST SPOTS	RS	
MISSING ELECTRICAL COVER PLATE	EC	
ABANDON FASTENER/HOLES	F	3 EA

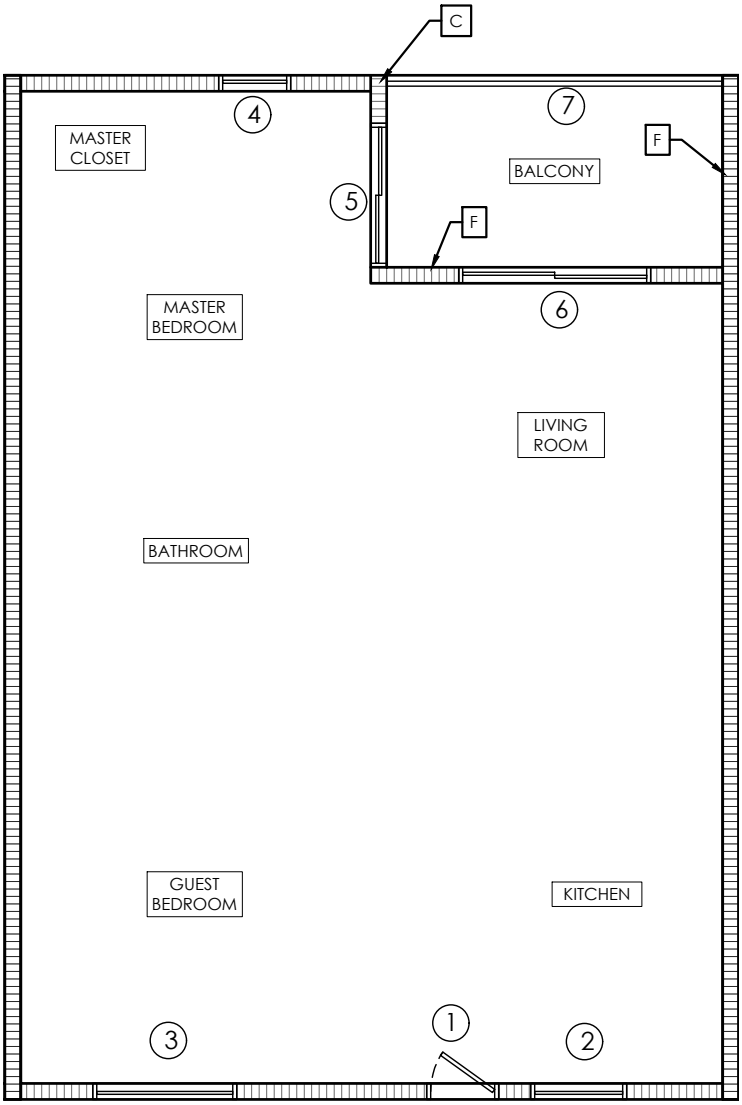
DESCRIPTION	SYM	EST. QTY.
EDGE REPAIR	E	
PARTIAL DECK REPAIR	D	
OVERHEAD REPAIR	O	
THRU DECK REPAIR	T	
STRESS CRACK REPAIR	R	
HOLLOW TILE	HT	2 SF
BEAM REPAIR	B	
COLUMN REPAIR	C	2 CF
DELAMINATED STUCCO REPAIR	S	
STUCCO CRACK REPAIR	SC	
RUST SPOTS	RS	
MISSING ELECTRICAL COVER PLATE	EC	
ABANDON FASTENER/HOLES	F	2 EA

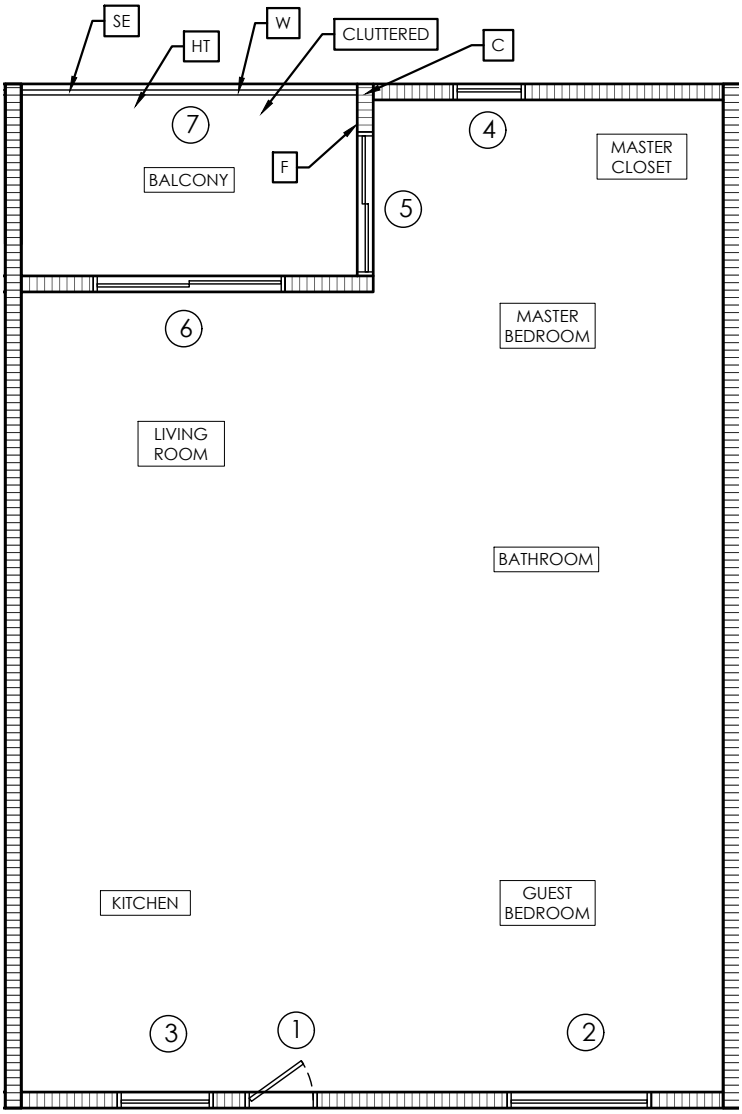
DESCRIPTION	SYM	EST, QTY.
EDGE REPAIR	E	
PARTIAL DECK REPAIR	D	
OVERHEAD REPAIR	O	
THRU DECK REPAIR	T	
STRESS CRACK REPAIR	R	
HOLLOW TILE	HT	
BEAM REPAIR	B	
COLUMN REPAIR	C	
DELAMINATED STUCCO REPAIR	S	
STUCCO CRACK REPAIR	SC	
RUST SPOTS	RS	
MISSING ELECTRICAL COVER PLATE	EC	1 EA
ABANDON FASTENER/HOLES	F	20 EA

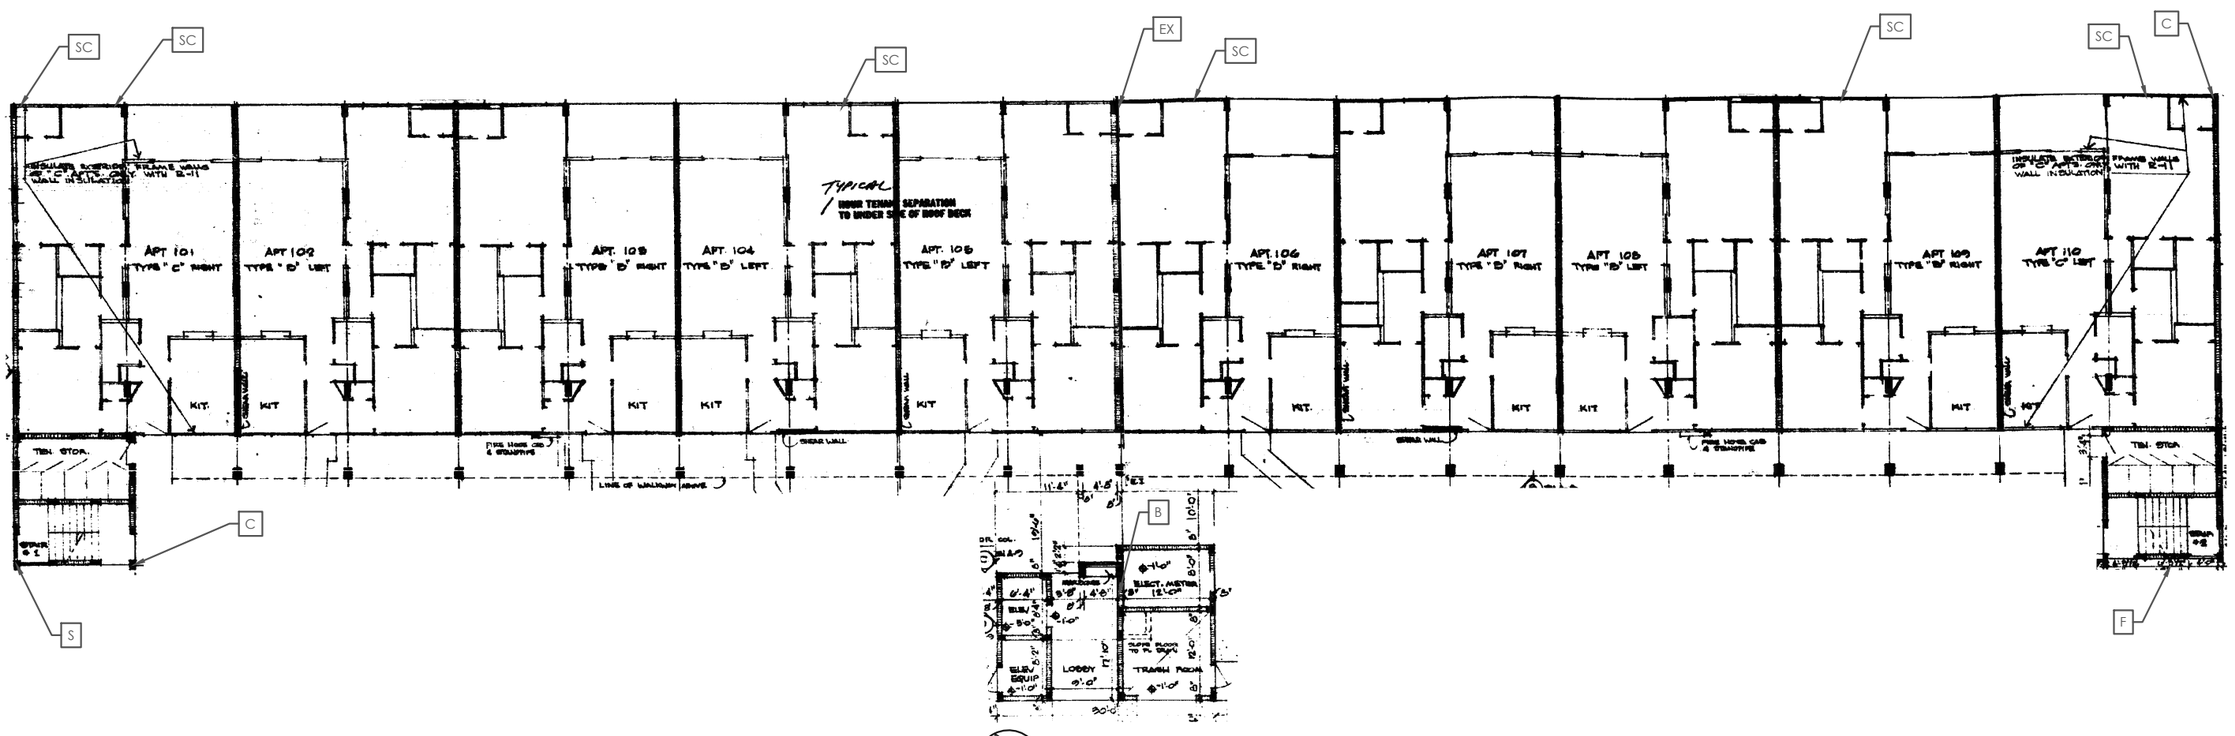
FIRST FLOOR PLAN
SCALE: NTS

ESTIMATED REPAIRS		
DESCRIPTION	SYM	EST. QTY.
EDGE REPAIR	E	
PARTIAL DECK REPAIR	D	
OVERHEAD REPAIR	O	
THRU DECK REPAIR	T	
STRESS CRACK REPAIR	R	
DELAMINATED TOPPING	DT	
BEAM REPAIR	B	2 CF
COLUMN REPAIR	C	8 CF
STUCCO REPAIR	S	8 SF
SOFFIT STUCCO REPAIR	SF	
STUCCO CRACK REPAIR	SC	26 LF
RUST SPOTS	RS	
WINDOW SILL REPAIR	SL	
POST POCKET REPAIRS	PP	
EXPANSION JOINT REPAIR	EX	8 LF
CONSTRUCT. JNT. REPAIR	CJ	
ABANDONED FASTENER/HOLES	F	3 EA

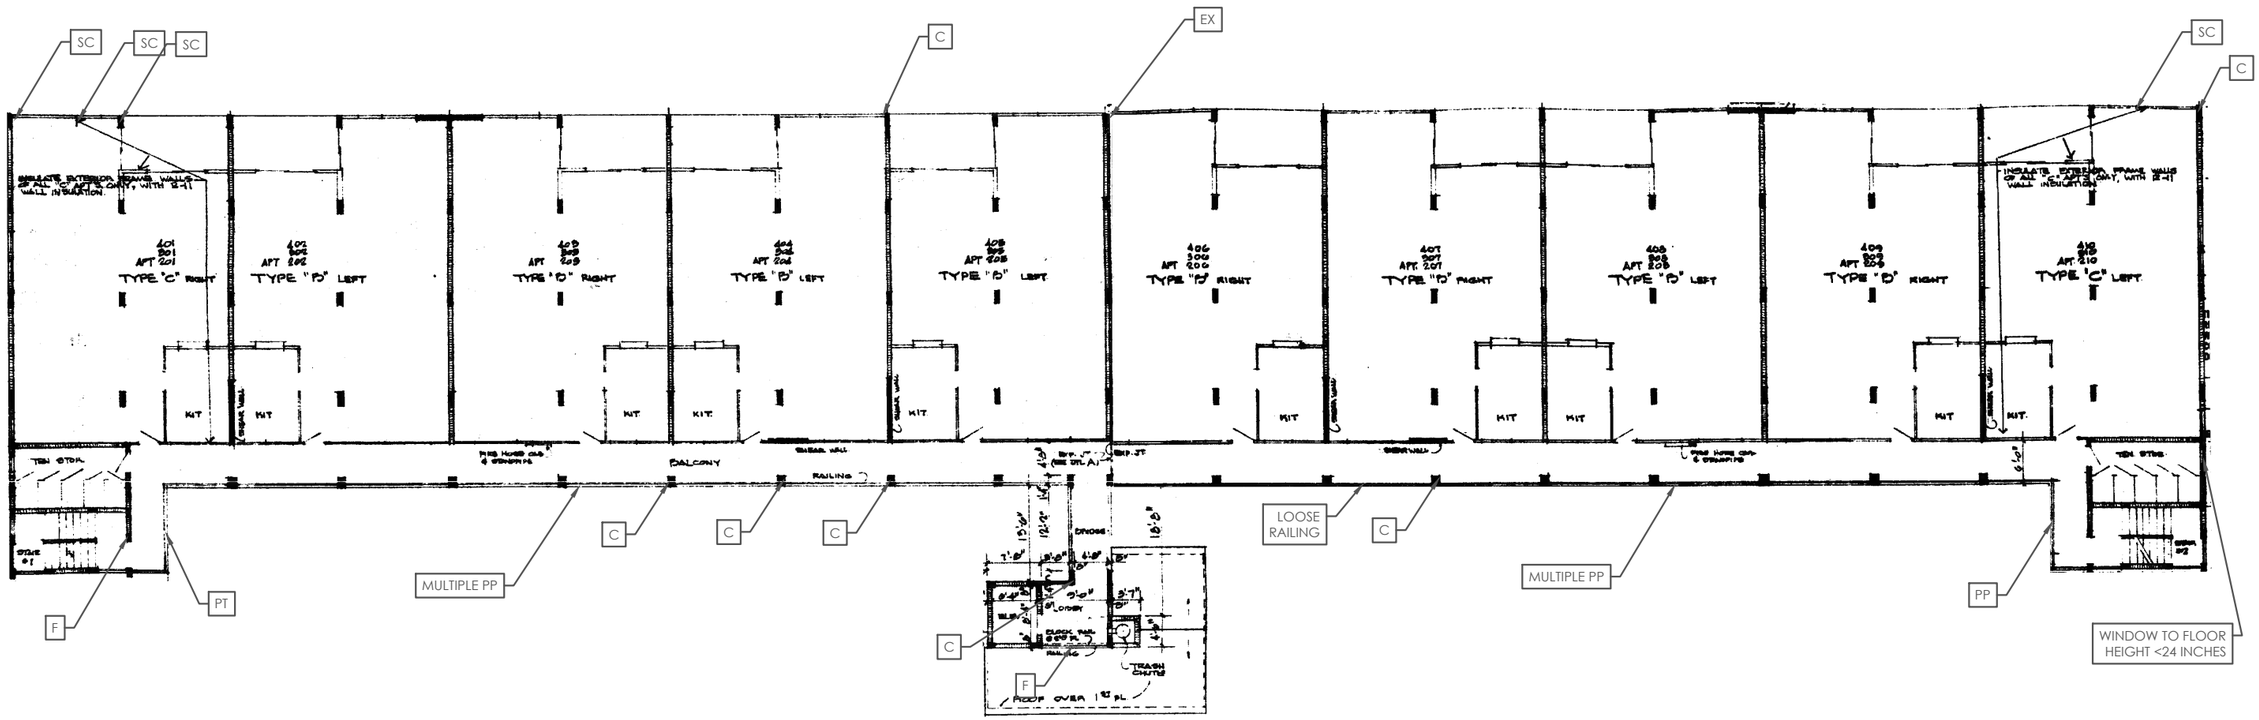
THIRD FLOOR PLAN
SCALE: NTS

ESTIMATED REPAIRS		
DESCRIPTION	SYM	EST. QTY.
EDGE REPAIR	E	
PARTIAL DECK REPAIR	D	
OVERHEAD REPAIR	O	
THRU DECK REPAIR	T	
STRESS CRACK REPAIR	R	
DELAMINATED TOPPING	DT	
BEAM REPAIR	B	
COLUMN REPAIR	C	16 CF
STUCCO REPAIR	S	
SOFFIT STUCCO REPAIR	SF	
STUCCO CRACK REPAIR	SC	19 LF
RUST SPOTS	RS	
WINDOW SILL REPAIR	SL	
POST POCKET REPAIRS	PP	29 EA
EXPANSION JOINT REPAIR	EX	8 LF
CONSTRUCT. JNT. REPAIR	CJ	
POST-TENSION ANCHOR REPAIR	PT	2 EA
ABANDONED FASTENER/HOLES	F	5 EA

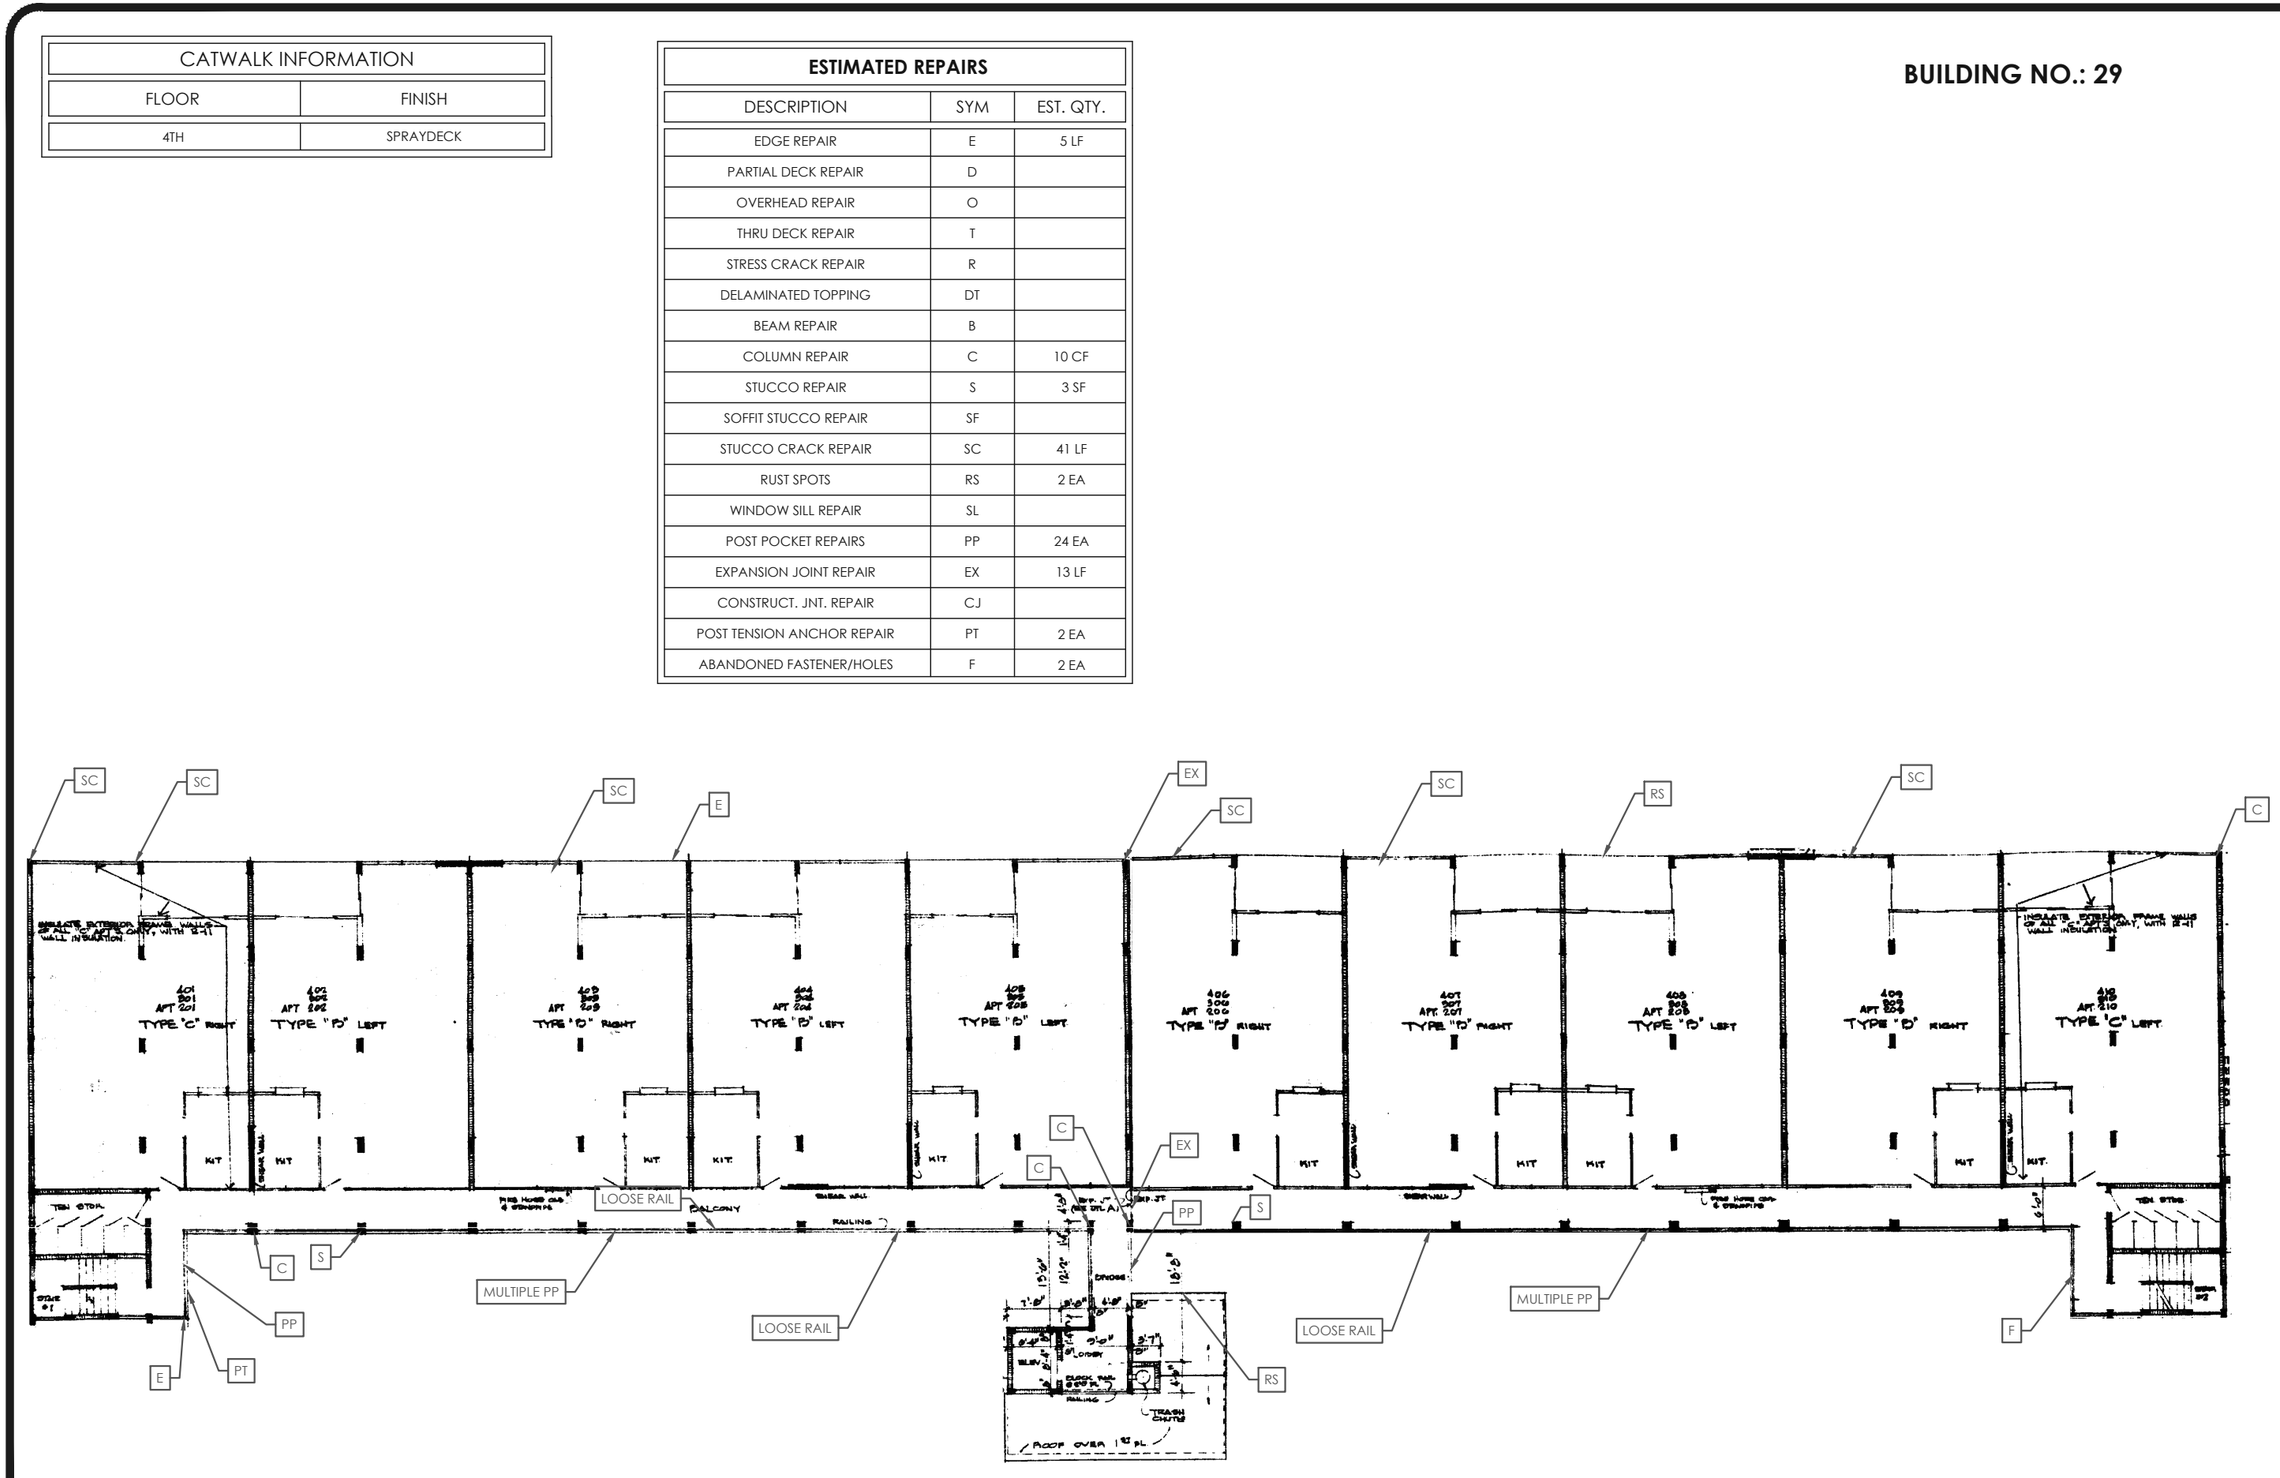
FOURTH FLOOR PLAN
SCALE: NTS

ESTIMATED REPAIRS		
DESCRIPTION	SYM	EST. QTY.
EDGE REPAIR	E	5 LF
PARTIAL DECK REPAIR	D	
OVERHEAD REPAIR	O	
THRU DECK REPAIR	T	
STRESS CRACK REPAIR	R	
DELAMINATED TOPPING	DT	
BEAM REPAIR	B	
COLUMN REPAIR	C	10 CF
STUCCO REPAIR	S	3 SF
SOFFIT STUCCO REPAIR	SF	
STUCCO CRACK REPAIR	SC	41 LF
RUST SPOTS	RS	2 EA
WINDOW SILL REPAIR	SL	
POST POCKET REPAIRS	PP	24 EA
EXPANSION JOINT REPAIR	EX	13 LF
CONSTRUCT. JNT. REPAIR	CJ	
POST TENSION ANCHOR REPAIR	PT	2 EA
ABANDONED FASTENER/HOLES	F	2 EA

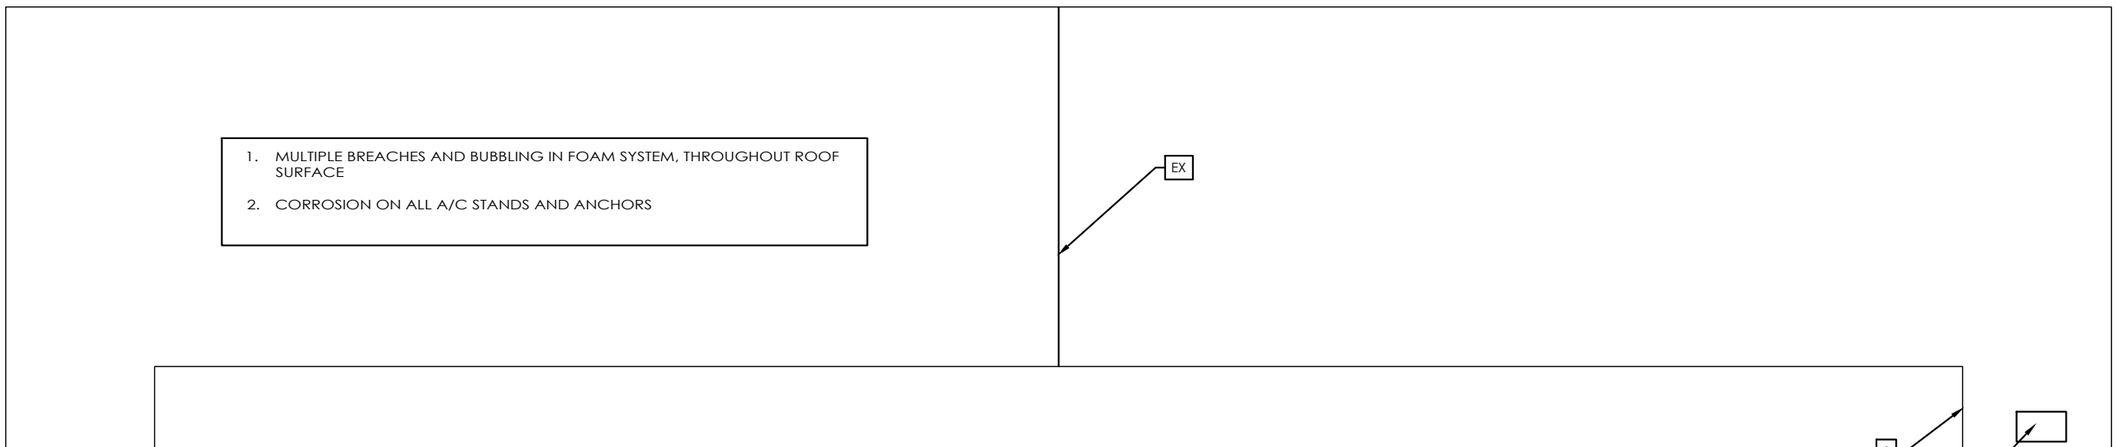
ROOF FLOOR
SCALE: NTS

1. MULTIPLE BREACHES AND BUBBLING IN FOAM SYSTEM, THROUGHOUT ROOF SURFACE
2. CORROSION ON ALL A/C STANDS AND ANCHORS

13. All flat roof systems should be fully replaced. The structural slabs should be inspected prior to the new roof systems being stalled. Stucco repairs will be required on parapet walls. A/C unit stands might require replacement to meet current roofing codes.
