HUNTINGTON LAKES SECTION 4
BUILDING 30

BUILDINGS STRUCTURAL PHASE TWO
MILESTONE INSPECTION REPORT

SEPTEMBER 2024

Re: Milestone Inspections
Huntington Lakes Section Four
7300 Amberly Lane – Building 30
Delray Beach, Florida 33446

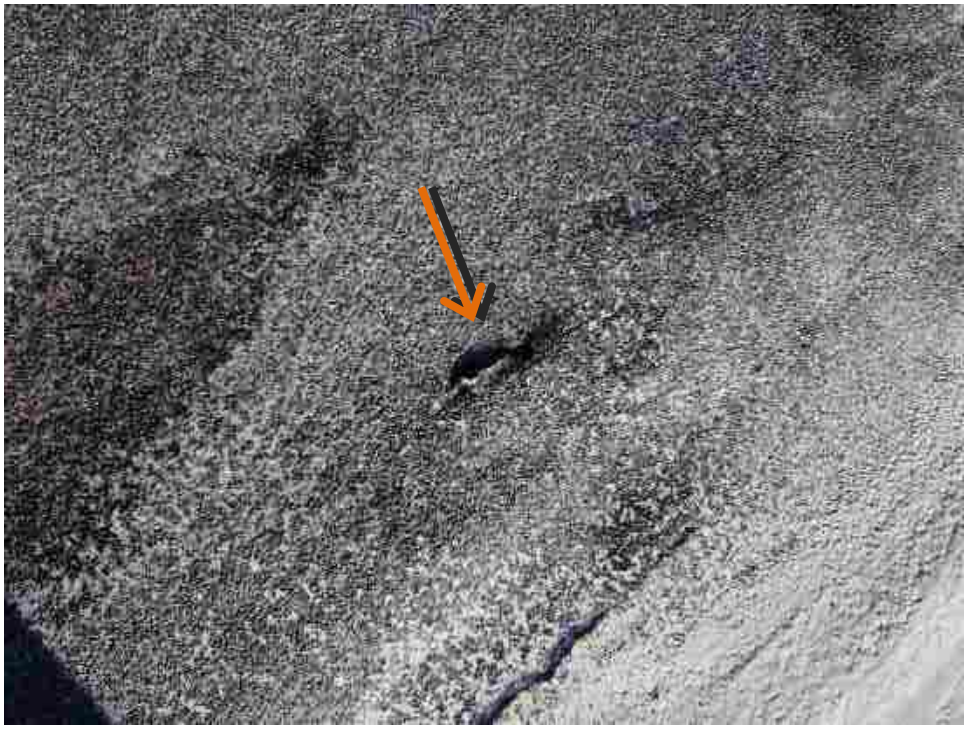
Figure 11: Typical roof area with parapet wall to sloped shingle roof, roof patching, and ponding water

13. All flat roof systems should be fully replaced. The structural slabs should be inspected prior to the new roof systems being stalled. Stucco repairs will be required on parapet walls. A/C unit stands might require replacement to meet current roofing codes.

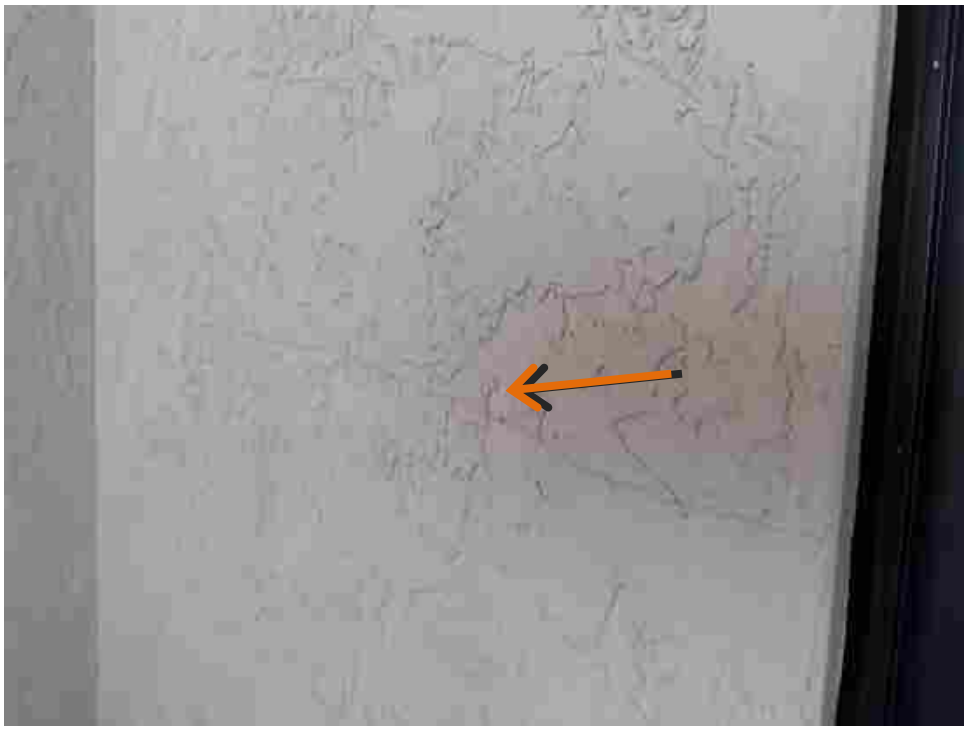
Figure 37: Stucco crack at balcony wall

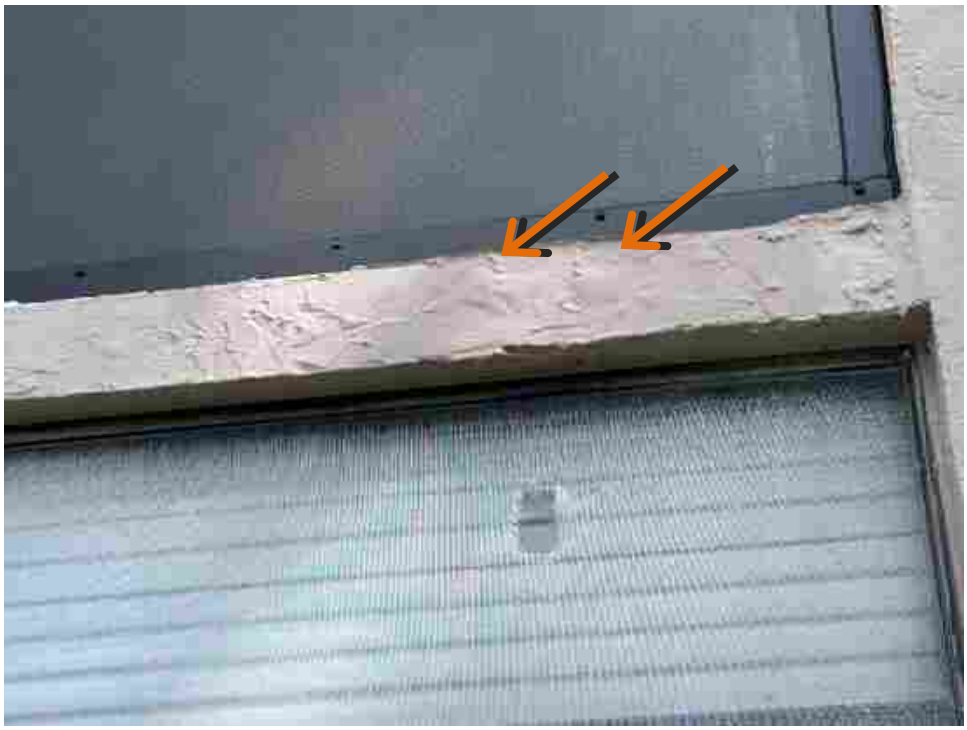
Figure 49: Bubbling paint at slab edge

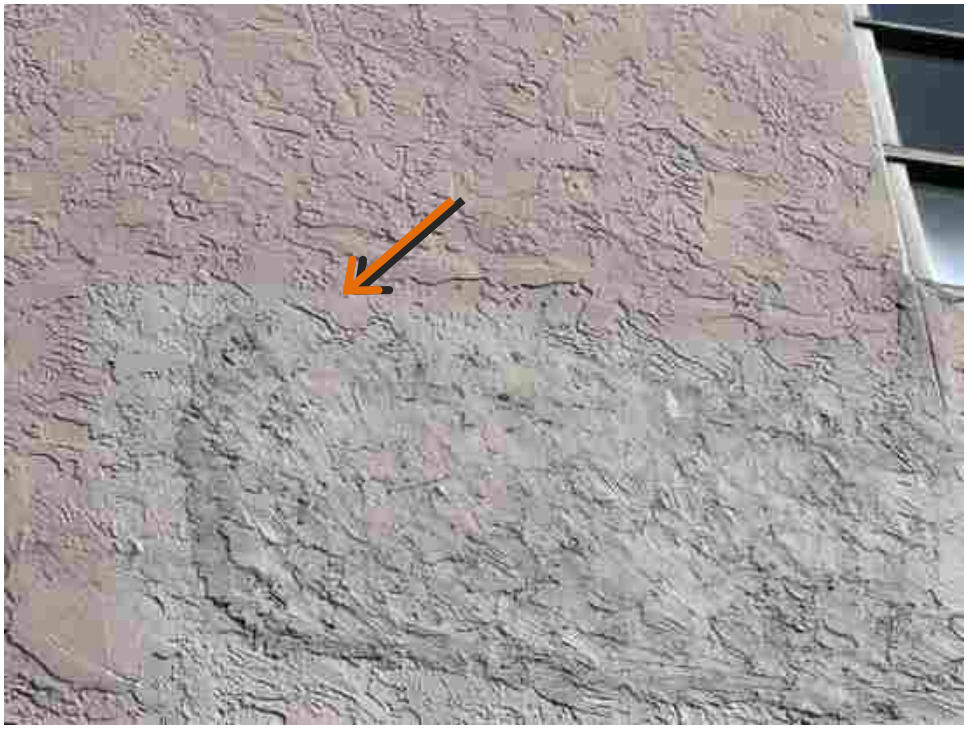
Figure 50: Failing previous repair at exterior wall

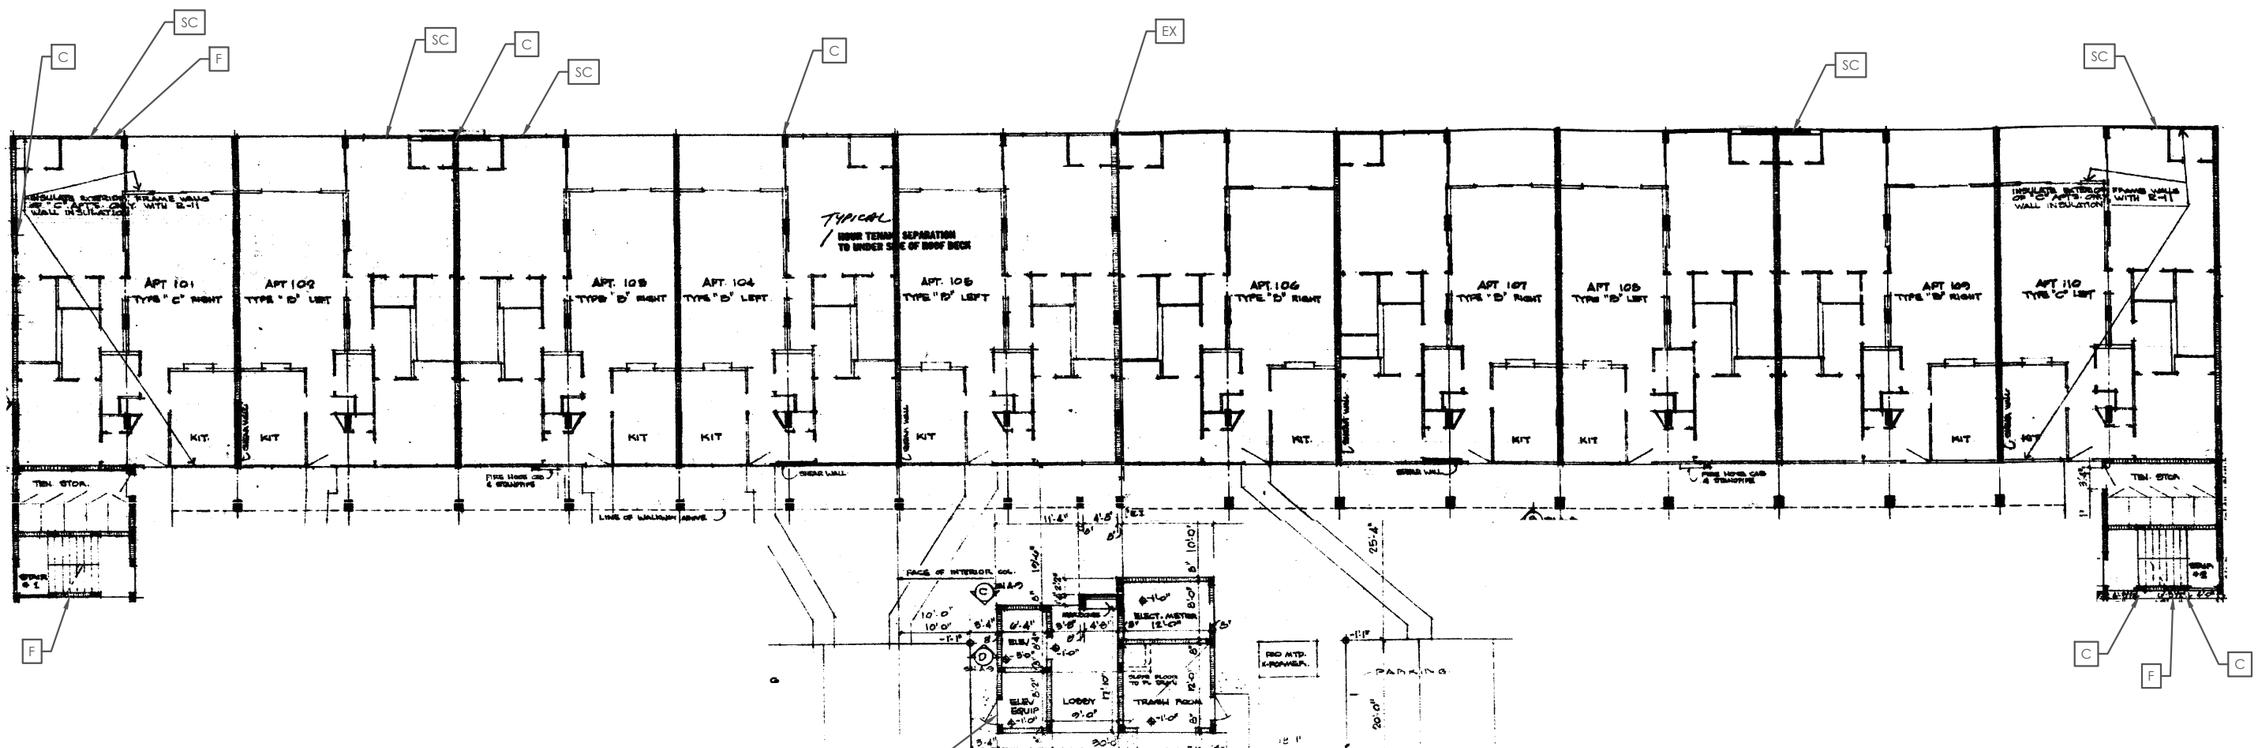
FIRST FLOOR PLAN
SCALE: NTS

ESTIMATED REPAIRS		
DESCRIPTION	SYM	EST. QTY.
EDGE REPAIR	E	
PARTIAL DECK REPAIR	D	
OVERHEAD REPAIR	O	
THRU DECK REPAIR	T	
STRESS CRACK REPAIR	R	
DELAMINATED TOPPING	DT	
BEAM REPAIR	B	
COLUMN REPAIR	C	24 CF
STUCCO REPAIR	S	
SOFFIT STUCCO REPAIR	SF	
STUCCO CRACK REPAIR	SC	39 LF
RUST SPOTS	RS	
WINDOW SILL REPAIR	SL	
POST POCKET REPAIRS	PP	
EXPANSION JOINT REPAIR	EX	8 LF
CONSTRUCT. JNT. REPAIR	CJ	
ABANDONED FASTENER/HOLES	F	10 EA

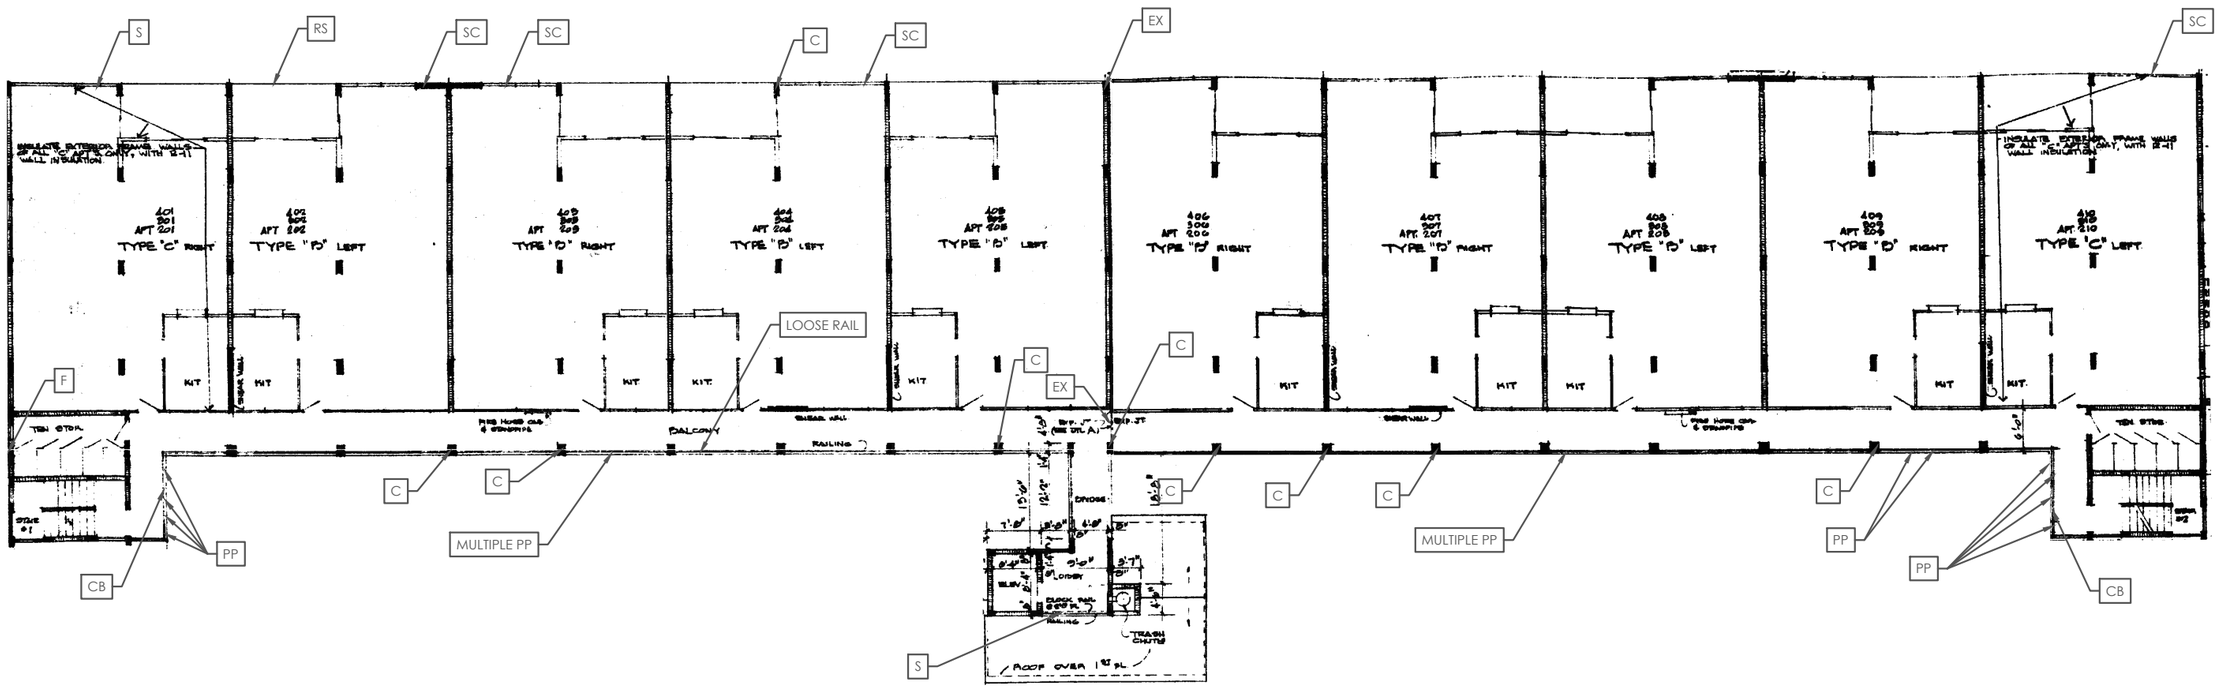
SECOND FLOOR PLAN
SCALE: NTS

ESTIMATED REPAIRS		
DESCRIPTION	SYM	EST. QTY.
EDGE REPAIR	E	
PARTIAL DECK REPAIR	D	
OVERHEAD REPAIR	O	
THRU DECK REPAIR	T	
STRESS CRACK REPAIR	R	
DELAMINATED TOPPING	DT	
BEAM REPAIR	B	
COLUMN REPAIR	C	17 CF
STUCCO REPAIR	S	16 SF
SOFFIT STUCCO REPAIR	SF	
STUCCO CRACK REPAIR	SC	20 LF
RUST SPOTS	RS	1 EA
WINDOW SILL REPAIR	SL	
POST POCKET REPAIRS	PP	33 EA
EXPANSION JOINT REPAIR	EX	13 LF
CONSTRUCT. JNT. REPAIR	CJ	
ABANDONED FASTENER/HOLES	F	3 EA
CORRODED RAIL BRACKETS	CB	8 EA

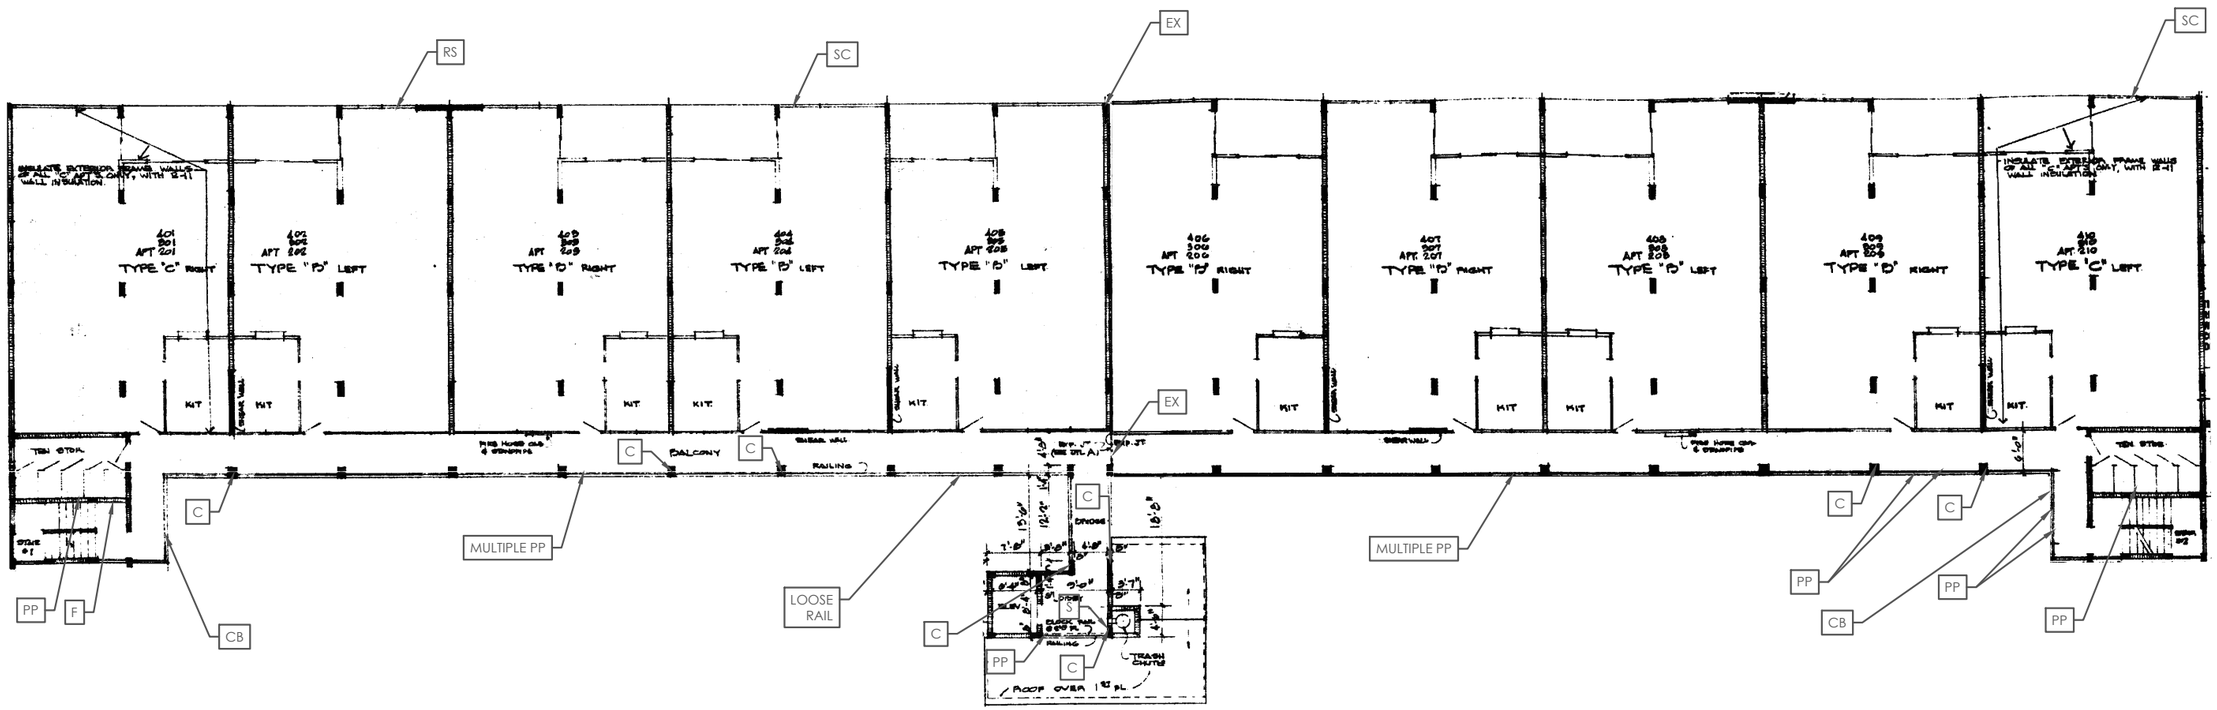
THIRD FLOOR PLAN
SCALE: NTS

ESTIMATED REPAIRS		
DESCRIPTION	SYM	EST. QTY.
EDGE REPAIR	E	
PARTIAL DECK REPAIR	D	
OVERHEAD REPAIR	O	
THRU DECK REPAIR	T	
STRESS CRACK REPAIR	R	
DELAMINATED TOPPING	DT	
BEAM REPAIR	B	
COLUMN REPAIR	C	23 CF
STUCCO REPAIR	S	5 SF
SOFFIT STUCCO REPAIR	SF	
STUCCO CRACK REPAIR	SC	22 LF
RUST SPOTS	RS	1 EA
WINDOW SILL REPAIR	SL	
POST POCKET REPAIRS	PP	40 EA
EXPANSION JOINT REPAIR	EX	21 LF
CONSTRUCT. JNT. REPAIR	CJ	
ABANDONED FASTENER/HOLES	F	1 EA
CORRODED RAIL BRACKETS	CB	7 EA

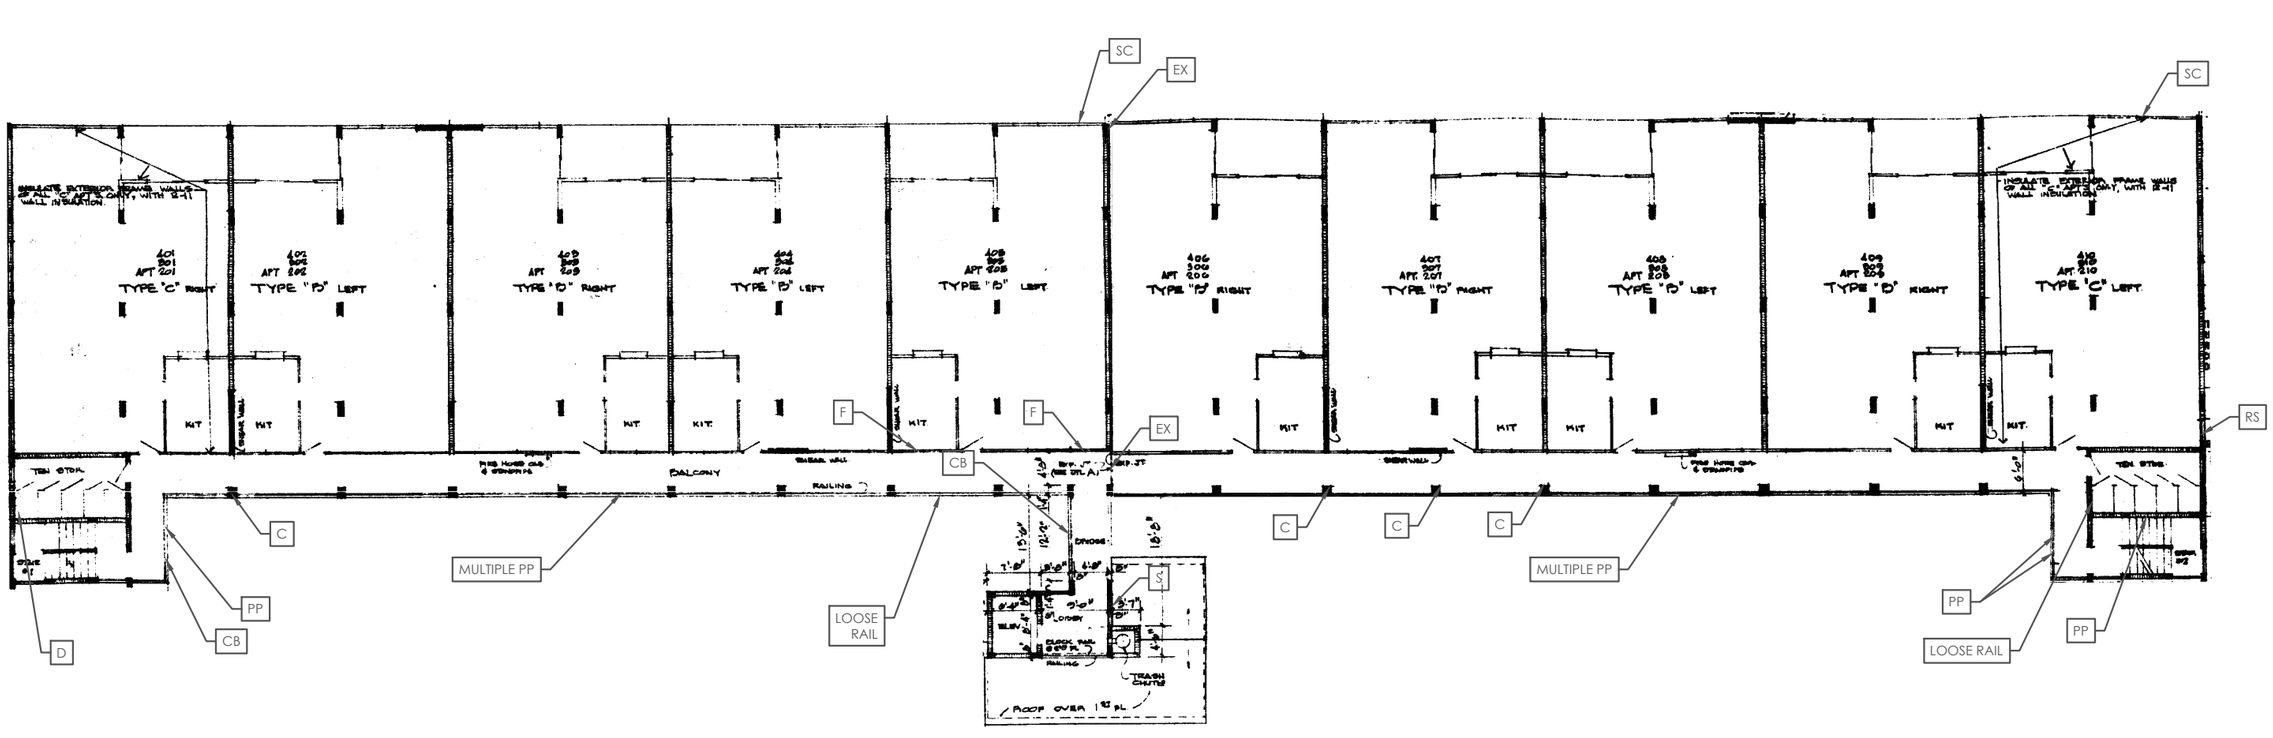
FOURTH FLOOR PLAN
SCALE: NTS

ESTIMATED REPAIRS		
DESCRIPTION	SYM	EST. QTY.
EDGE REPAIR	E	
PARTIAL DECK REPAIR	D	2 SF
OVERHEAD REPAIR	O	
THRU DECK REPAIR	T	
STRESS CRACK REPAIR	R	
DELAMINATED TOPPING	DT	
BEAM REPAIR	B	
COLUMN REPAIR	C	9 CF
STUCCO REPAIR	S	4 SF
SOFFIT STUCCO REPAIR	SF	
STUCCO CRACK REPAIR	SC	20 LF
RUST SPOTS	RS	4 EA
WINDOW SILL REPAIR	SL	
POST POCKET REPAIRS	PP	30 EA
EXPANSION JOINT REPAIR	EX	21 LF
CONSTRUCT. JNT. REPAIR	CJ	
ABANDONED FASTENER/HOLES	F	22 EA
CORRODED RAIL BRACKETS	CB	4 EA

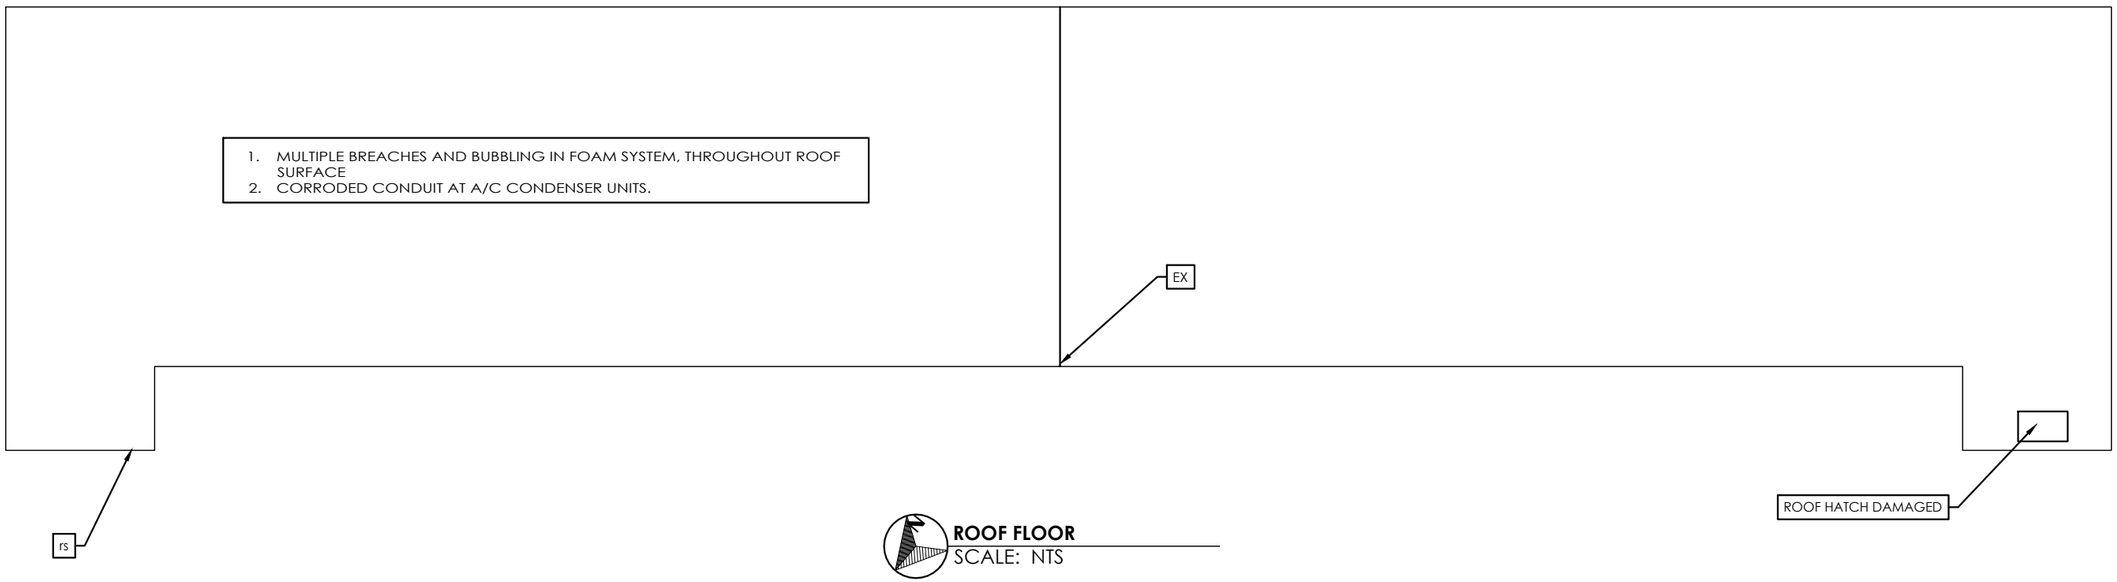
ROOF FLOOR
SCALE: NTS

1. MULTIPLE BREACHES AND BUBBLING IN FOAM SYSTEM, THROUGHOUT ROOF SURFACE
2. CORRODED CONDUIT AT A/C CONDENSER UNITS.
