HUNTINGTON LAKES SECTION 4
BUILDING 32

BUILDINGS STRUCTURAL PHASE TWO
MILESTONE INSPECTION REPORT

SEPTEMBER 2024

Re: Milestone Inspections
Huntington Lakes Section Four
7340 Amberly Lane – Building 32
Delray Beach, Florida 33446

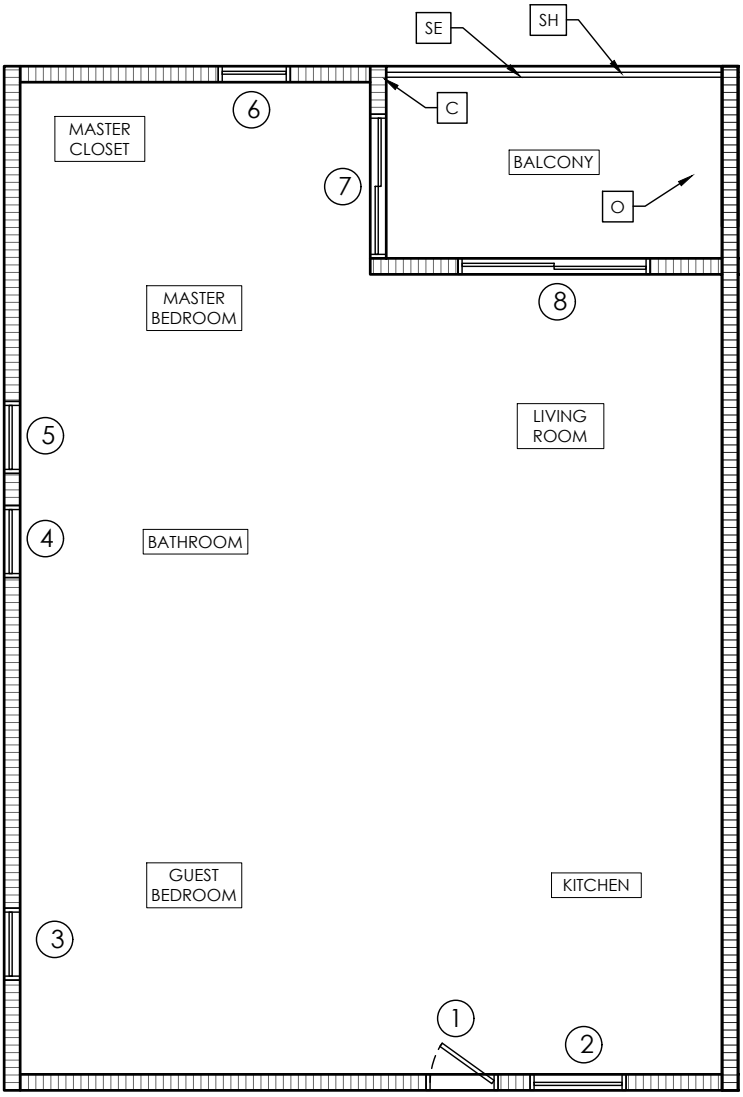
FLOOR PLAN
SCALE: 1/8" = 1'-0"

DESCRIPTION	SYM	EST, QTY.
EDGE REPAIR	E	
PARTIAL DECK REPAIR	D	
OVERHEAD REPAIR	O	
THRU DECK REPAIR	T	
STRESS CRACK REPAIR	R	
HOLLOW TILE	HT	
BEAM REPAIR	B	
COLUMN REPAIR	C	2 CF
DELAMINATED STUCCO REPAIR	S	
STUCCO CRACK REPAIR	SC	
RUST SPOTS	RS	
MISSING ELECTRICAL COVER PLATE	EC	
ABANDON FASTENER/HOLES	F	16 EA

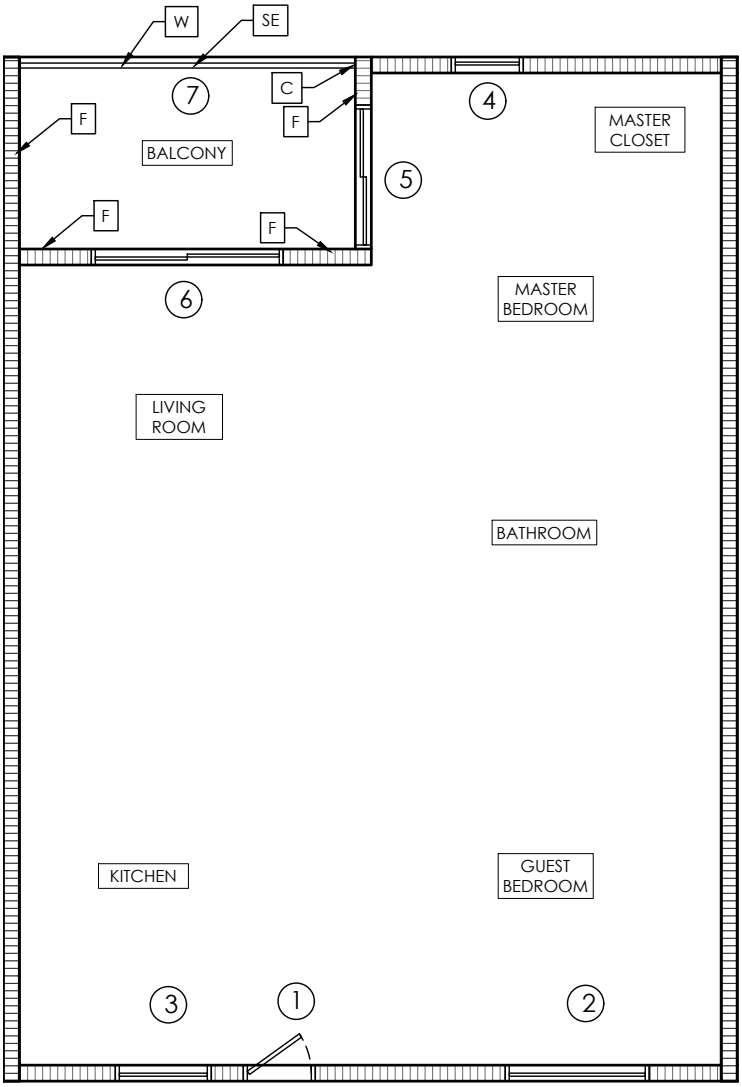
FLOOR PLAN
SCALE: 1/8" = 1'-0"

DESCRIPTION	SYM	EST. QTY.
EDGE REPAIR	E	
PARTIAL DECK REPAIR	D	
OVERHEAD REPAIR	O	4 SF
THRU DECK REPAIR	T	
STRESS CRACK REPAIR	R	
HOLLOW TILE	HT	4 SF
BEAM REPAIR	B	
COLUMN REPAIR	C	2 CF
DELAMINATED STUCCO REPAIR	S	
STUCCO CRACK REPAIR	SC	
RUST SPOTS	RS	
MISSING ELECTRICAL COVER PLATE	EC	
ABANDON FASTENER/HOLES	F	2 EA

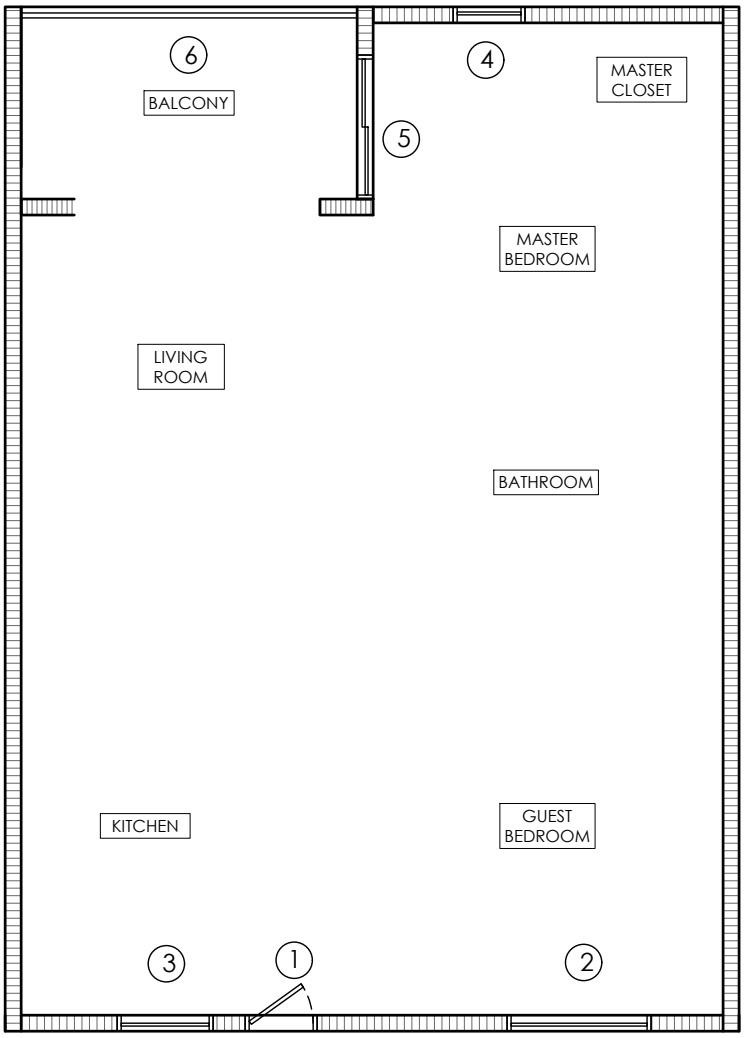
FLOOR PLAN
SCALE: 1/8" = 1'-0"

DESCRIPTION	SYM	EST. QTY.
EDGE REPAIR	E	
PARTIAL DECK REPAIR	D	
OVERHEAD REPAIR	O	4 SF
THRU DECK REPAIR	T	
STRESS CRACK REPAIR	R	
HOLLOW TILE	HT	
BEAM REPAIR	B	
COLUMN REPAIR	C	1 CF
DELAMINATED STUCCO REPAIR	S	
STUCCO CRACK REPAIR	SC	
RUST SPOTS	RS	
MISSING ELECTRICAL COVER PLATE	EC	1 EA
ABANDON FASTENER/HOLES	F

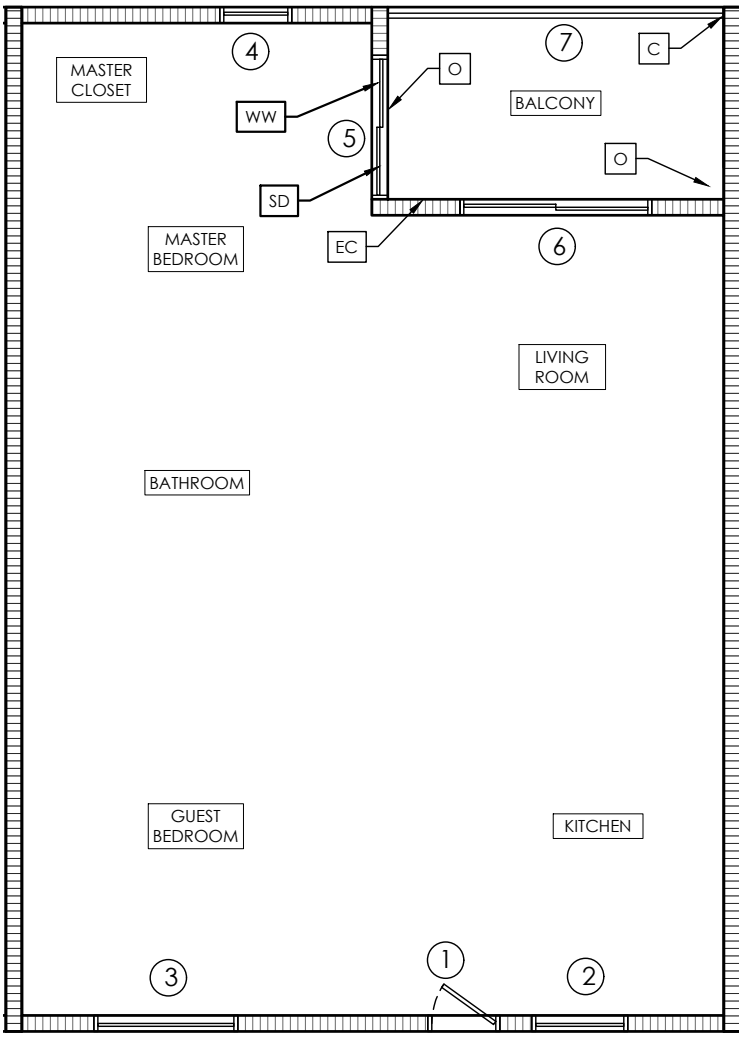
FLOOR PLAN
SCALE: 1/8" = 1'-0"

DESCRIPTION	SYM	EST. QTY.
EDGE REPAIR	E	
PARTIAL DECK REPAIR	D	
OVERHEAD REPAIR	O	2 SF
THRU DECK REPAIR	T	
STRESS CRACK REPAIR	R	
HOLLOW TILE	HT	
BEAM REPAIR	B	
COLUMN REPAIR	C	2 CF
DELAMINATED STUCCO REPAIR	S	
STUCCO CRACK REPAIR	SC	
RUST SPOTS	RS	
MISSING ELECTRICAL COVER PLATE	EC	
ABANDON FASTENER/HOLES	F

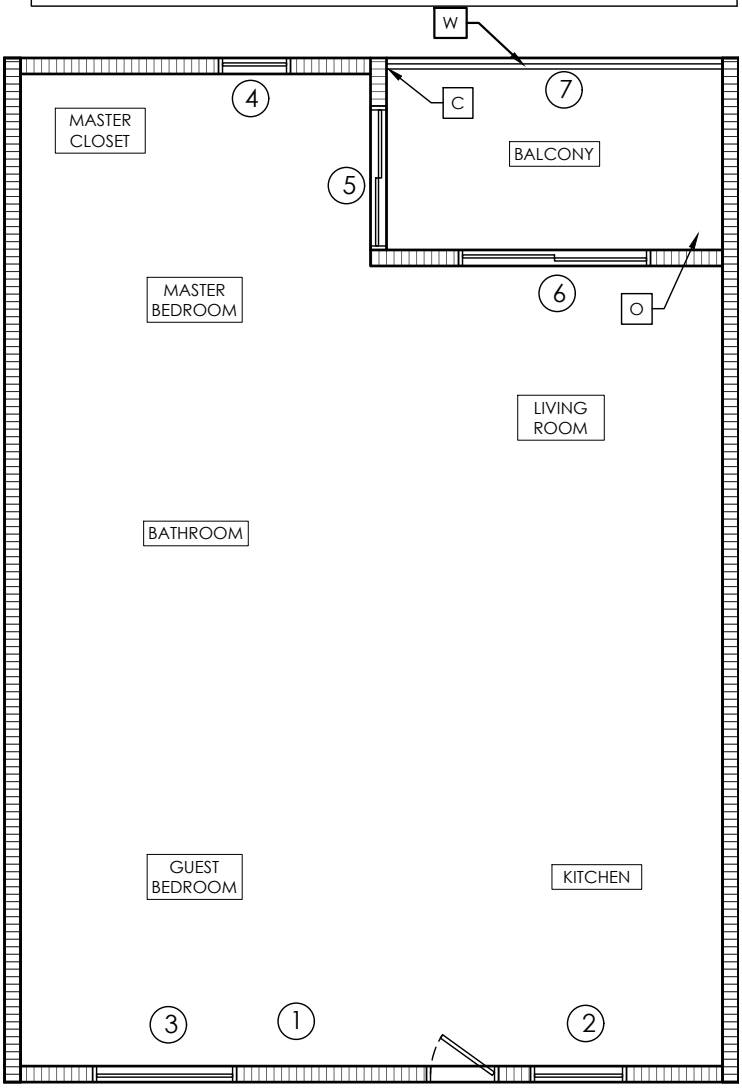
FLOOR PLAN
SCALE: 1/8" = 1'-0"

DESCRIPTION	SYM	EST, QTY.
EDGE REPAIR	E	
PARTIAL DECK REPAIR	D	
OVERHEAD REPAIR	O	
THRU DECK REPAIR	T	
STRESS CRACK REPAIR	R	
HOLLOW TILE	HT	
BEAM REPAIR	B	
COLUMN REPAIR	C	1 CF
DELAMINATED STUCCO REPAIR	S	
STUCCO CRACK REPAIR	SC	
RUST SPOTS	RS	
MISSING ELECTRICAL COVER PLATE	EC	
ABANDON FASTENER/HOLES	F

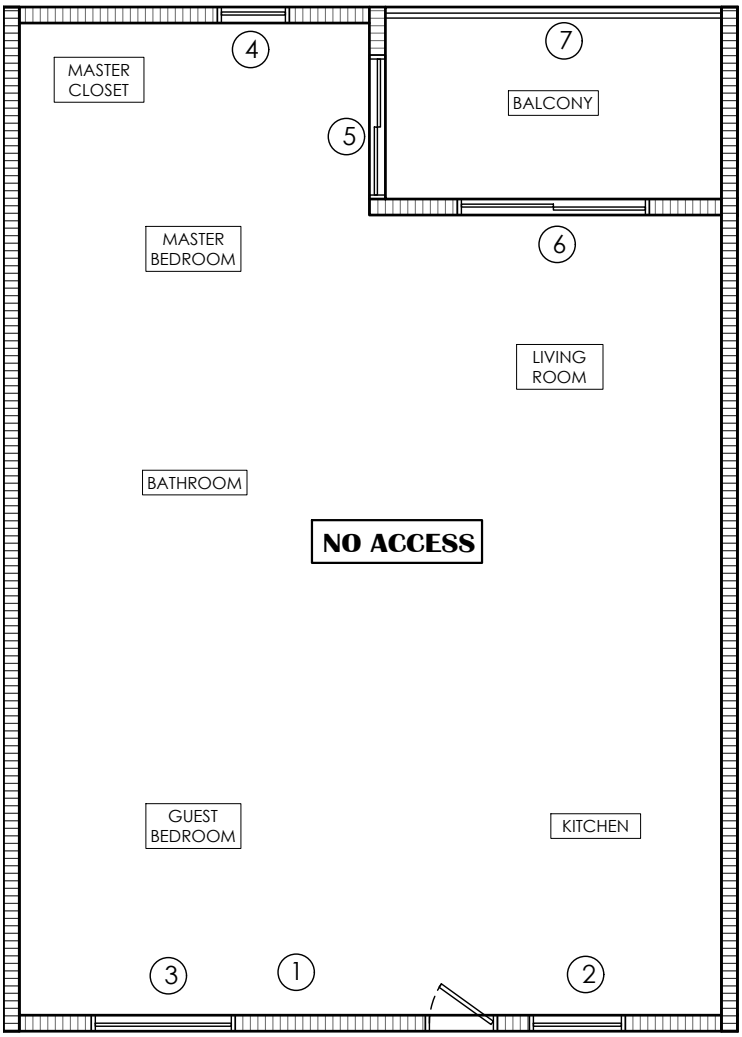
FLOOR PLAN
SCALE: 1/8" = 1'-0"

DESCRIPTION	SYM	EST. QTY.
EDGE REPAIR	E	
PARTIAL DECK REPAIR	D	
OVERHEAD REPAIR	O	2 SF
THRU DECK REPAIR	T	
STRESS CRACK REPAIR	R	
HOLLOW TILE	HT	
BEAM REPAIR	B	
COLUMN REPAIR	C	2 CF
DELAMINATED STUCCO REPAIR	S	
STUCCO CRACK REPAIR	SC	
RUST SPOTS	RS	
MISSING ELECTRICAL COVER PLATE	EC	
ABANDON FASTENER/HOLES	F

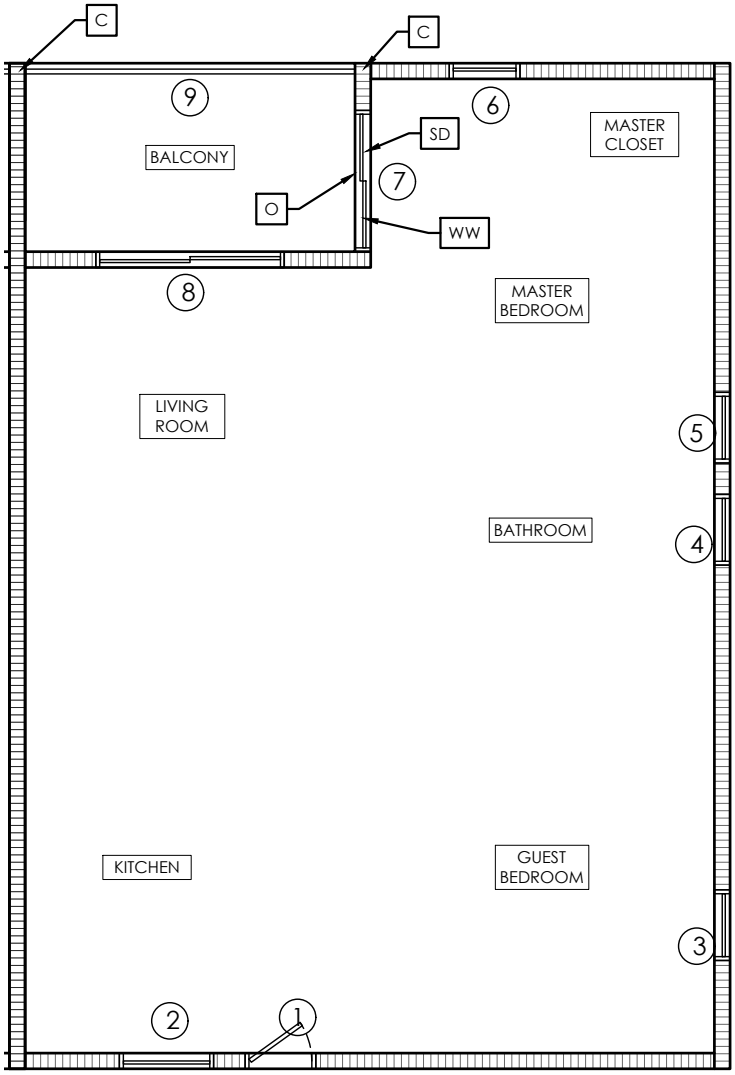
FLOOR PLAN
SCALE: 1/8" = 1'-0"

DESCRIPTION	SYM	EST, QTY.
EDGE REPAIR	E	
PARTIAL DECK REPAIR	D	
OVERHEAD REPAIR	O	
THRU DECK REPAIR	T	
STRESS CRACK REPAIR	R	
HOLLOW TILE	HT	
BEAM REPAIR	B	
COLUMN REPAIR	C	2 CF
DELAMINATED STUCCO REPAIR	S	
STUCCO CRACK REPAIR	SC	
RUST SPOTS	RS	
MISSING ELECTRICAL COVER PLATE	EC	
ABANDON FASTENER/HOLES	F	6 EA

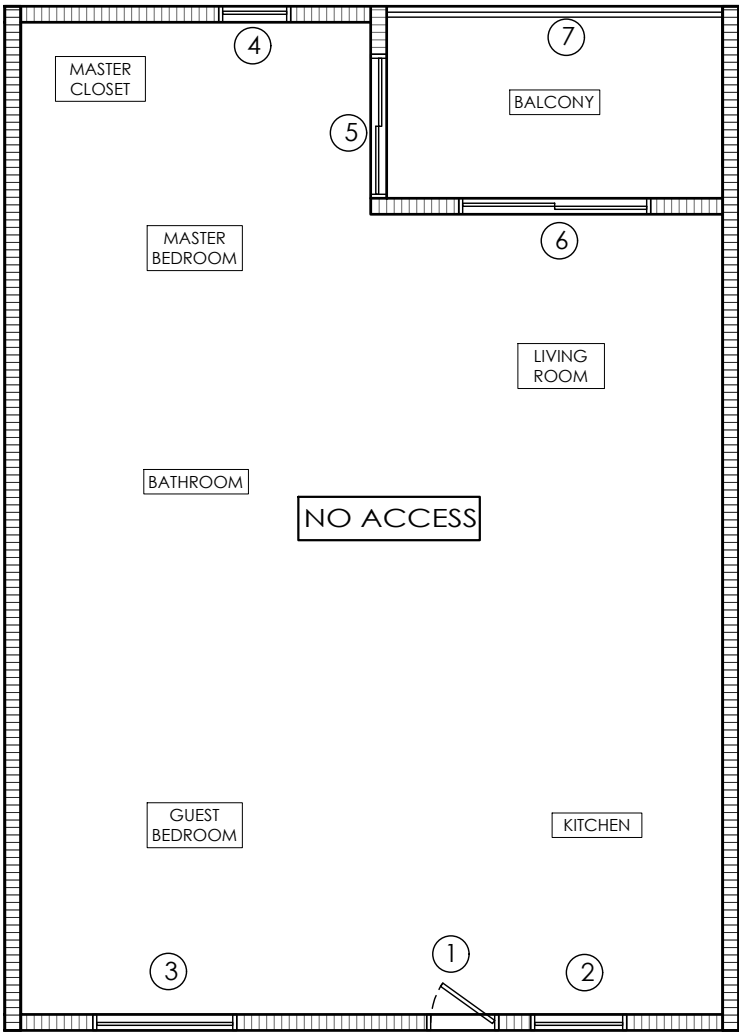
FLOOR PLAN
SCALE: 1/8" = 1'-0"

DESCRIPTION	SYM	EST, QTY.
EDGE REPAIR	E	
PARTIAL DECK REPAIR	D	
OVERHEAD REPAIR	O	
THRU DECK REPAIR	T	
STRESS CRACK REPAIR	R	
HOLLOW TILE	HT	
BEAM REPAIR	B	
COLUMN REPAIR	C	1 CF
DELAMINATED STUCCO REPAIR	S	
STUCCO CRACK REPAIR	SC	
RUST SPOTS	RS	
MISSING ELECTRICAL COVER PLATE	EC	
ABANDON FASTENER/HOLES	F

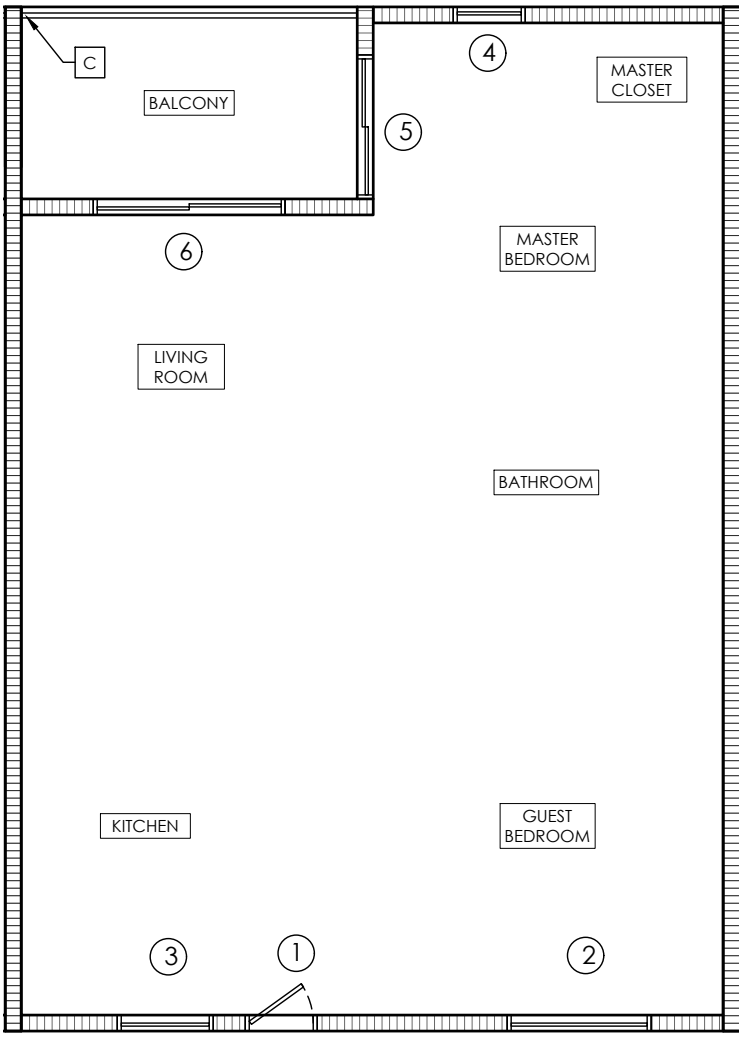
FLOOR PLAN
SCALE: 1/8" = 1'-0"

DESCRIPTION	SYM	EST, QTY.
EDGE REPAIR	E	
PARTIAL DECK REPAIR	D	
OVERHEAD REPAIR	O	
THRU DECK REPAIR	T	
STRESS CRACK REPAIR	R	
HOLLOW TILE	HT	
BEAM REPAIR	B	
COLUMN REPAIR	C	1 CF
DELAMINATED STUCCO REPAIR	S	
STUCCO CRACK REPAIR	SC	
RUST SPOTS	RS	
MISSING ELECTRICAL COVER PLATE	EC	
ABANDON FASTENER/HOLES	F	1 EA

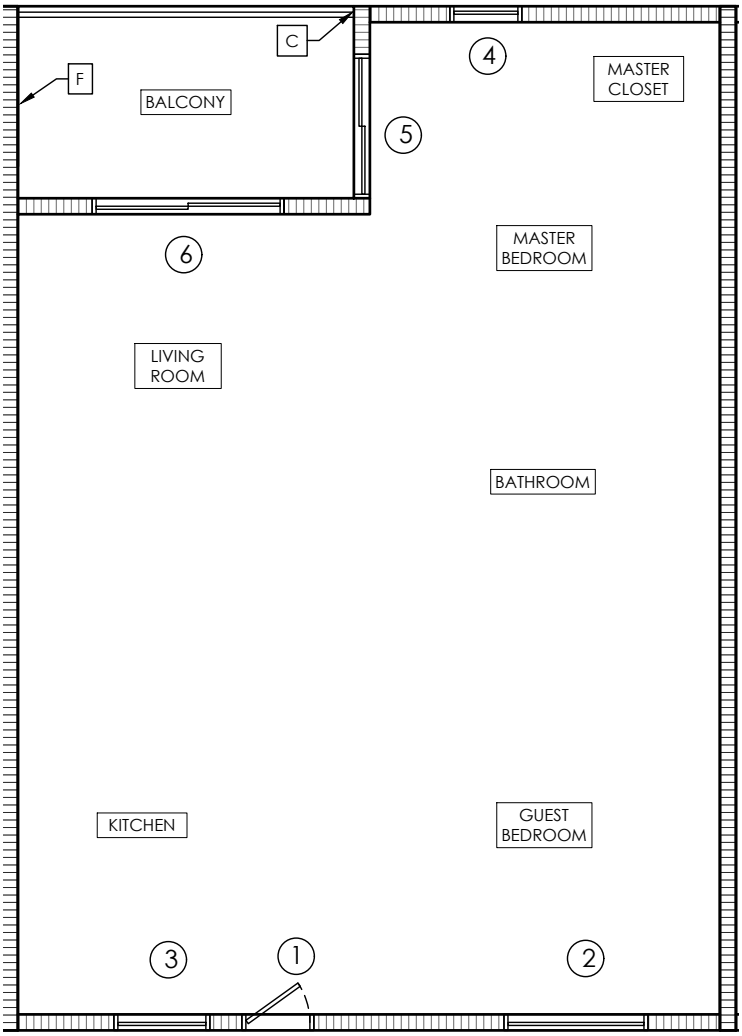
FLOOR PLAN
SCALE: 1/8" = 1'-0"

DESCRIPTION	SYM	EST, QTY.
EDGE REPAIR	E	
PARTIAL DECK REPAIR	D	
OVERHEAD REPAIR	O	
THRU DECK REPAIR	T	
STRESS CRACK REPAIR	R	
HOLLOW TILE	HT	12 SF
BEAM REPAIR	B	
COLUMN REPAIR	C	
DELAMINATED STUCCO REPAIR	S	
STUCCO CRACK REPAIR	SC	
RUST SPOTS	RS	
MISSING ELECTRICAL COVER PLATE	EC	
ABANDON FASTENER/HOLES	F

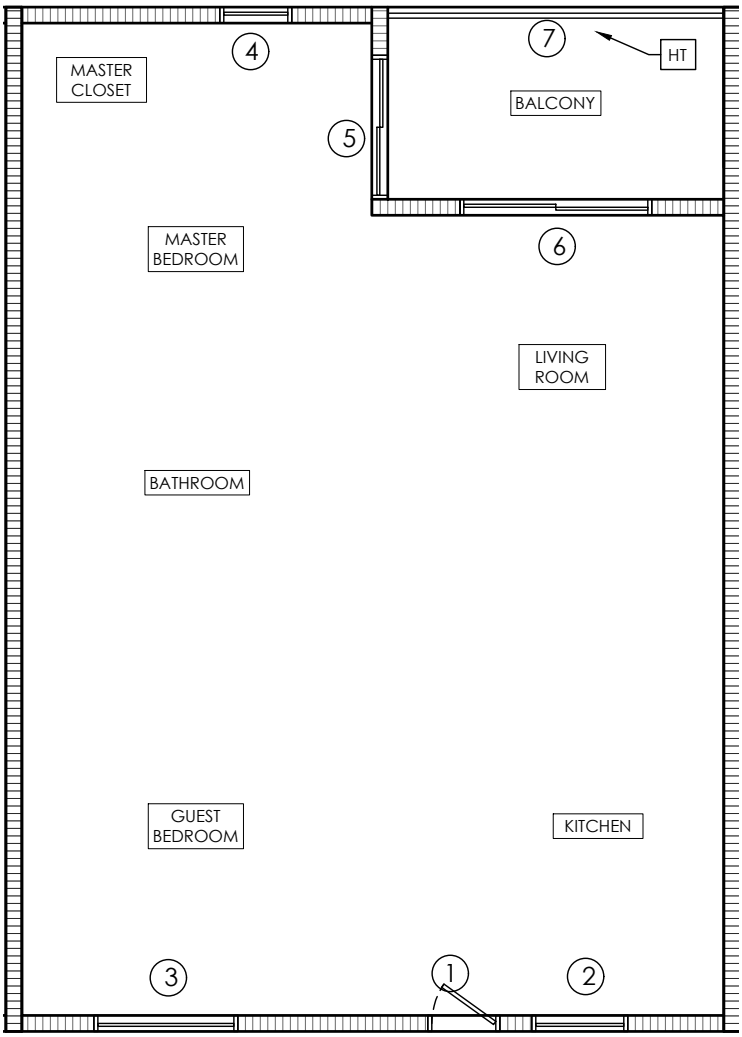
FLOOR PLAN
SCALE: 1/8" = 1'-0"

DESCRIPTION	SYM	EST, QTY.
EDGE REPAIR	E	
PARTIAL DECK REPAIR	D	
OVERHEAD REPAIR	O	
THRU DECK REPAIR	T	
STRESS CRACK REPAIR	R	
HOLLOW TILE	HT	12 SF
BEAM REPAIR	B	
COLUMN REPAIR	C	2 CF
DELAMINATED STUCCO REPAIR	S	
STUCCO CRACK REPAIR	SC	
RUST SPOTS	RS	
MISSING ELECTRICAL COVER PLATE	EC	1 EA
ABANDON FASTENER/HOLES	F	6 EA

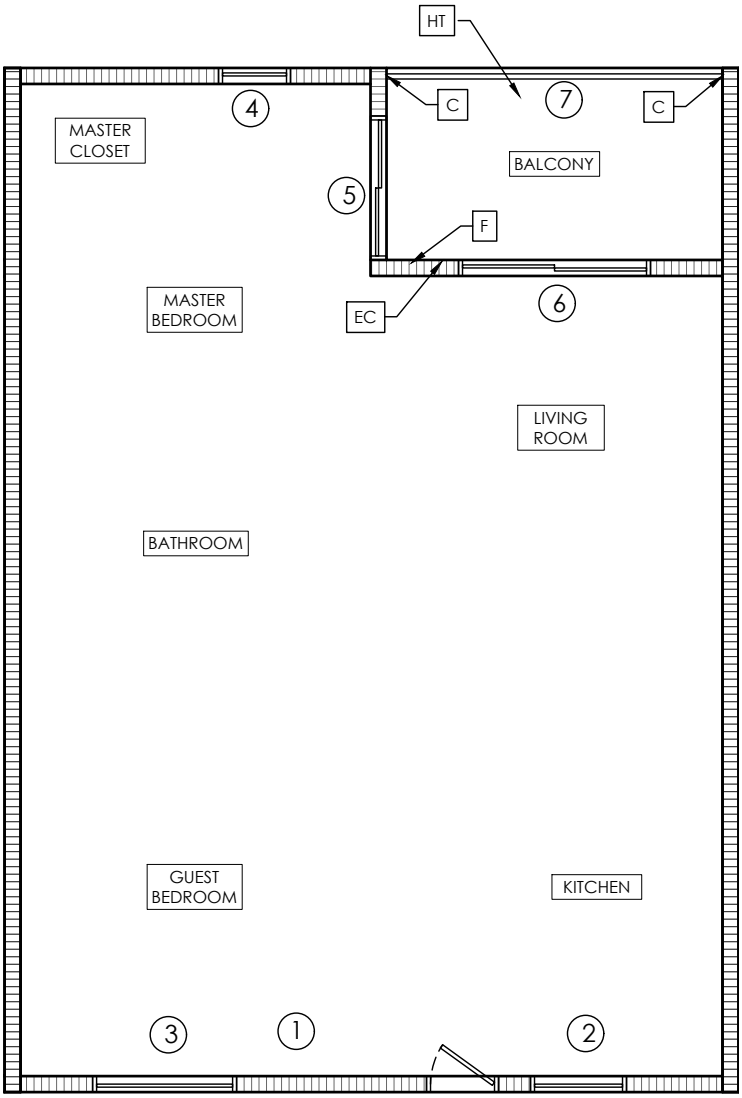
FLOOR PLAN
SCALE: 1/8" = 1'-0"

DESCRIPTION	SYM	EST, QTY.
EDGE REPAIR	E	
PARTIAL DECK REPAIR	D	
OVERHEAD REPAIR	O	
THRU DECK REPAIR	T	
STRESS CRACK REPAIR	R	
HOLLOW TILE	HT	
BEAM REPAIR	B	
COLUMN REPAIR	C	7 CF
DELAMINATED STUCCO REPAIR	S	
STUCCO CRACK REPAIR	SC	
RUST SPOTS	RS	
MISSING ELECTRICAL COVER PLATE	EC	
ABANDON FASTENER/HOLES	F

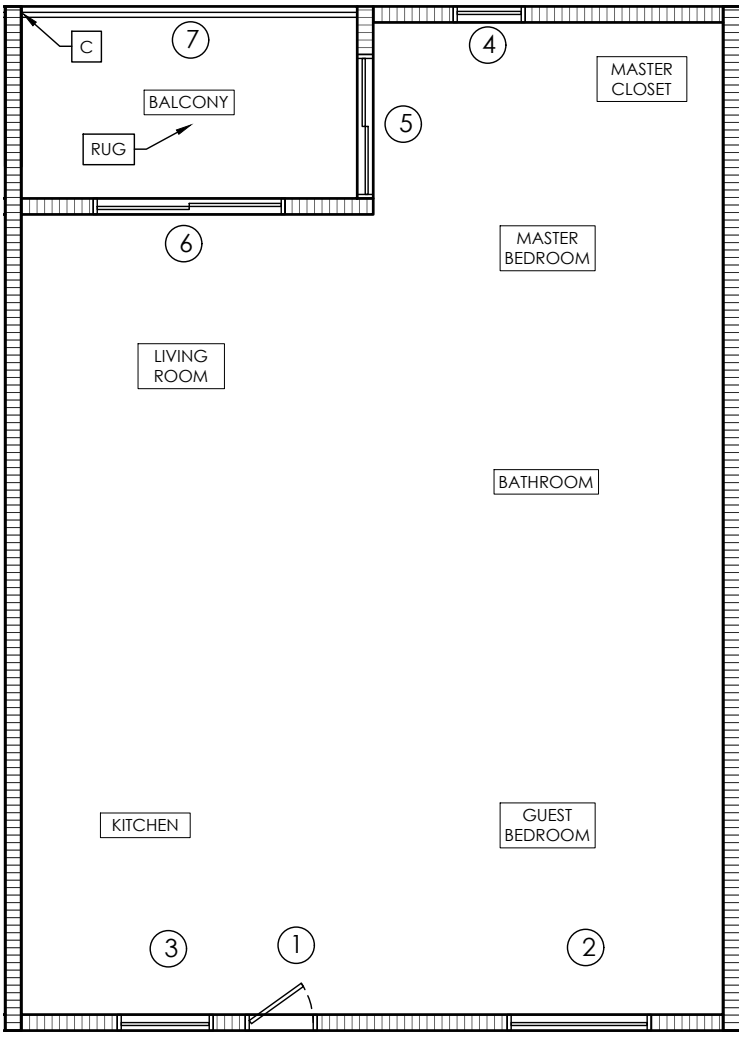
FLOOR PLAN
SCALE: 1/8" = 1'-0"

DESCRIPTION	SYM	EST, QTY.
EDGE REPAIR	E	
PARTIAL DECK REPAIR	D	
OVERHEAD REPAIR	O	
THRU DECK REPAIR	T	
STRESS CRACK REPAIR	R	
HOLLOW TILE	HT	112 SF
BEAM REPAIR	B	
COLUMN REPAIR	C	2 CF
DELAMINATED STUCCO REPAIR	S	
STUCCO CRACK REPAIR	SC	
RUST SPOTS	RS	
MISSING ELECTRICAL COVER PLATE	EC	
ABANDON FASTENER/HOLES	F

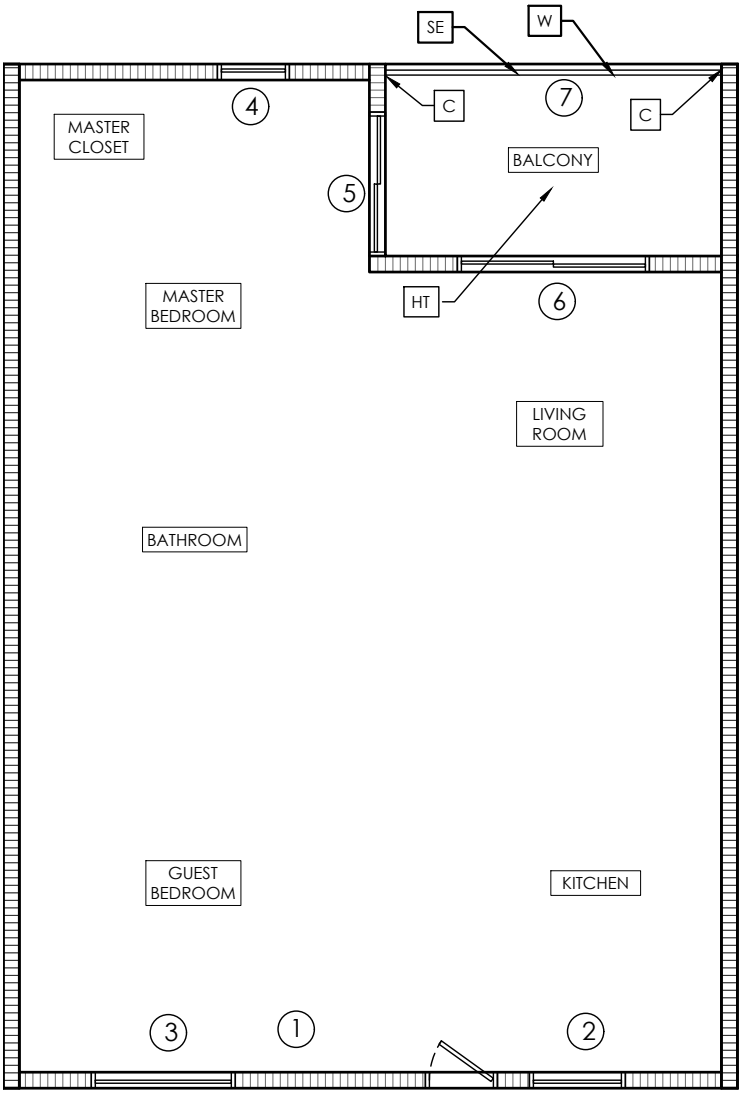
FLOOR PLAN
SCALE: 1/8" = 1'-0"

DESCRIPTION	SYM	EST. QTY.
EDGE REPAIR	E	
PARTIAL DECK REPAIR	D	
OVERHEAD REPAIR	O	
THRU DECK REPAIR	T	
STRESS CRACK REPAIR	R	
HOLLOW TILE	HT	4 SF
BEAM REPAIR	B	
COLUMN REPAIR	C	5 CF
DELAMINATED STUCCO REPAIR	S	
STUCCO CRACK REPAIR	SC	
RUST SPOTS	RS	
MISSING ELECTRICAL COVER PLATE	EC	
ABANDON FASTENER/HOLES	F	1 EA

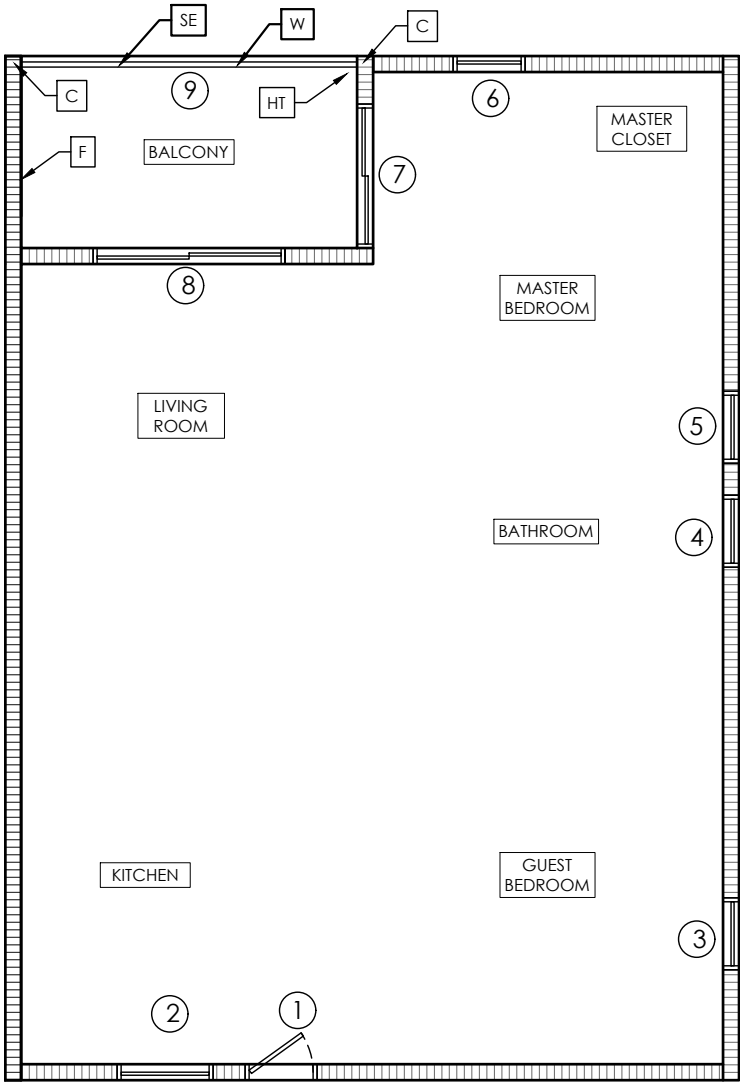
FLOOR PLAN
SCALE: 1/8" = 1'-0"

DESCRIPTION	SYM	EST, QTY.
EDGE REPAIR	E	
PARTIAL DECK REPAIR	D	
OVERHEAD REPAIR	O	
THRU DECK REPAIR	T	
STRESS CRACK REPAIR	R	
HOLLOW TILE	HT	6 SF
BEAM REPAIR	B	
COLUMN REPAIR	C	2 CF
DELAMINATED STUCCO REPAIR	S	
STUCCO CRACK REPAIR	SC	
RUST SPOTS	RS	
MISSING ELECTRICAL COVER PLATE	EC	
ABANDON FASTENER/HOLES	F

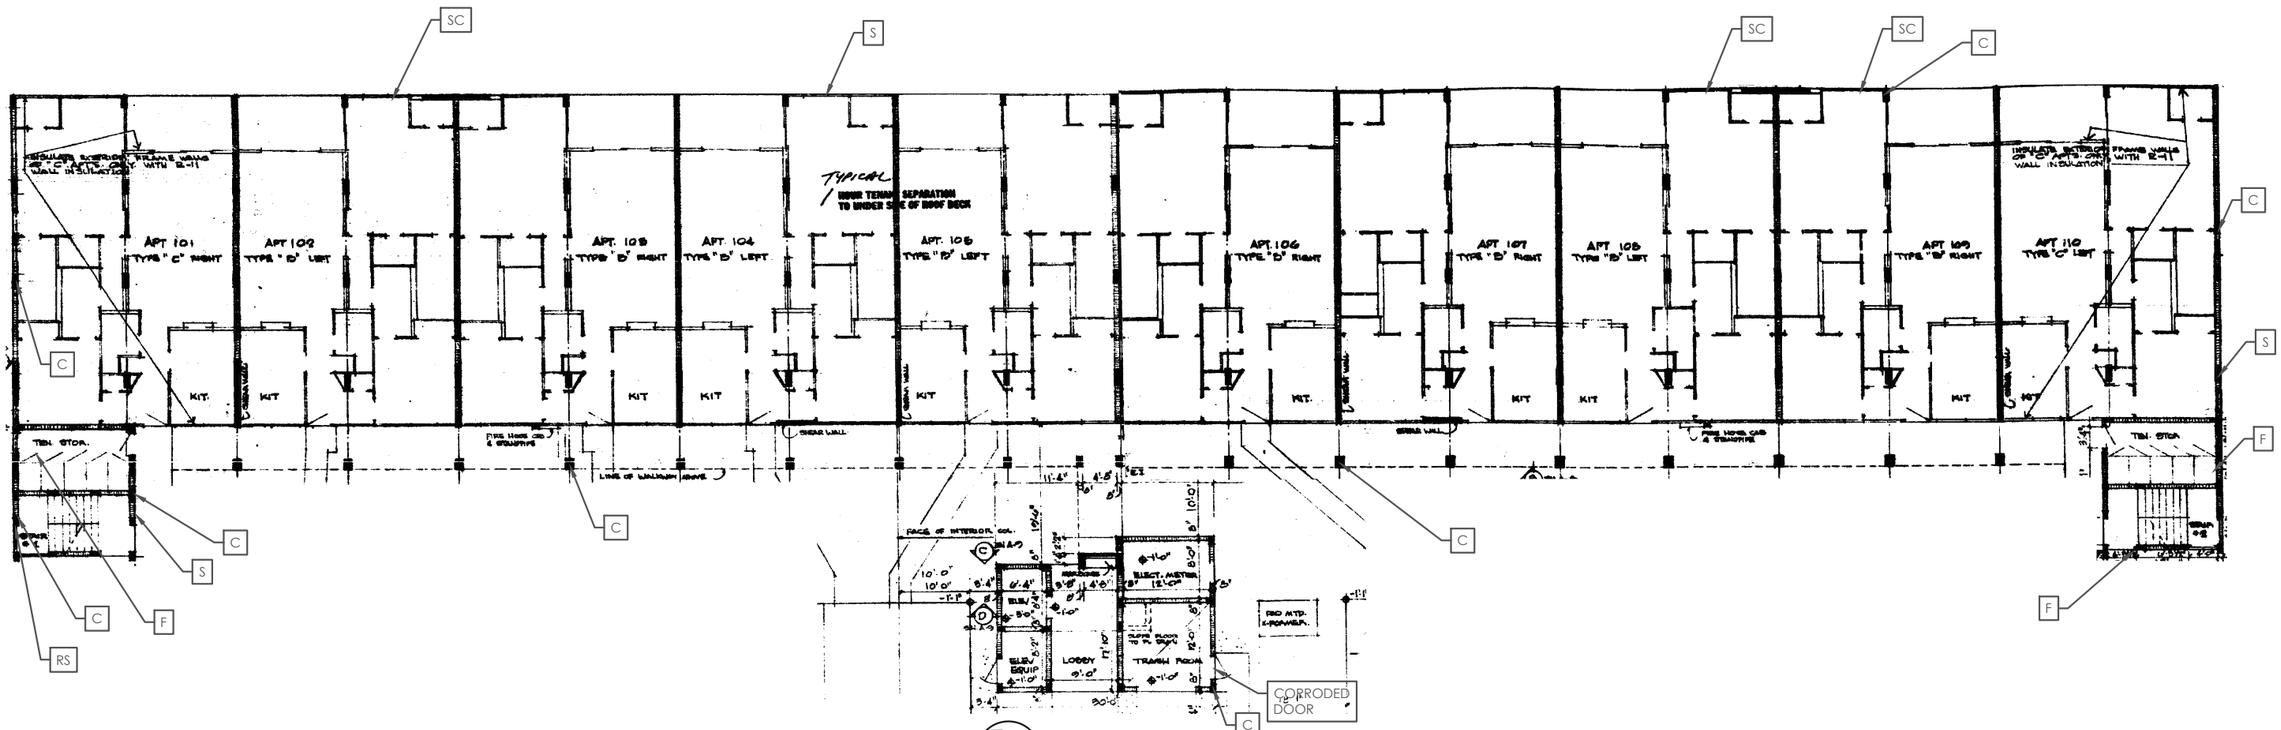
FIRST FLOOR PLAN
SCALE: NTS

ESTIMATED REPAIRS		
DESCRIPTION	SYM	EST. QTY.
EDGE REPAIR	E	
PARTIAL DECK REPAIR	D	
OVERHEAD REPAIR	O	
THRU DECK REPAIR	T	
STRESS CRACK REPAIR	R	
DELAMINATED TOPPING	DT	
BEAM REPAIR	B	
COLUMN REPAIR	C	23 CF
STUCCO REPAIR	S	5 SF
SOFFIT STUCCO REPAIR	SF	
STUCCO CRACK REPAIR	SC	9 LF
RUST SPOTS	RS	1 EA
WINDOW SILL REPAIR	SL	
POST POCKET REPAIRS	PP	
EXPANSION JOINT REPAIR	EX	
CONSTRUCT. JNT. REPAIR	CJ	
ABANDONED FASTENER/HOLES	F	11 EA

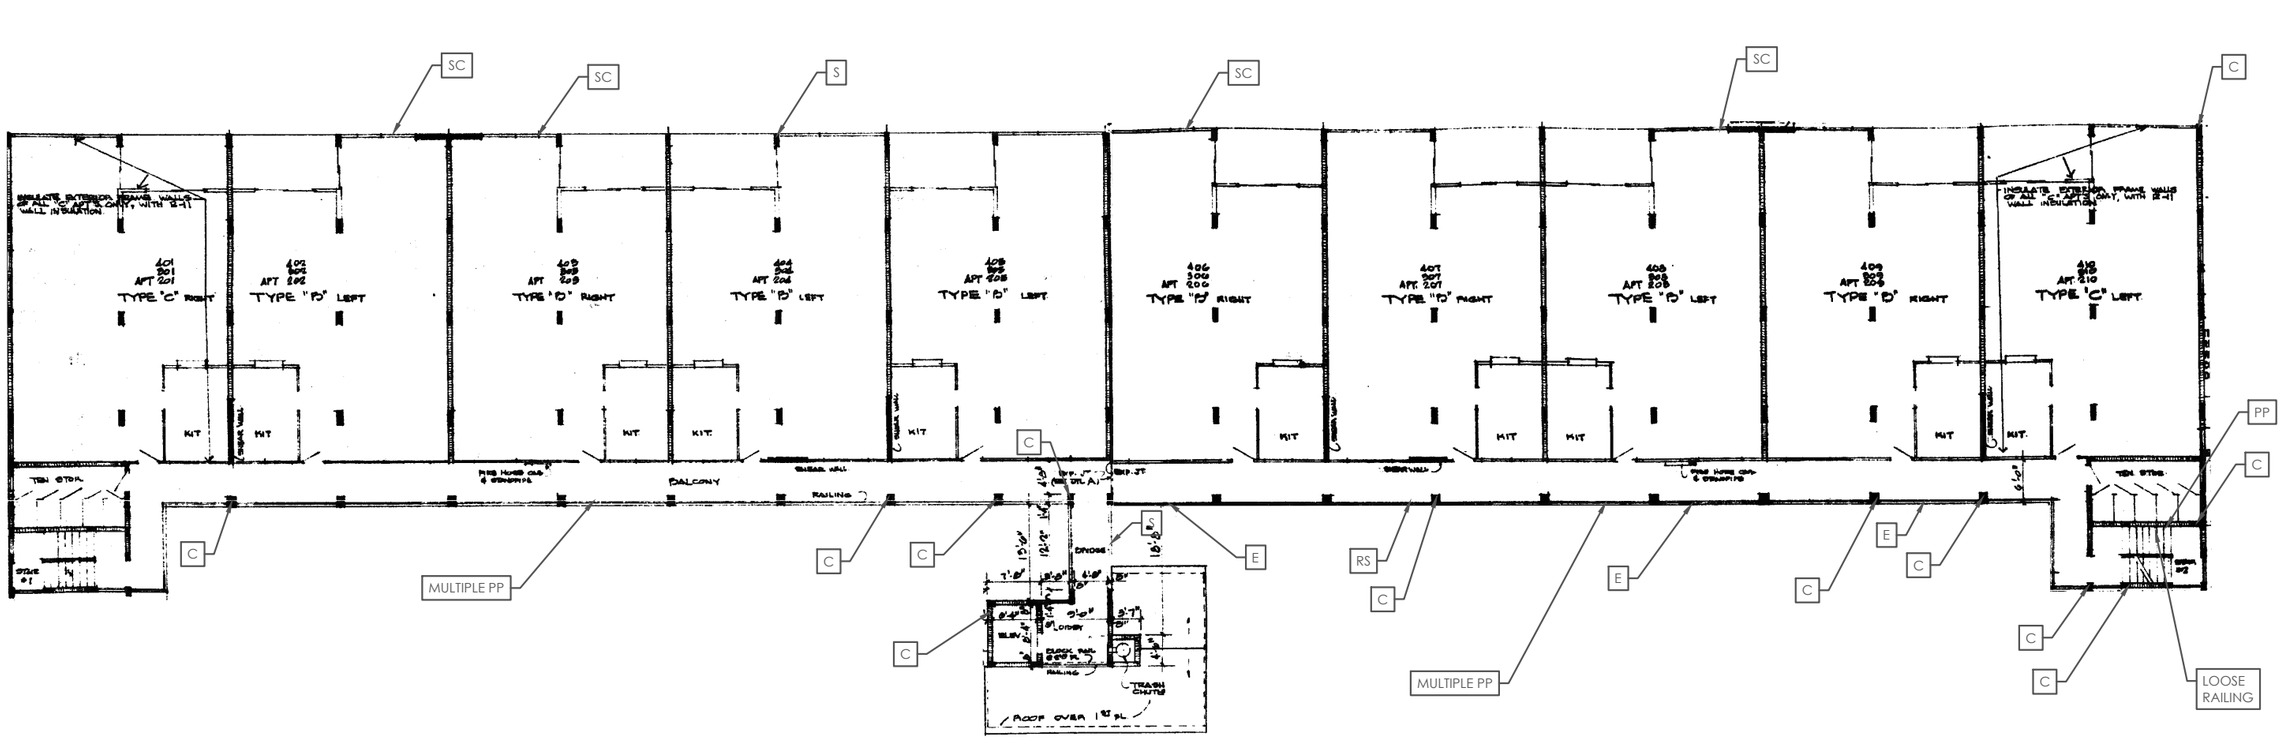
SECOND FLOOR PLAN
SCALE: NTS

ESTIMATED REPAIRS		
DESCRIPTION	SYM	EST. QTY.
EDGE REPAIR	E	8 LF
PARTIAL DECK REPAIR	D	
OVERHEAD REPAIR	O	
THRU DECK REPAIR	T	
STRESS CRACK REPAIR	R	
DELAMINATED TOPPING	DT	
BEAM REPAIR	B	
COLUMN REPAIR	C	21 CF
STUCCO REPAIR	S	9 SF
SOFFIT STUCCO REPAIR	SF	
STUCCO CRACK REPAIR	SC	12 LF
RUST SPOTS	RS	1 EA
WINDOW SILL REPAIR	SL	
POST POCKET REPAIRS	PP	38 EA
EXPANSION JOINT REPAIR	EX	
CONSTRUCT. JNT. REPAIR	CJ	
ABANDONED FASTENER/HOLES	F

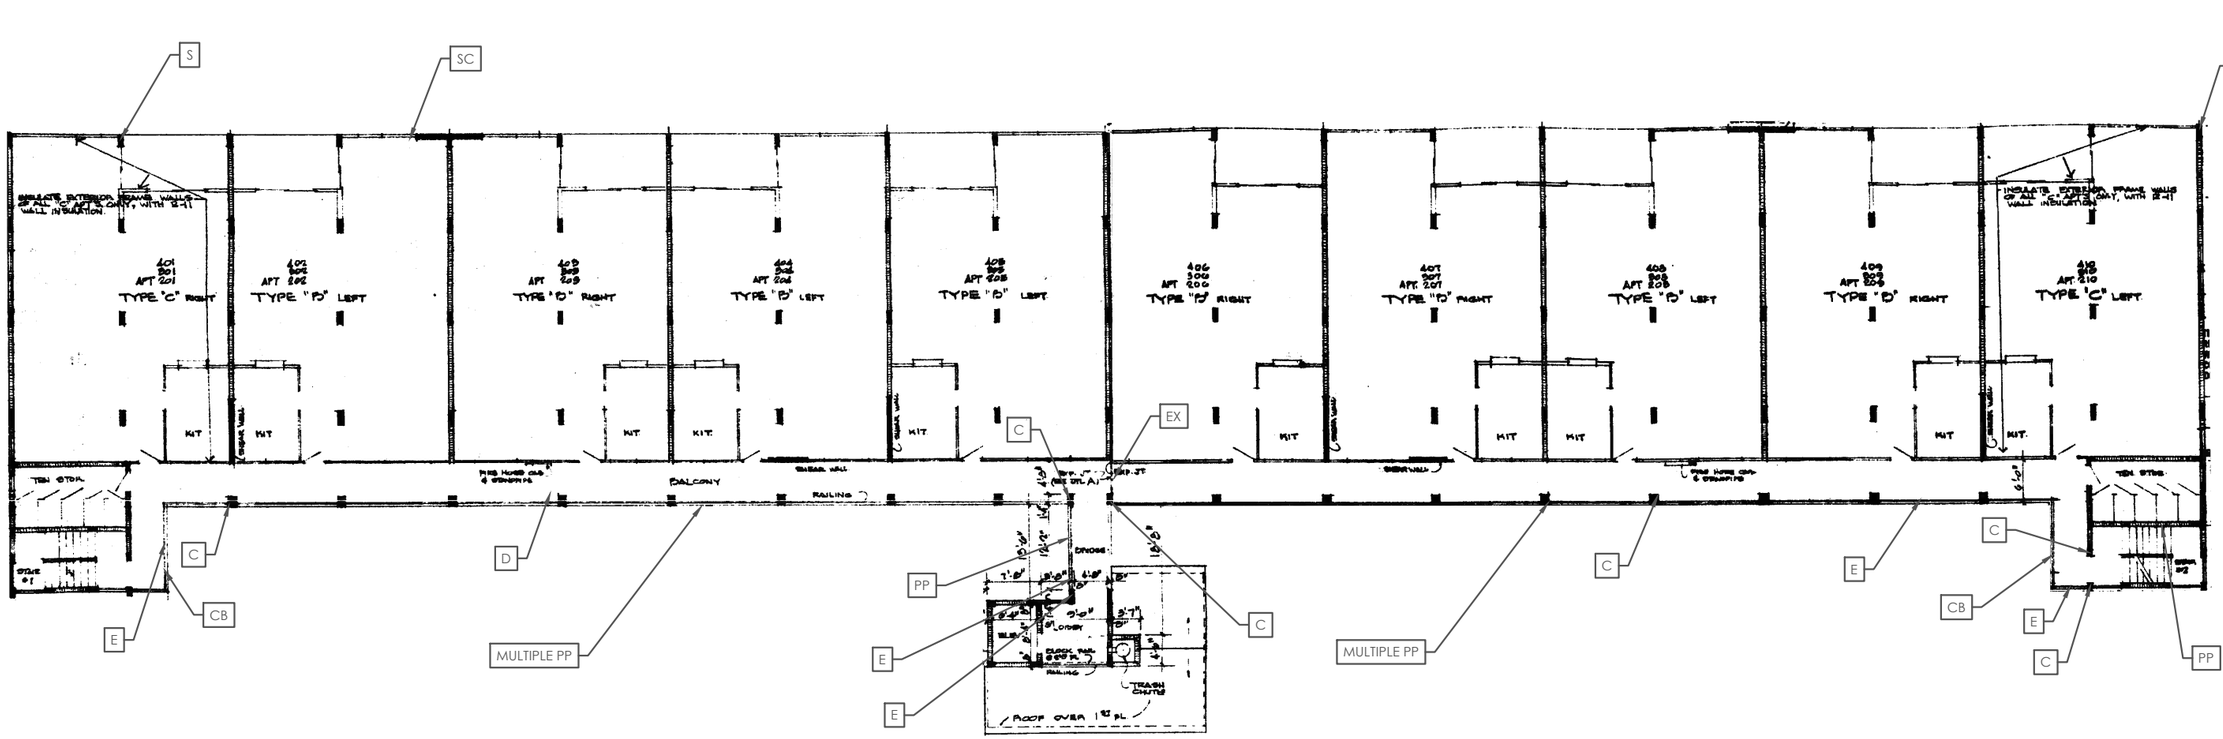
THIRD FLOOR PLAN
SCALE: NTS

ESTIMATED REPAIRS		
DESCRIPTION	SYM	EST. QTY.
EDGE REPAIR	E	12 LF
PARTIAL DECK REPAIR	D	2 SF
OVERHEAD REPAIR	O	
THRU DECK REPAIR	T	
STRESS CRACK REPAIR	R	
DELAMINATED TOPPING	DT	
BEAM REPAIR	B	
COLUMN REPAIR	C	17 CF
STUCCO REPAIR	S	3 SF
SOFFIT STUCCO REPAIR	SF	
STUCCO CRACK REPAIR	SC	3 LF
RUST SPOTS	RS	
WINDOW SILL REPAIR	SL	
POST POCKET REPAIRS	PP	30 EA
EXPANSION JOINT REPAIR	EX	5 LF
CONSTRUCT. JNT. REPAIR	CJ	
ABANDONED FASTENER/HOLES	F	
CORRODED RAIL BRACKETS	CB	4 EA

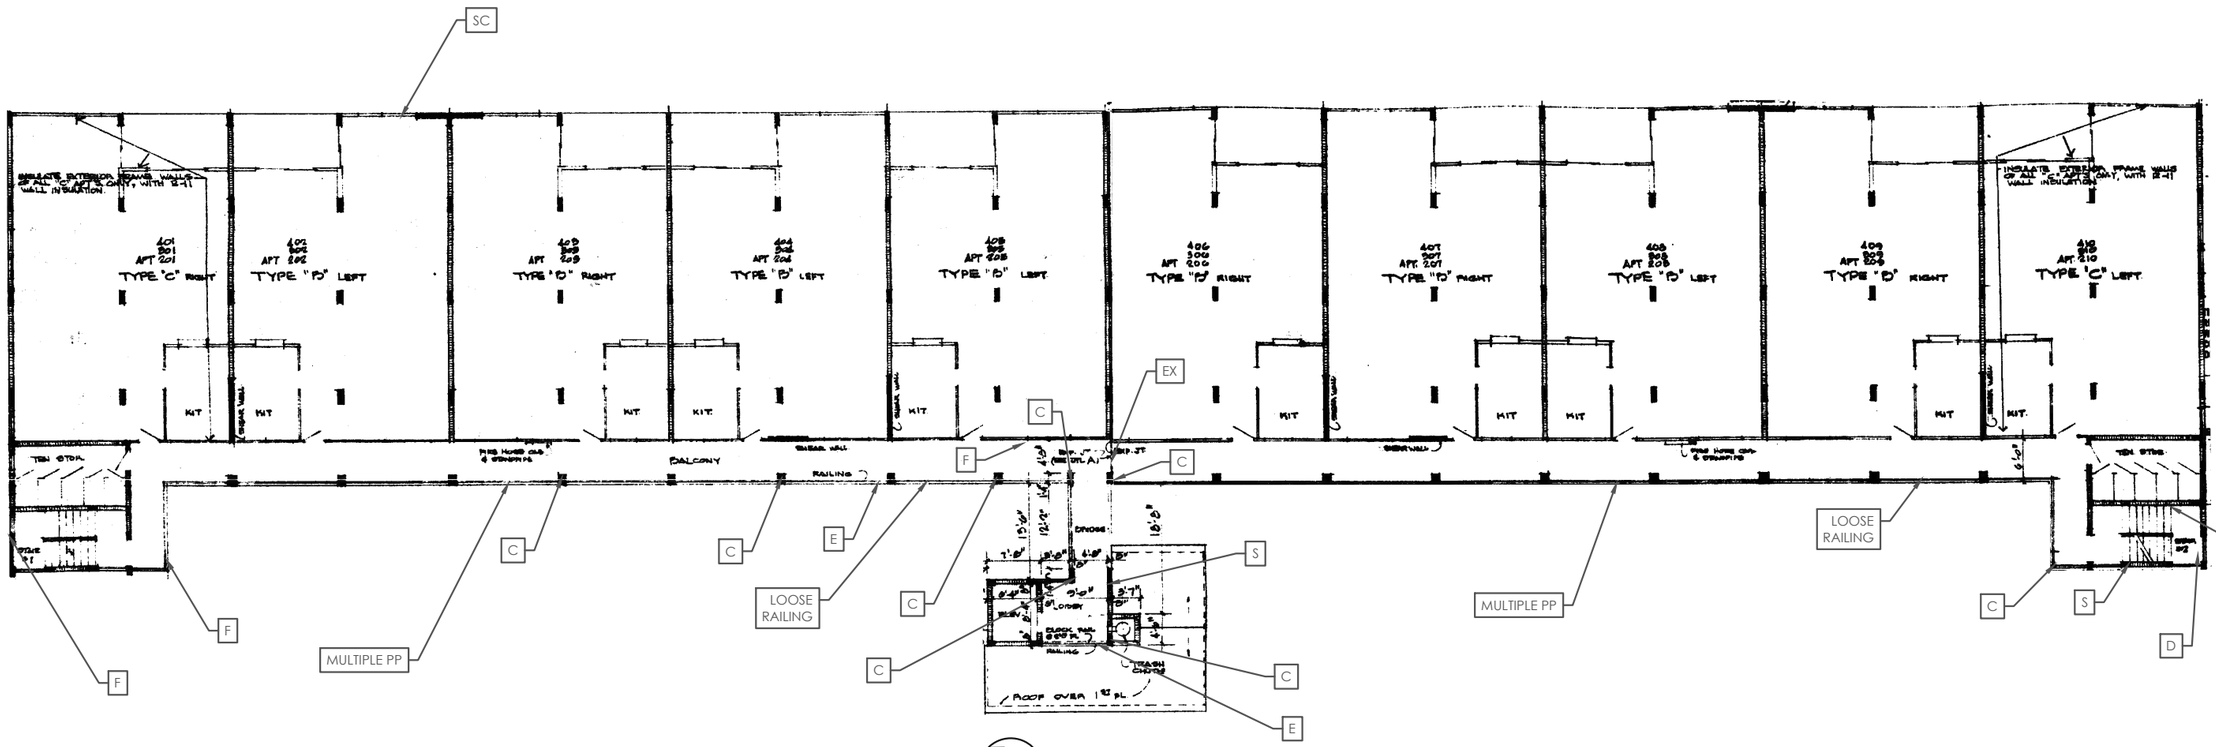
FOURTH FLOOR PLAN
SCALE: NTS

ESTIMATED REPAIRS		
DESCRIPTION	SYM	EST. QTY.
EDGE REPAIR	E	4 LF
PARTIAL DECK REPAIR	D	2 SF
OVERHEAD REPAIR	O	
THRU DECK REPAIR	T	
STRESS CRACK REPAIR	R	
DELAMINATED TOPPING	DT	
BEAM REPAIR	B	
COLUMN REPAIR	C	11 CF
STUCCO REPAIR	S	11 SF
SOFFIT STUCCO REPAIR	SF	
STUCCO CRACK REPAIR	SC	3 LF
RUST SPOTS	RS	
WINDOW SILL REPAIR	SL	
POST POCKET REPAIRS	PP	39 EA
EXPANSION JOINT REPAIR	EX	16 LF
CONSTRUCT. JNT. REPAIR	CJ	
ABANDONED FASTENER/HOLES	F	3 EA

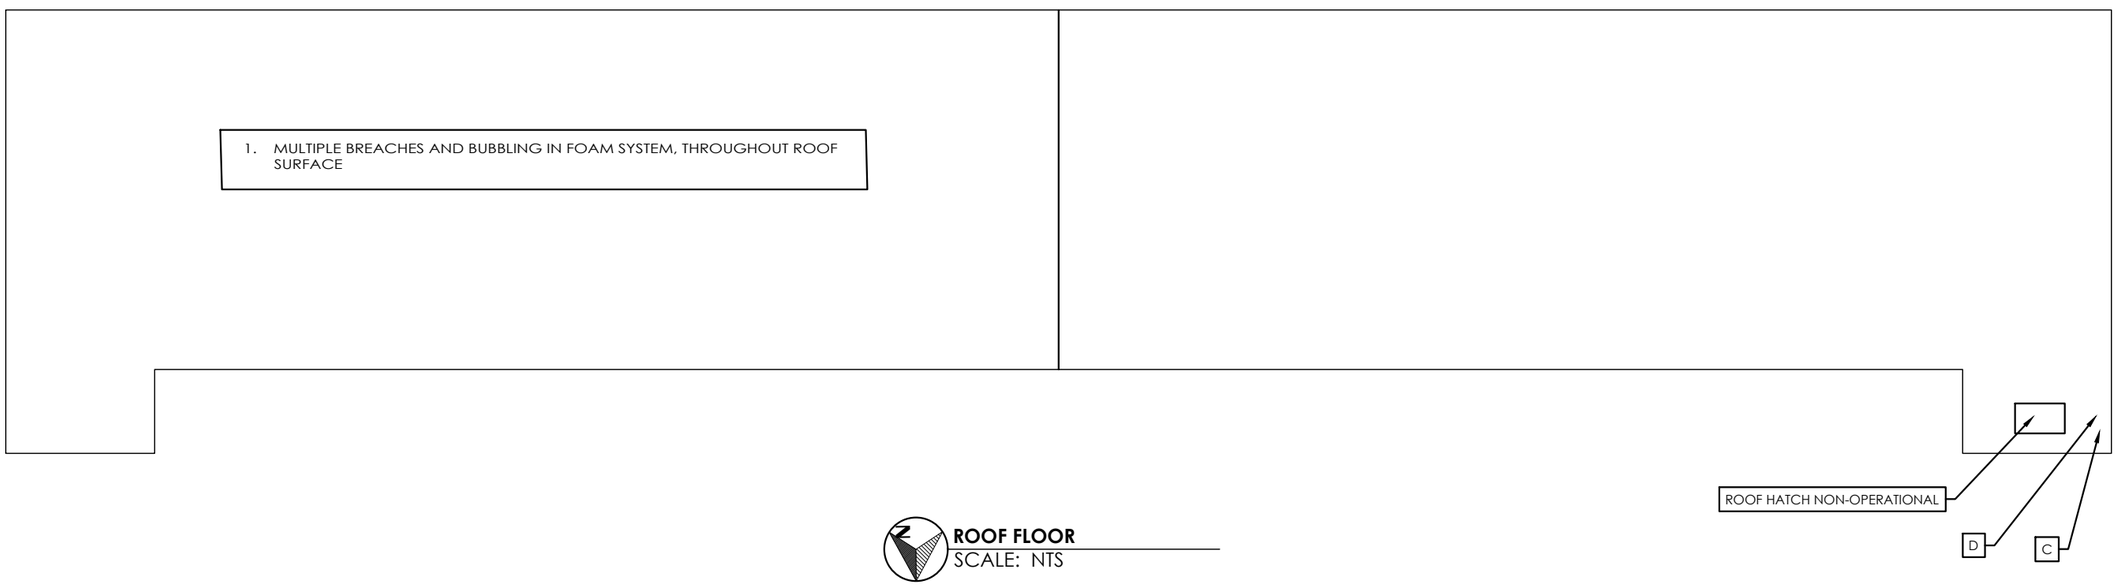
ROOF FLOOR
SCALE: NTS

7. The Property Appraiser did not identify the roofing system, however all roof areas and portions of parapet walls appear to be covered in a spray foam. This foam has delaminated in many areas and the roof appears to have extensive patch repairs. Large and small areas of ponding water and breaching were observed throughout the flat roof areas. The roof appears to be reaching the end of its useful live.

1. MULTIPLE BREACHES AND BUBBLING IN FOAM SYSTEM, THROUGHOUT ROOF SURFACE

13. All flat roof systems should be fully replaced. The structural slabs should be inspected prior to the new roof systems being stalled. Stucco repairs will be required on parapet walls. A/C unit stands might require replacement to meet current roofing codes.
14. Egress windows and doors in bedrooms must be operational and unobstructed at minimum, and temporary screw locks at the egress windows should be removed. If needed, the doors and windows should be refurbished or replaced with new code compliant components. Fasteners should be installed where missing at door and window frames. Any window or door nearing the end of its useful life should also be replaced.
