HUNTINGTON LAKES SECTION 4
BUILDING 33

BUILDINGS STRUCTURAL PHASE TWO
MILESTONE INSPECTION REPORT

SEPTEMBER 2024

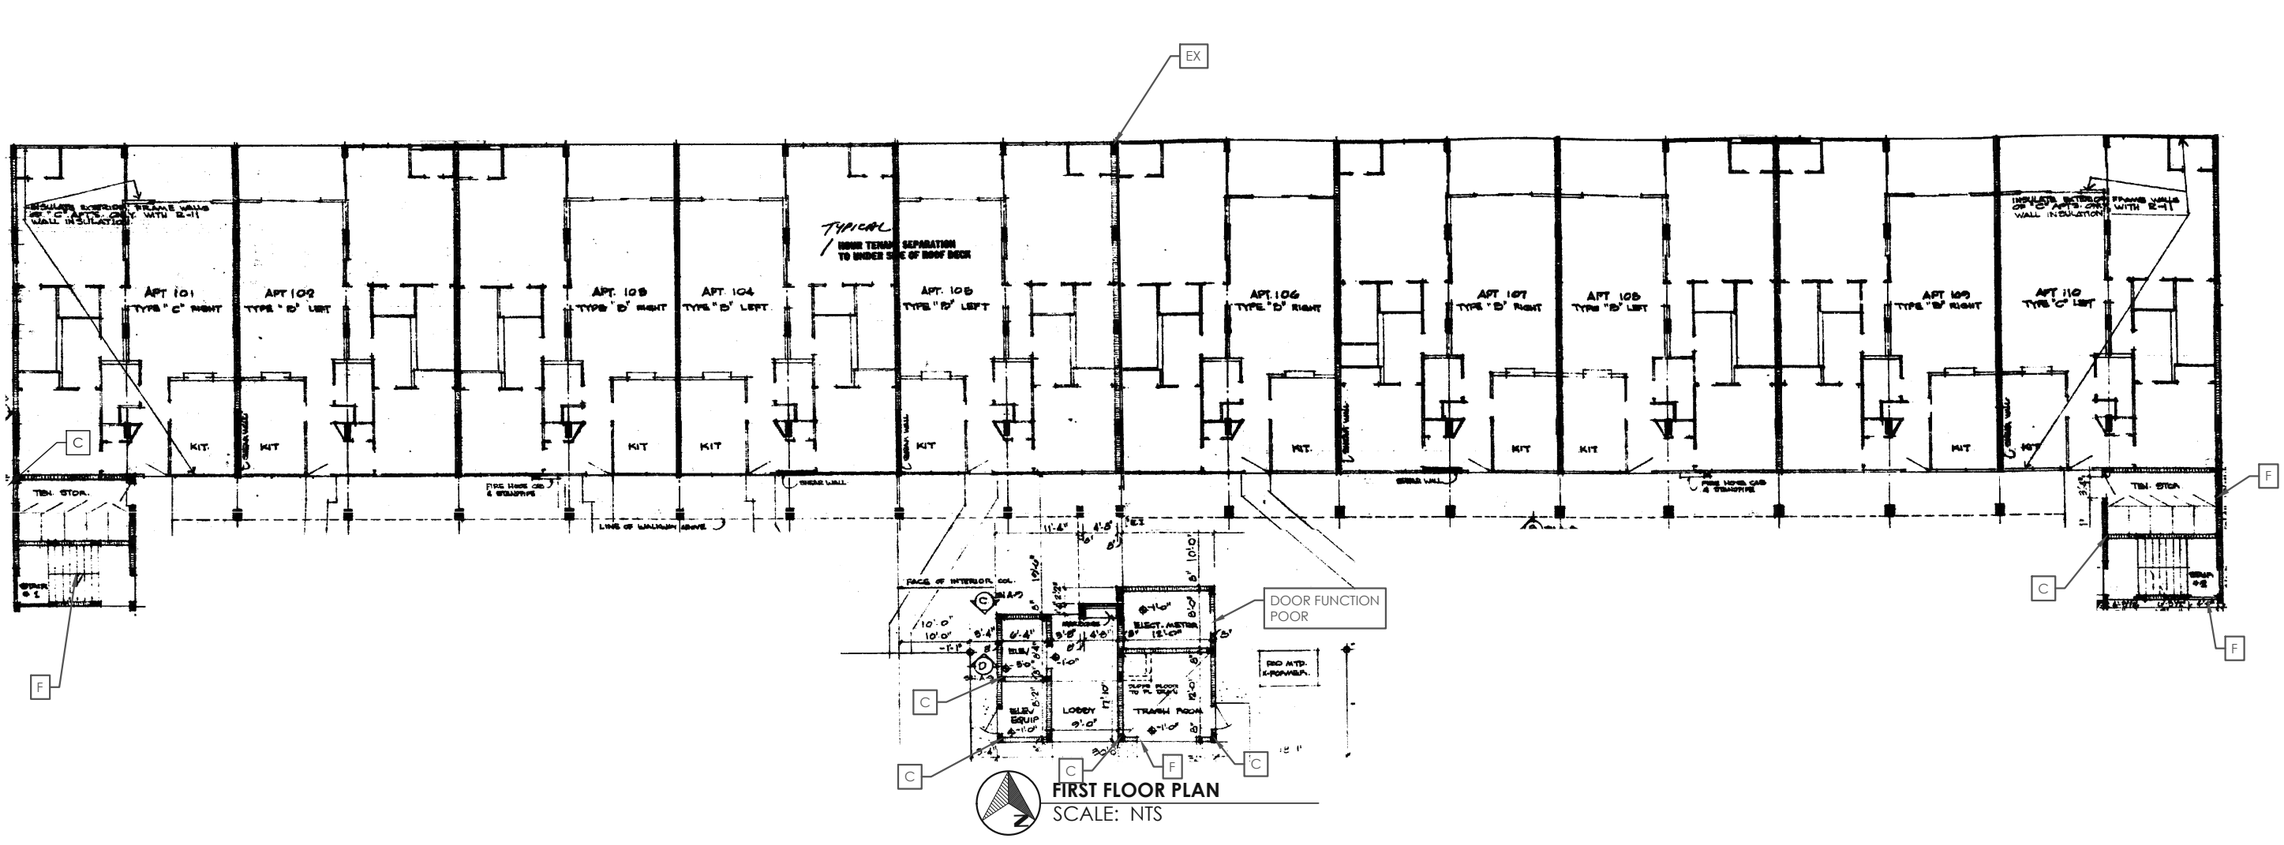
FIRST FLOOR PLAN
SCALE: NTS

ESTIMATED REPAIRS		
DESCRIPTION	SYM	EST. QTY.
EDGE REPAIR	E	
PARTIAL DECK REPAIR	D	
OVERHEAD REPAIR	O	
THRU DECK REPAIR	T	
STRESS CRACK REPAIR	R	
DELAMINATED TOPPING	DT	
BEAM REPAIR	B	
COLUMN REPAIR	C	6 CF
STUCCO REPAIR	S	
SOFFIT STUCCO REPAIR	SF	
STUCCO CRACK REPAIR	SC	
RUST SPOTS	RS	
WINDOW SILL REPAIR	SL	
POST POCKET REPAIRS	PP	
EXPANSION JOINT REPAIR	EX	8 LF
CONSTRUCT. JNT. REPAIR	CJ	
ABANDONED FASTENER/HOLES	F	6 EA

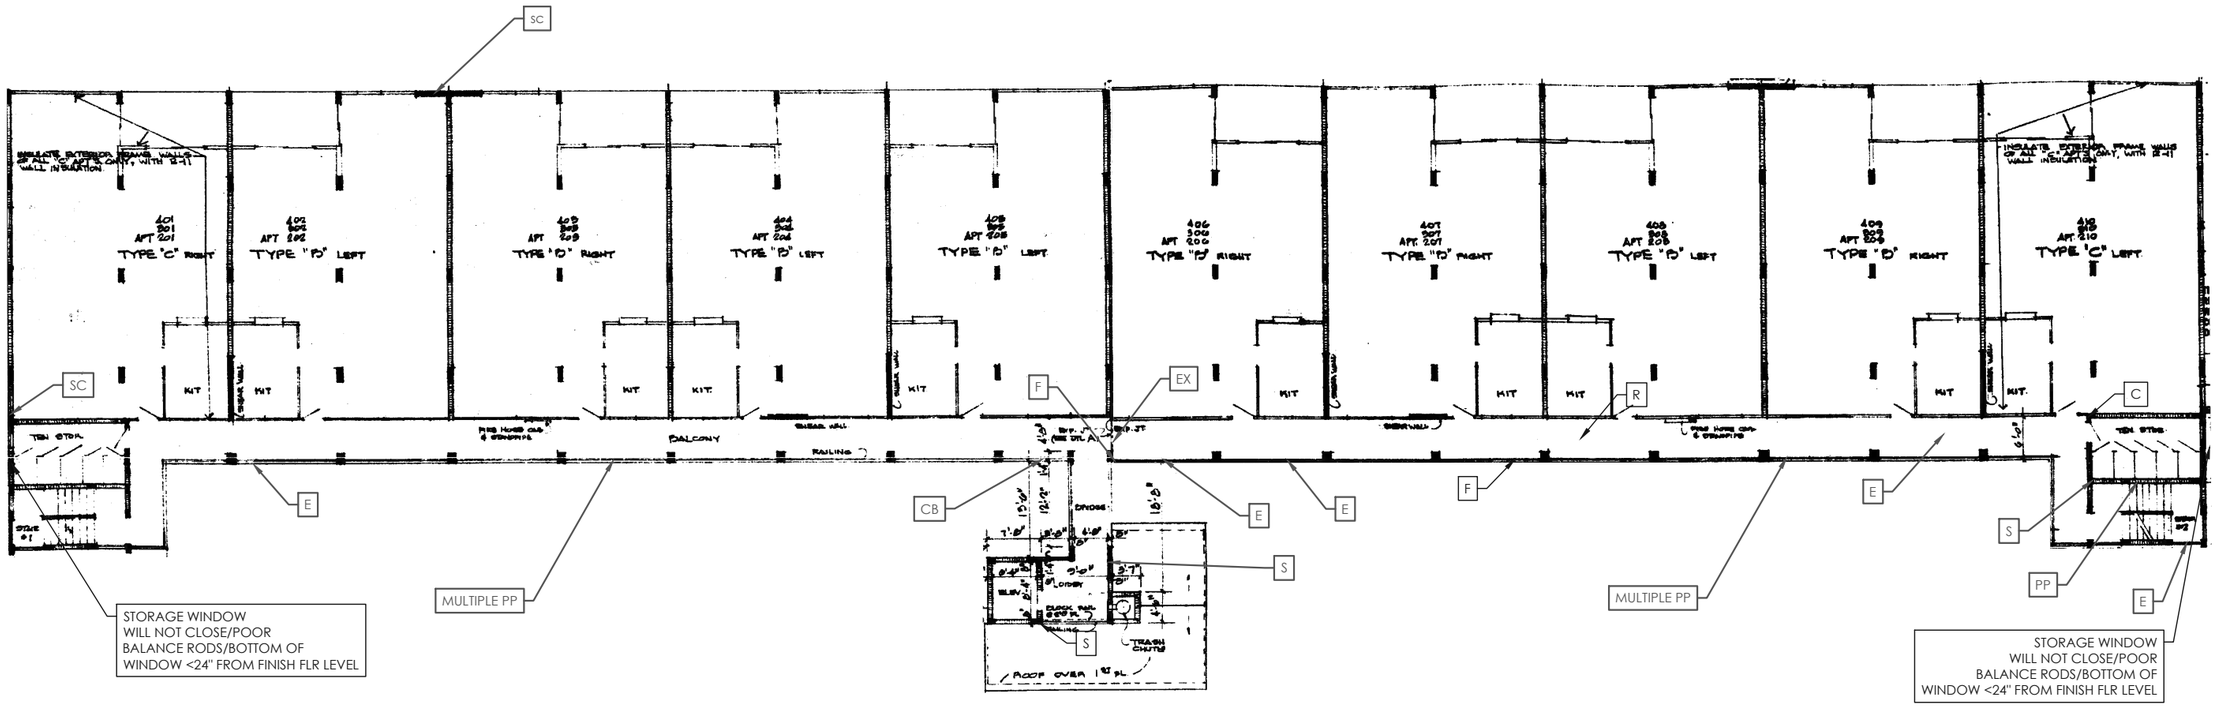
SECOND FLOOR PLAN
SCALE: NTS

ESTIMATED REPAIRS		
DESCRIPTION	SYM	EST. QTY.
EDGE REPAIR	E	5 LF
PARTIAL DECK REPAIR	D	
OVERHEAD REPAIR	O	
THRU DECK REPAIR	T	
STRESS CRACK REPAIR	R	3 LF
DELAMINATED TOPPING	DT	
BEAM REPAIR	B	
COLUMN REPAIR	C	
STUCCO REPAIR	S	8 SF
SOFFIT STUCCO REPAIR	SF	
STUCCO CRACK REPAIR	SC	8 LF
RUST SPOTS	RS	
WINDOW SILL REPAIR	SL	
POST POCKET REPAIRS	PP	28 EA
EXPANSION JOINT REPAIR	EX	13 LF
CONSTRUCT. JNT. REPAIR	CJ	
ABANDONED FASTENER/HOLES	F	1 EA
CORRODED RAIL BRACKETS	CB	2 EA

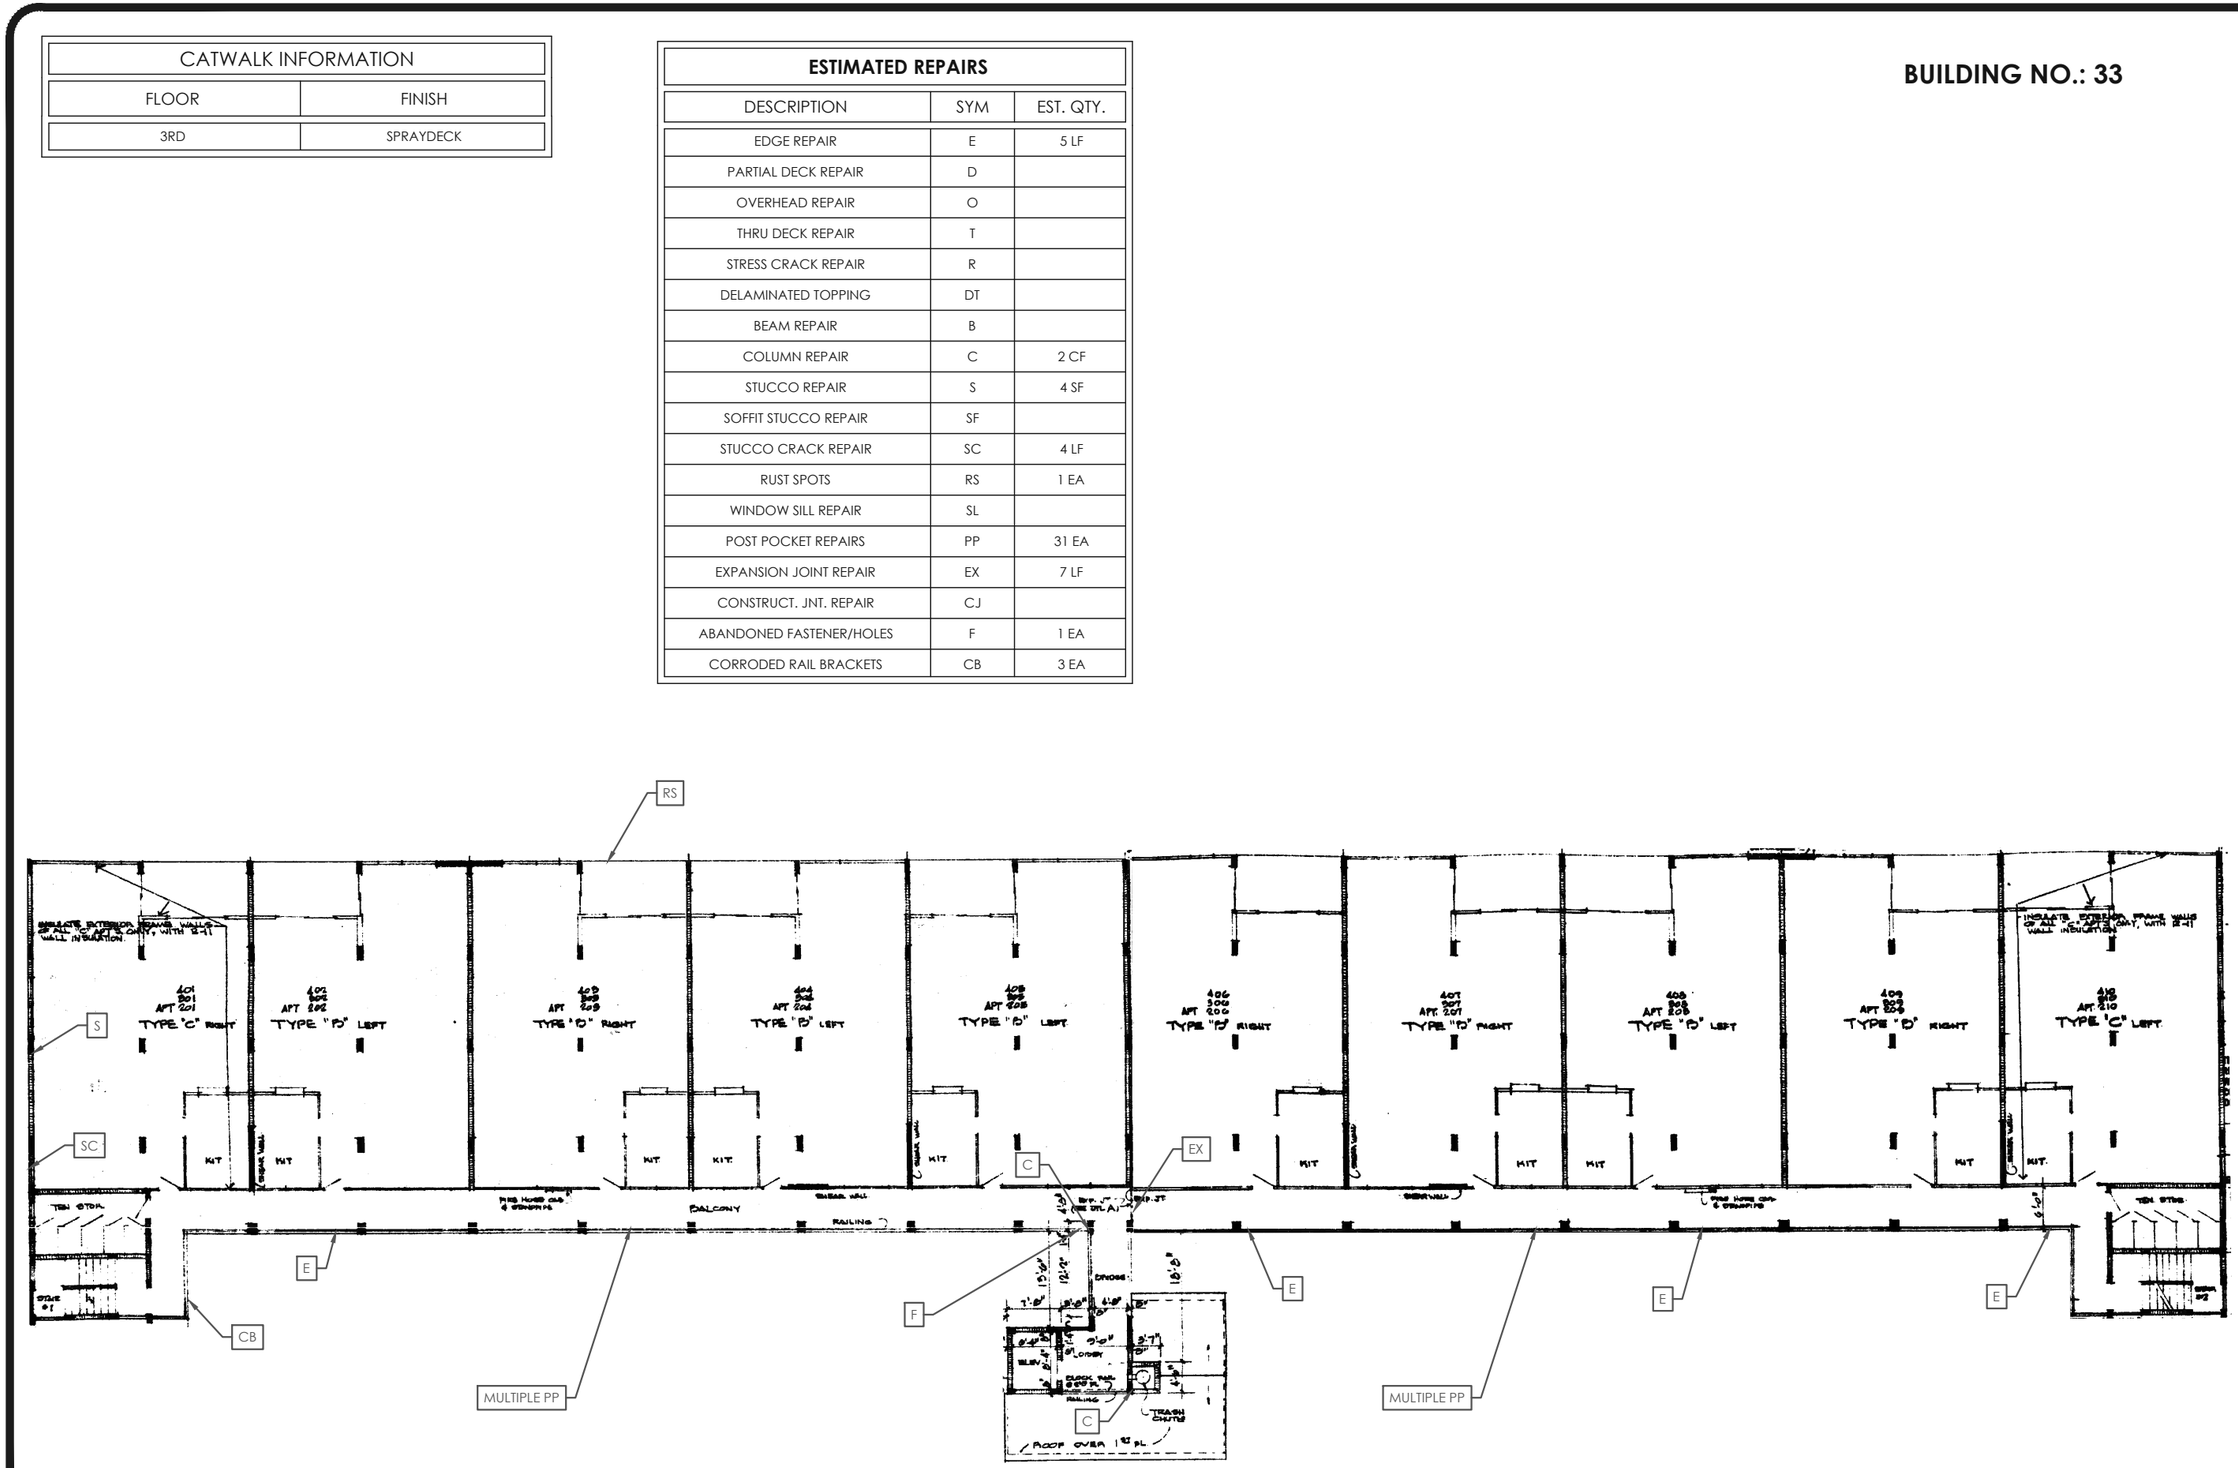
THIRD FLOOR PLAN
SCALE: NTS

ESTIMATED REPAIRS		
DESCRIPTION	SYM	EST. QTY.
EDGE REPAIR	E	5 LF
PARTIAL DECK REPAIR	D	
OVERHEAD REPAIR	O	
THRU DECK REPAIR	T	
STRESS CRACK REPAIR	R	
DELAMINATED TOPPING	DT	
BEAM REPAIR	B	
COLUMN REPAIR	C	2 CF
STUCCO REPAIR	S	4 SF
SOFFIT STUCCO REPAIR	SF	
STUCCO CRACK REPAIR	SC	4 LF
RUST SPOTS	RS	1 EA
WINDOW SILL REPAIR	SL	
POST POCKET REPAIRS	PP	31 EA
EXPANSION JOINT REPAIR	EX	7 LF
CONSTRUCT. JNT. REPAIR	CJ	
ABANDONED FASTENER/HOLES	F	1 EA
CORRODED RAIL BRACKETS	CB	3 EA

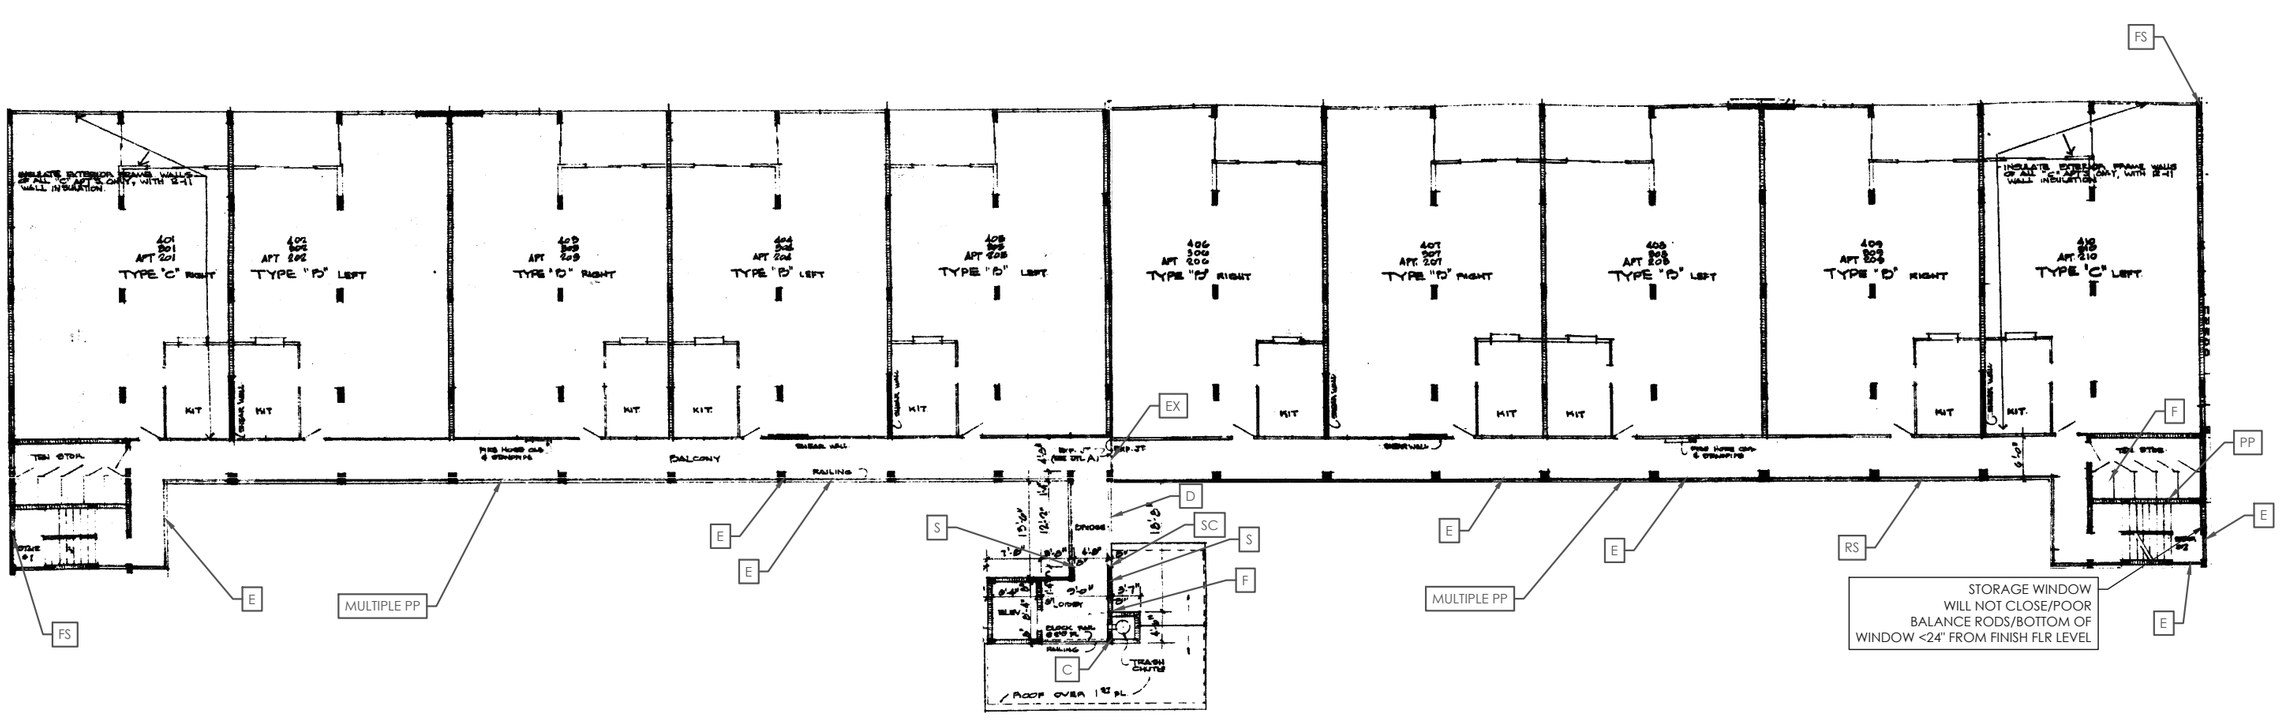
FOURTH FLOOR PLAN
SCALE: NTS

ESTIMATED REPAIRS		
DESCRIPTION	SYM	EST. QTY.
EDGE REPAIR	E	21 LF
PARTIAL DECK REPAIR	D	2 SF
OVERHEAD REPAIR	O	
THRU DECK REPAIR	T	
STRESS CRACK REPAIR	R	
DELAMINATED TOPPING	DT	
BEAM REPAIR	B	
COLUMN REPAIR	C	2 CF
STUCCO REPAIR	S	5 SF
SOFFIT STUCCO REPAIR	SF	
STUCCO CRACK REPAIR	SC	7 LF
RUST SPOTS	RS	
WINDOW SILL REPAIR	SL	
POST POCKET REPAIRS	PP	31 EA
EXPANSION JOINT REPAIR	EX	5 LF
CONSTRUCT. JNT. REPAIR	CJ	
ABANDONED FASTENER/HOLES	F	3 EA
CORRODED RAIL BRACKETS	CB	
DETERIORATED WOOD FASCIA	FS	20 LF

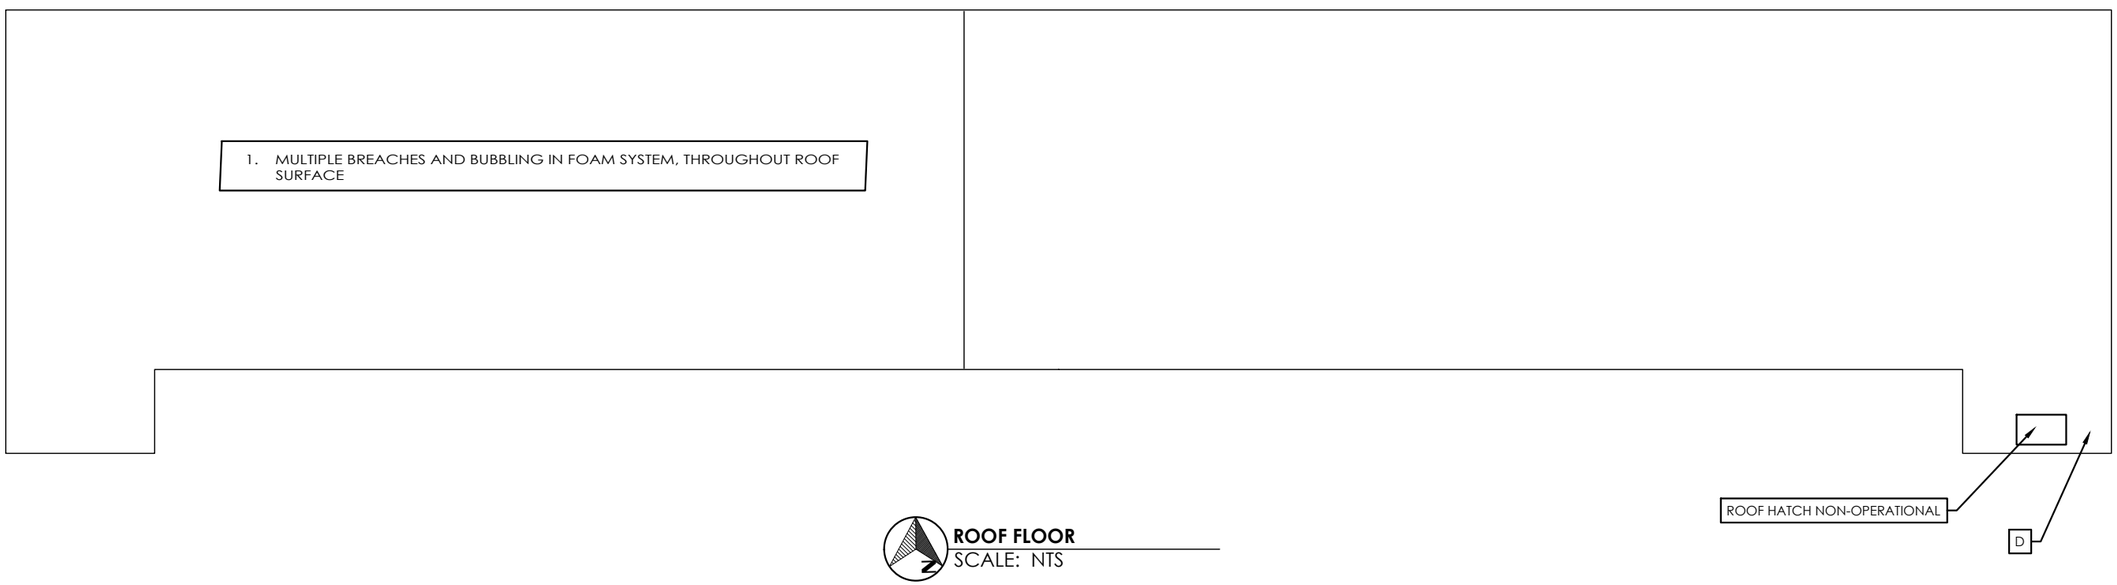
ROOF FLOOR
SCALE: NTS

1. MULTIPLE BREACHES AND BUBBLING IN FOAM SYSTEM, THROUGHOUT ROOF SURFACE

13. All flat roof systems should be fully replaced. The structural slabs should be inspected prior to the new roof systems being stalled. Stucco repairs will be required on parapet walls. A/C unit stands might require replacement to meet current roofing codes.
14. Egress windows and doors in bedrooms must be operational and unobstructed at minimum, and temporary screw locks at the egress windows should be removed. If needed, the doors and windows should be refurbished or replaced with new code compliant components. Fasteners should be installed where missing at door and window frames. Any window or door nearing the end of its useful life should also be replaced.
