HUNTINGTON LAKES SECTION 4
BUILDING 34

BUILDINGS STRUCTURAL PHASE TWO
MILESTONE INSPECTION REPORT

SEPTEMBER 2024

Re: Milestone Inspections
Huntington Lakes Section Four
7321 Amberly Lane – Building 34
Delray Beach, Florida 33446

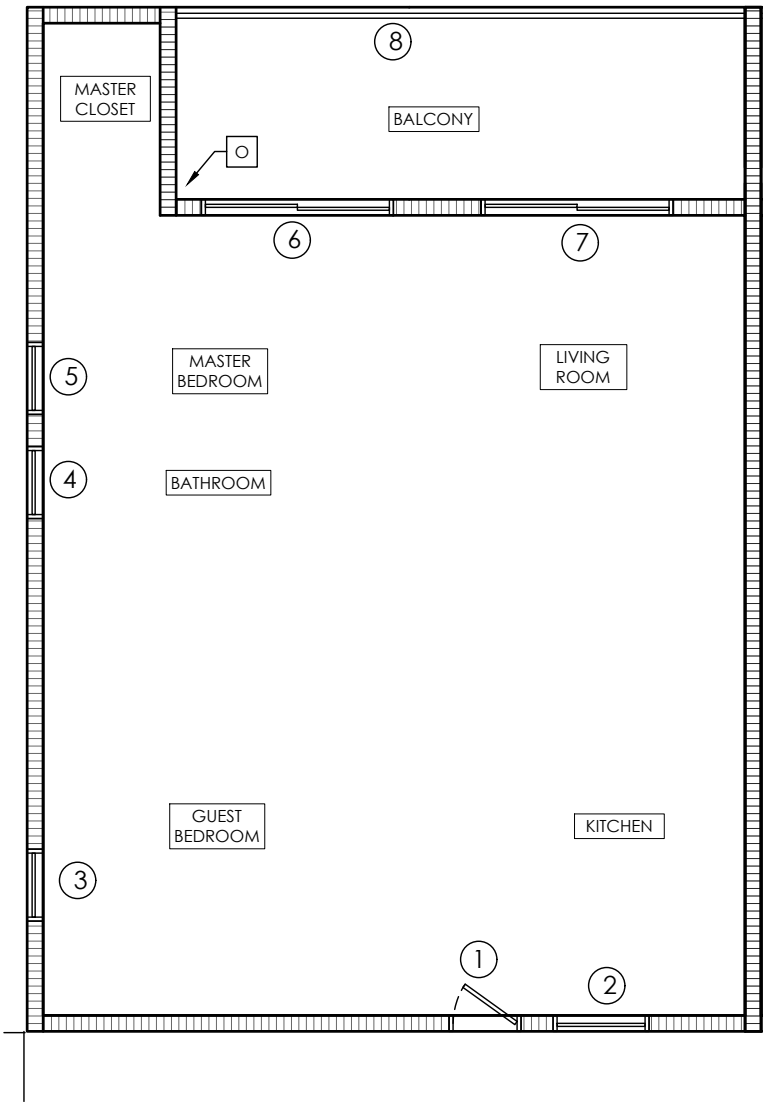
DESCRIPTION	SYM	EST, QTY.
EDGE REPAIR	E	
PARTIAL DECK REPAIR	D	
OVERHEAD REPAIR	O	
THRU DECK REPAIR	T	
STRESS CRACK REPAIR	R	
HOLLOW TILE	HT	
BEAM REPAIR	B	
COLUMN REPAIR	C	
DELAMINATED STUCCO REPAIR	S	
STUCCO CRACK REPAIR	SC	
RUST SPOTS	RS	
MISSING ELECTRICAL COVER PLATE	EC	
ABANDON FASTENER/HOLES	F	2 EA

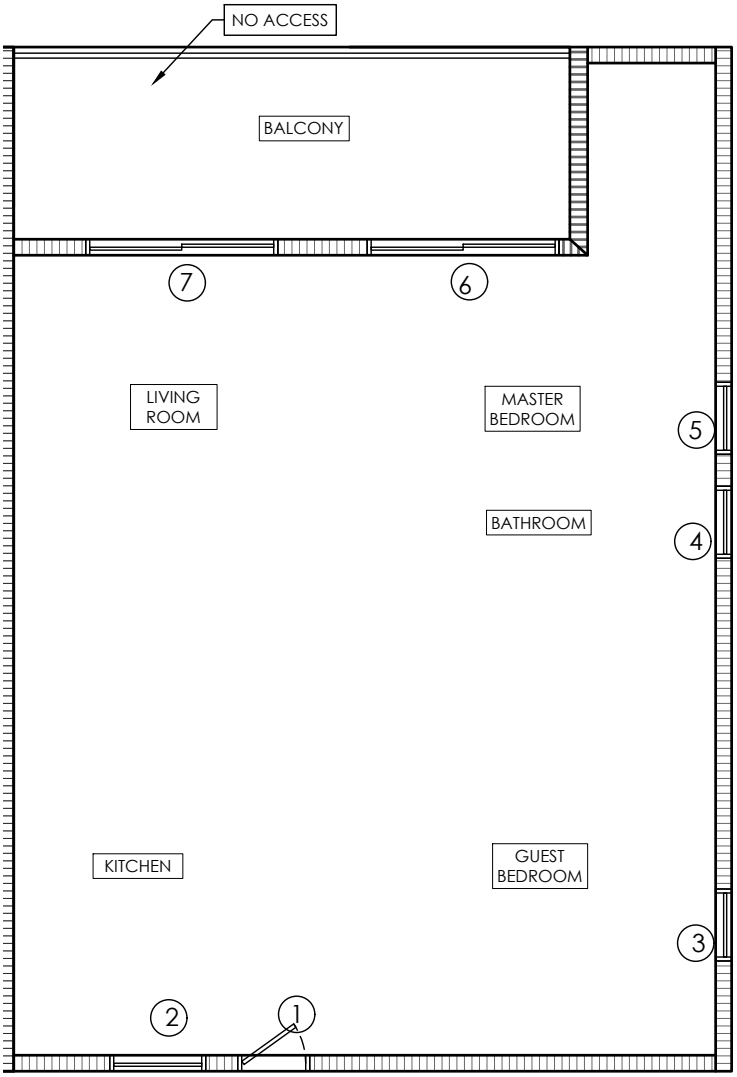
DESCRIPTION	SYM	EST. QTY.
EDGE REPAIR	E	
PARTIAL DECK REPAIR	D	
OVERHEAD REPAIR	O	1 SF
THRU DECK REPAIR	T	
STRESS CRACK REPAIR	R	
HOLLOW TILE	HT	40 SF
BEAM REPAIR	B	
COLUMN REPAIR	C	
DELAMINATED STUCCO REPAIR	S	
STUCCO CRACK REPAIR	SC	
RUST SPOTS	RS	
MISSING ELECTRICAL COVER PLATE	EC	
ABANDON FASTENER/HOLES	F	1 EA

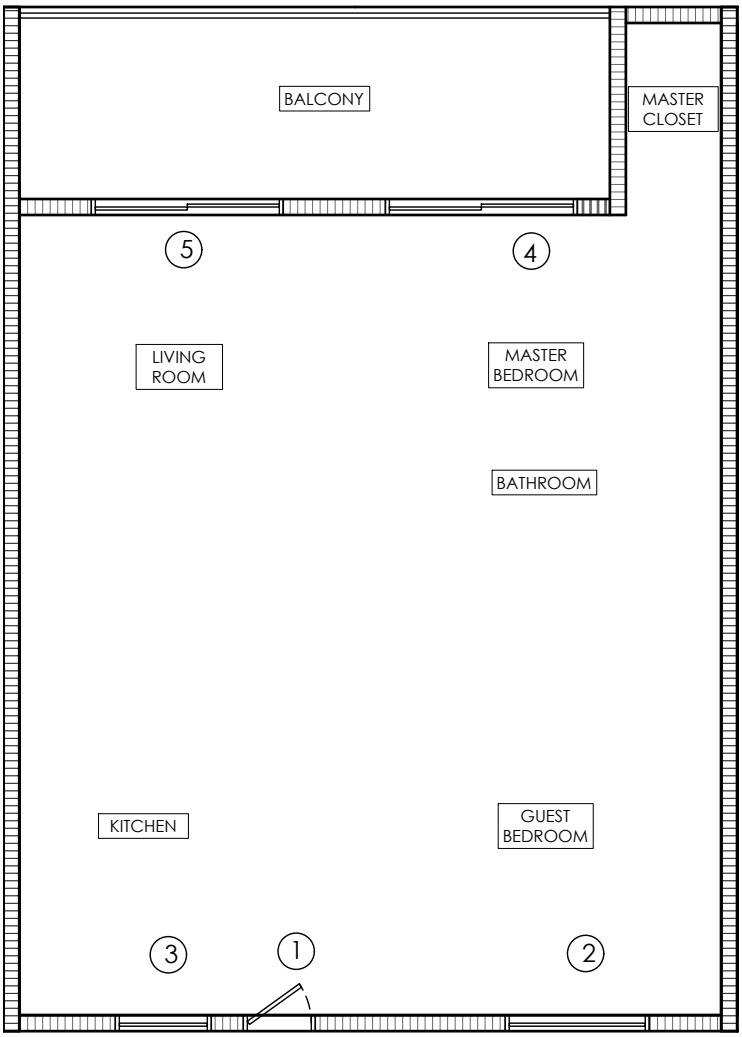
DESCRIPTION	SYM	EST, QTY.
EDGE REPAIR	E	
PARTIAL DECK REPAIR	D	
OVERHEAD REPAIR	O	2 SF
THRU DECK REPAIR	T	
STRESS CRACK REPAIR	R	
HOLLOW TILE	HT	100 SF
BEAM REPAIR	B	
COLUMN REPAIR	C	
DELAMINATED STUCCO REPAIR	S	
STUCCO CRACK REPAIR	SC	
RUST SPOTS	RS	
MISSING ELECTRICAL COVER PLATE	EC	
ABANDON FASTENER/HOLES	F

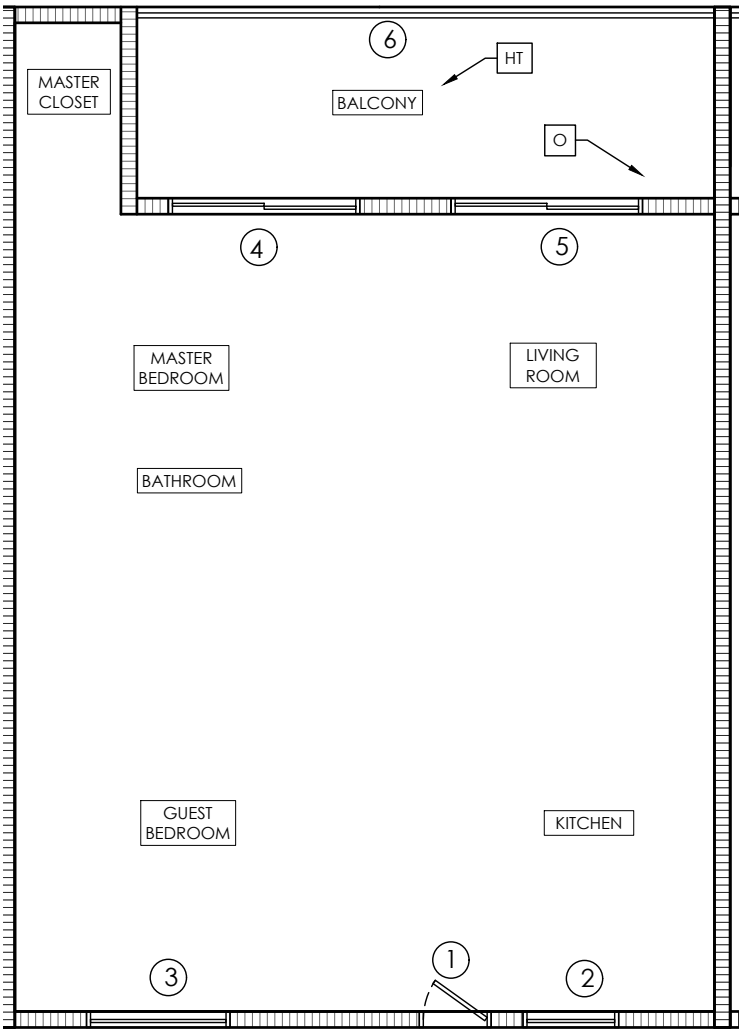
DESCRIPTION	SYM	EST, QTY.
EDGE REPAIR	E	
PARTIAL DECK REPAIR	D	
OVERHEAD REPAIR	O	
THRU DECK REPAIR	T	
STRESS CRACK REPAIR	R	
HOLLOW TILE	HT	220 SF
BEAM REPAIR	B	
COLUMN REPAIR	C	
DELAMINATED STUCCO REPAIR	S	
STUCCO CRACK REPAIR	SC	
RUST SPOTS	RS	
MISSING ELECTRICAL COVER PLATE	EC	1A
ABANDON FASTENER/HOLES	F	2 EA

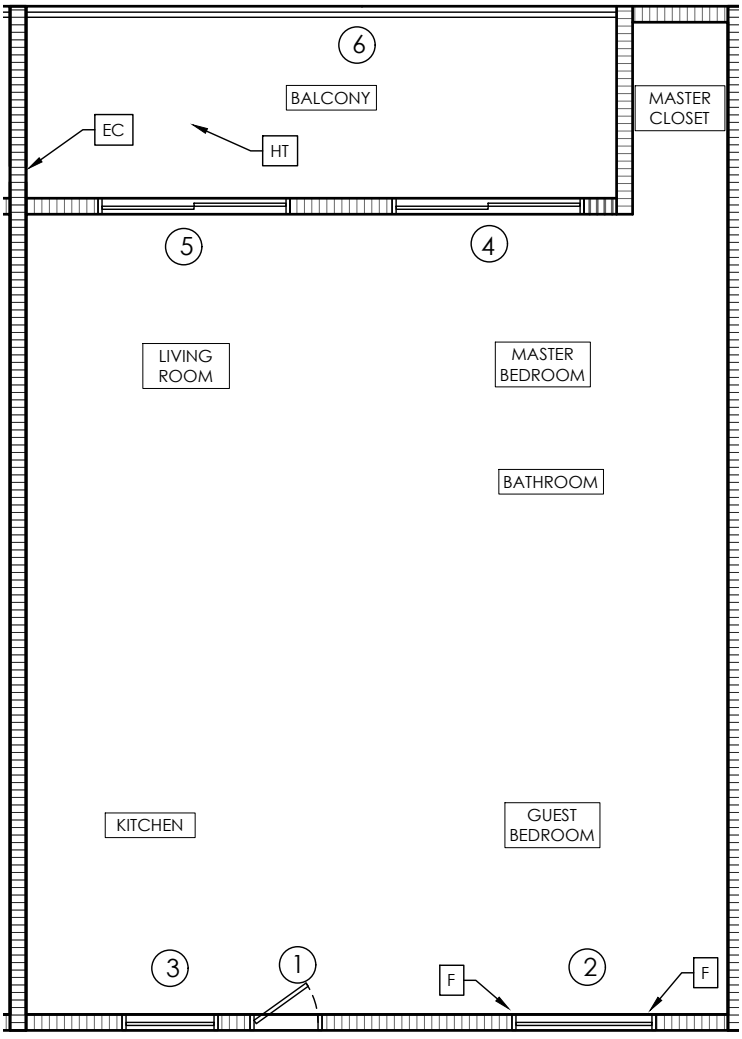
DESCRIPTION	SYM	EST. QTY.
EDGE REPAIR	E	
PARTIAL DECK REPAIR	D	
OVERHEAD REPAIR	O	2 SF
THRU DECK REPAIR	T	
STRESS CRACK REPAIR	R	
HOLLOW TILE	HT	80 SF
BEAM REPAIR	B	
COLUMN REPAIR	C	
DELAMINATED STUCCO REPAIR	S	
STUCCO CRACK REPAIR	SC	
RUST SPOTS	RS	
MISSING ELECTRICAL COVER PLATE	EC	
ABANDON FASTENER/HOLES	F	1 EA

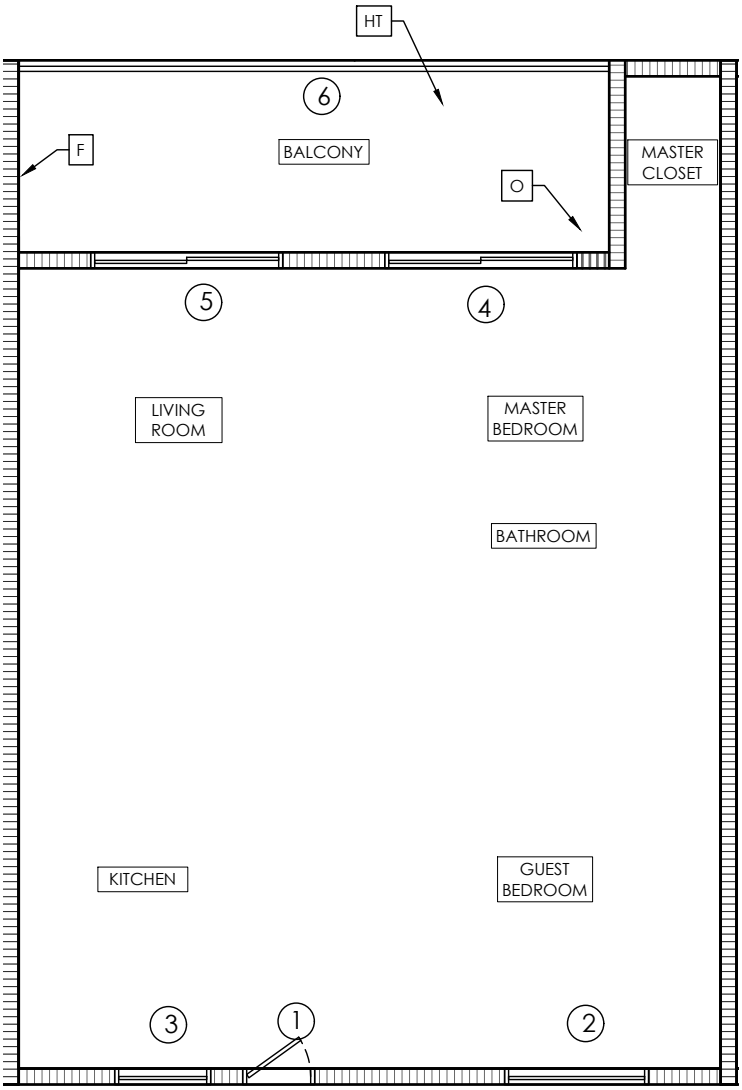
DESCRIPTION	SYM	EST, QTY.
EDGE REPAIR	E	
PARTIAL DECK REPAIR	D	
OVERHEAD REPAIR	O	
THRU DECK REPAIR	T	
STRESS CRACK REPAIR	R	
HOLLOW TILE	HT	100 SF
BEAM REPAIR	B	
COLUMN REPAIR	C	
DELAMINATED STUCCO REPAIR	S	
STUCCO CRACK REPAIR	SC	1 LF
RUST SPOTS	RS	
MISSING ELECTRICAL COVER PLATE	EC	1 EA
ABANDON FASTENER/HOLES	F

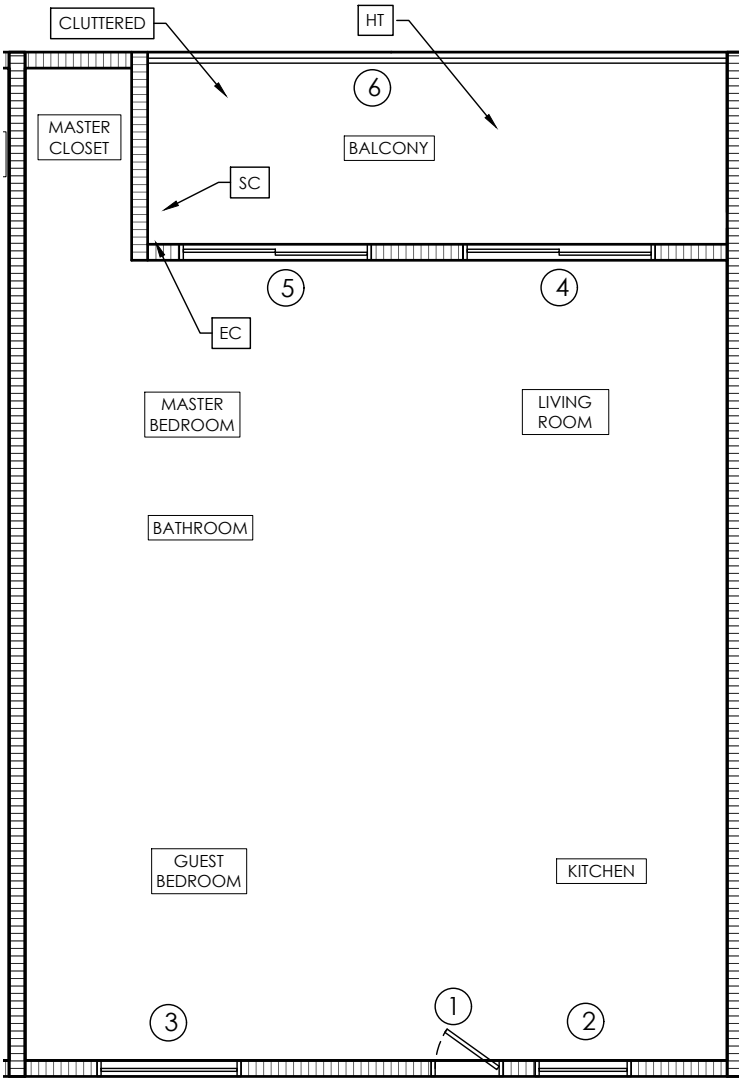
DESCRIPTION	SYM	EST. QTY.
EDGE REPAIR	E	
PARTIAL DECK REPAIR	D	
OVERHEAD REPAIR	O	1 SF
THRU DECK REPAIR	T	
STRESS CRACK REPAIR	R	
HOLLOW TILE	HT	
BEAM REPAIR	B	
COLUMN REPAIR	C	
DELAMINATED STUCCO REPAIR	S	5 SF
STUCCO CRACK REPAIR	SC	6 LF
RUST SPOTS	RS	
MISSING ELECTRICAL COVER PLATE	EC	
ABANDON FASTENER/HOLES	F	2 EA

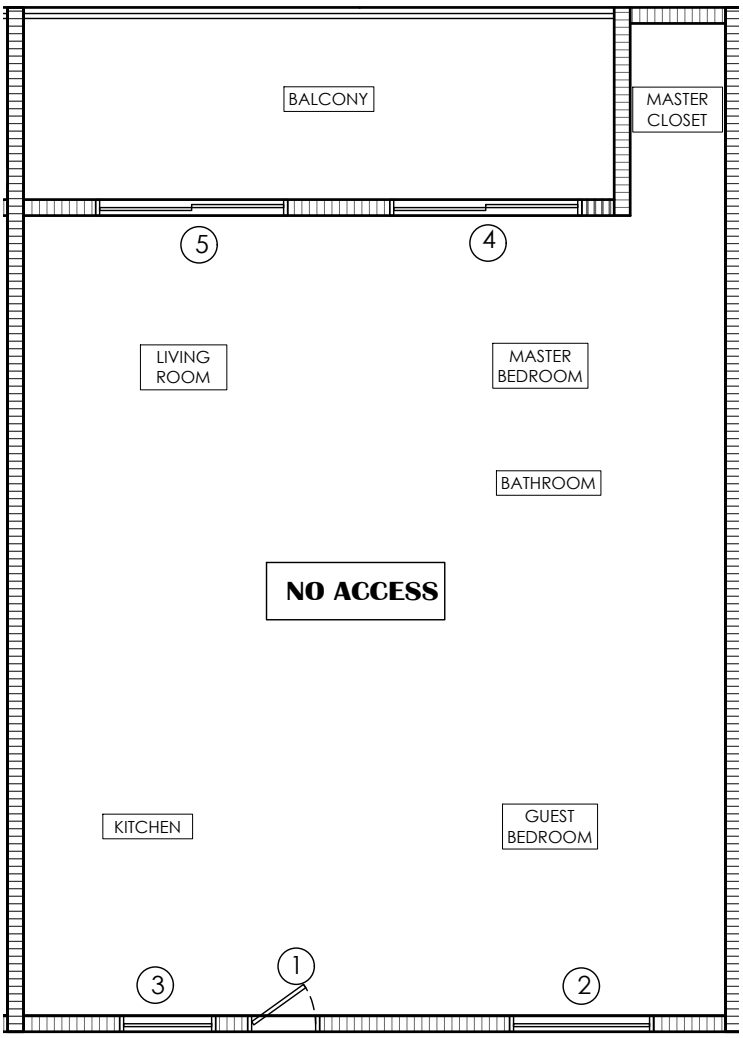
DESCRIPTION	SYM	EST, QTY.
EDGE REPAIR	E	
PARTIAL DECK REPAIR	D	
OVERHEAD REPAIR	O	
THRU DECK REPAIR	T	
STRESS CRACK REPAIR	R	
HOLLOW TILE	HT	50 SF
BEAM REPAIR	B	
COLUMN REPAIR	C	
DELAMINATED STUCCO REPAIR	S	1 LF
STUCCO CRACK REPAIR	SC	
RUST SPOTS	RS	
MISSING ELECTRICAL COVER PLATE	EC	
ABANDON FASTENER/HOLES	F

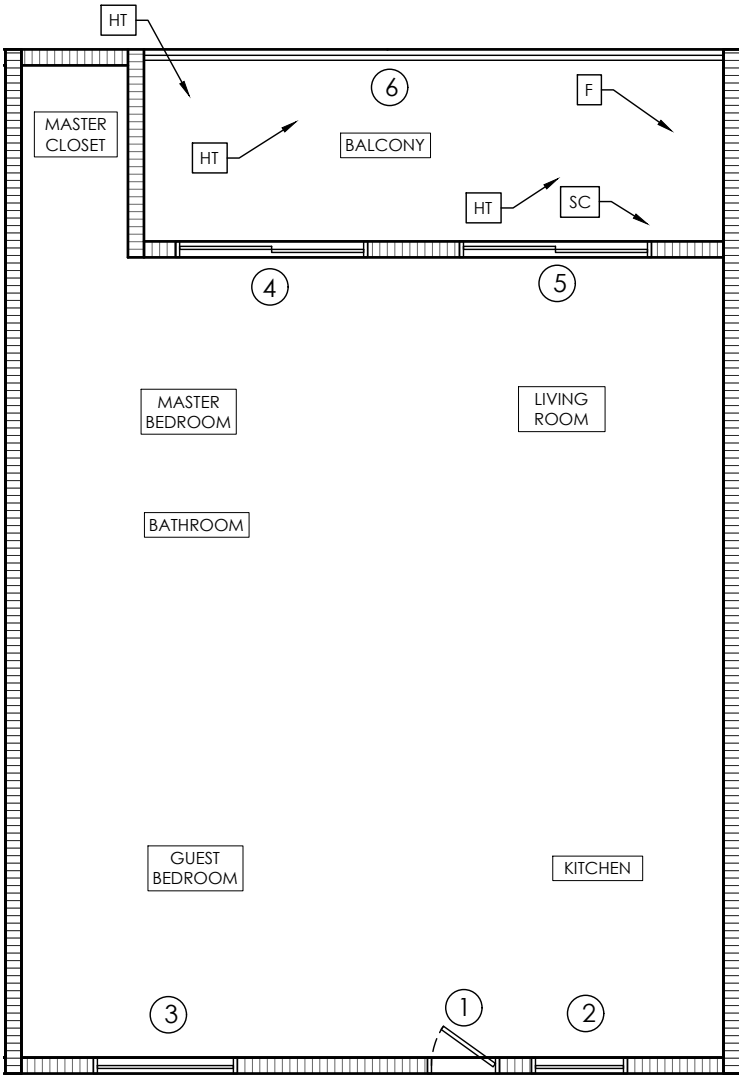
DESCRIPTION	SYM	EST. QTY.
EDGE REPAIR	E	
PARTIAL DECK REPAIR	D	
OVERHEAD REPAIR	O	
THRU DECK REPAIR	T	
STRESS CRACK REPAIR	R	5 LF
HOLLOW TILE	HT	
BEAM REPAIR	B	
COLUMN REPAIR	C	
DELAMINATED STUCCO REPAIR	S	
STUCCO CRACK REPAIR	SC	25 LF
RUST SPOTS	RS	
MISSING ELECTRICAL COVER PLATE	EC	
ABANDON FASTENER/HOLES	F	35 EA

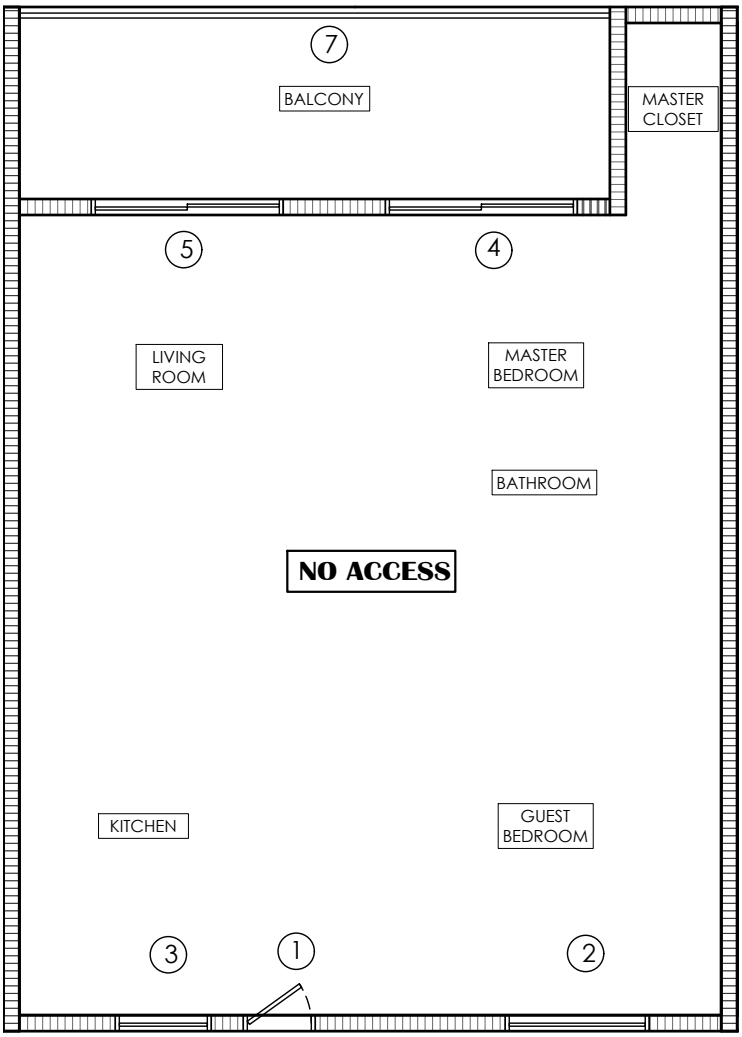
DESCRIPTION	SYM	EST, QTY.
EDGE REPAIR	E	
PARTIAL DECK REPAIR	D	
OVERHEAD REPAIR	O	2 SF
THRU DECK REPAIR	T	
STRESS CRACK REPAIR	R	
HOLLOW TILE	HT	
BEAM REPAIR	B	
COLUMN REPAIR	C	
DELAMINATED STUCCO REPAIR	S	
STUCCO CRACK REPAIR	SC	
RUST SPOTS	RS	
MISSING ELECTRICAL COVER PLATE	EC	
ABANDON FASTENER/HOLES	F
