HUNTINGTON LAKES SECTION 4
BUILDING 35

BUILDINGS STRUCTURAL PHASE TWO
MILESTONE INSPECTION REPORT

SEPTEMBER 2024

Re: Milestone Inspections
Huntington Lakes Section Four
7301 Amberly Lane – Building 35
Delray Beach, Florida 33446

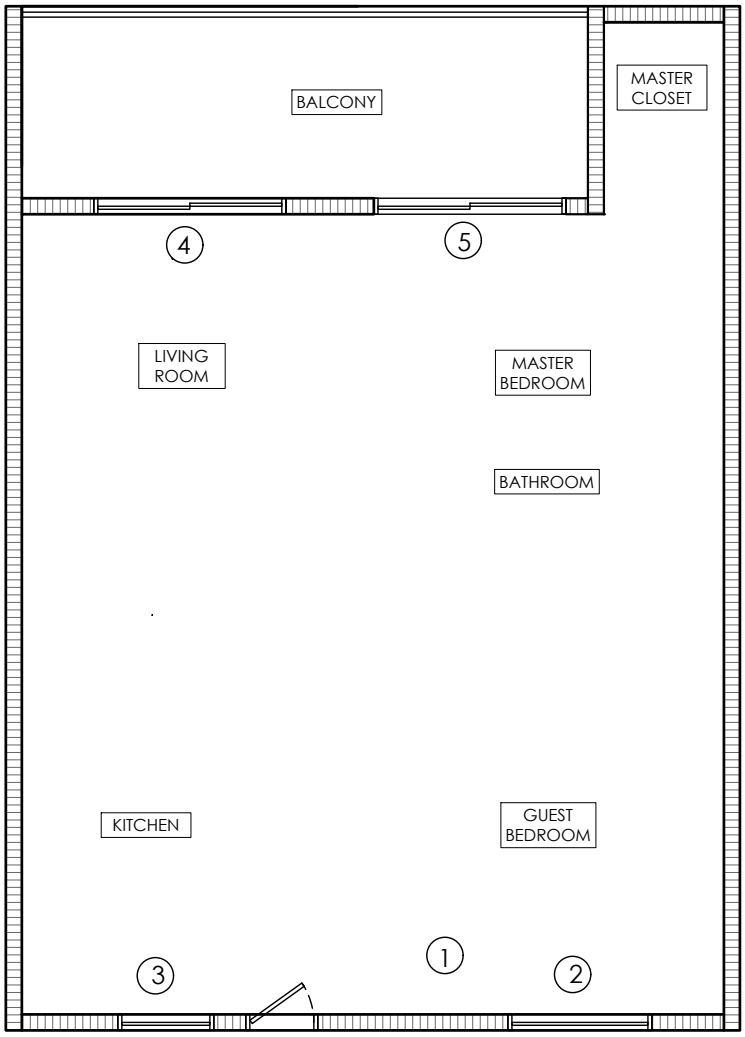
DESCRIPTION	SYM	EST, QTY.
EDGE REPAIR	E	
PARTIAL DECK REPAIR	D	
OVERHEAD REPAIR	O	2 SF
THRU DECK REPAIR	T	
STRESS CRACK REPAIR	R	
HOLLOW TILE	HT	
BEAM REPAIR	B	
COLUMN REPAIR	C	
DELAMINATED STUCCO REPAIR	S	
STUCCO CRACK REPAIR	SC	
RUST SPOTS	RS	
MISSING ELECTRICAL COVER PLATE	EC	
ABANDON FASTENER/HOLES	F

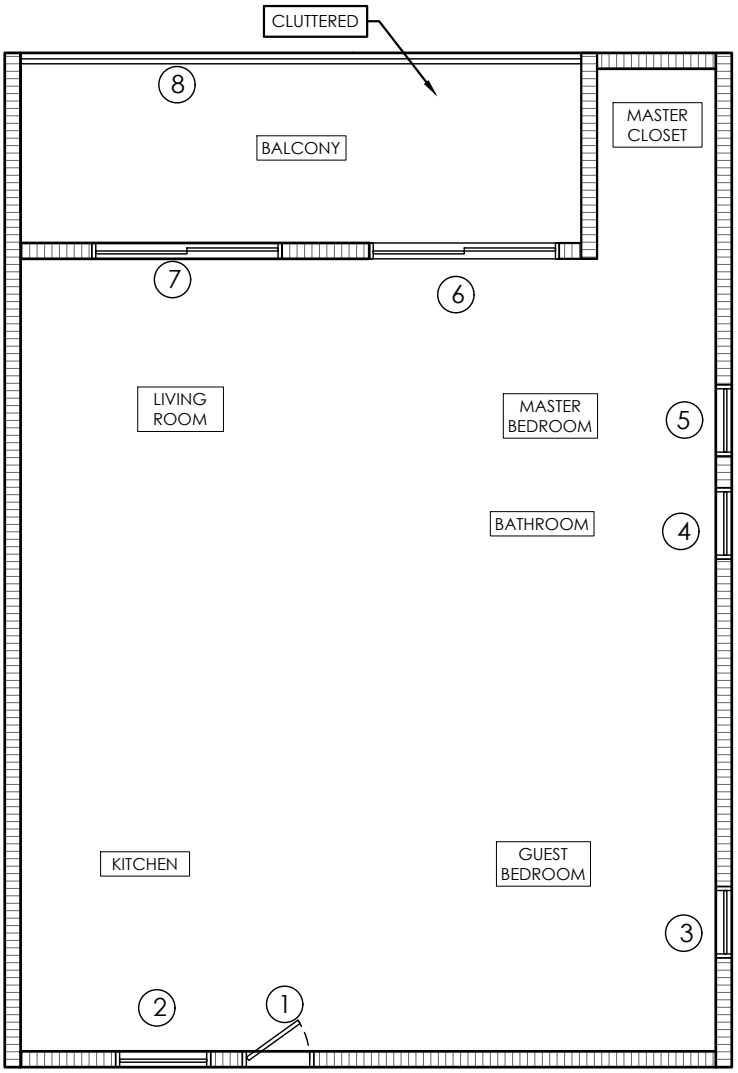
DESCRIPTION	SYM	EST, QTY.
EDGE REPAIR	E	
PARTIAL DECK REPAIR	D	
OVERHEAD REPAIR	O	1 SF
THRU DECK REPAIR	T	
STRESS CRACK REPAIR	R	
HOLLOW TILE	HT	
BEAM REPAIR	B	
COLUMN REPAIR	C	
DELAMINATED STUCCO REPAIR	S	
STUCCO CRACK REPAIR	SC	
RUST SPOTS	RS	
MISSING ELECTRICAL COVER PLATE	EC	
ABANDON FASTENER/HOLES	F

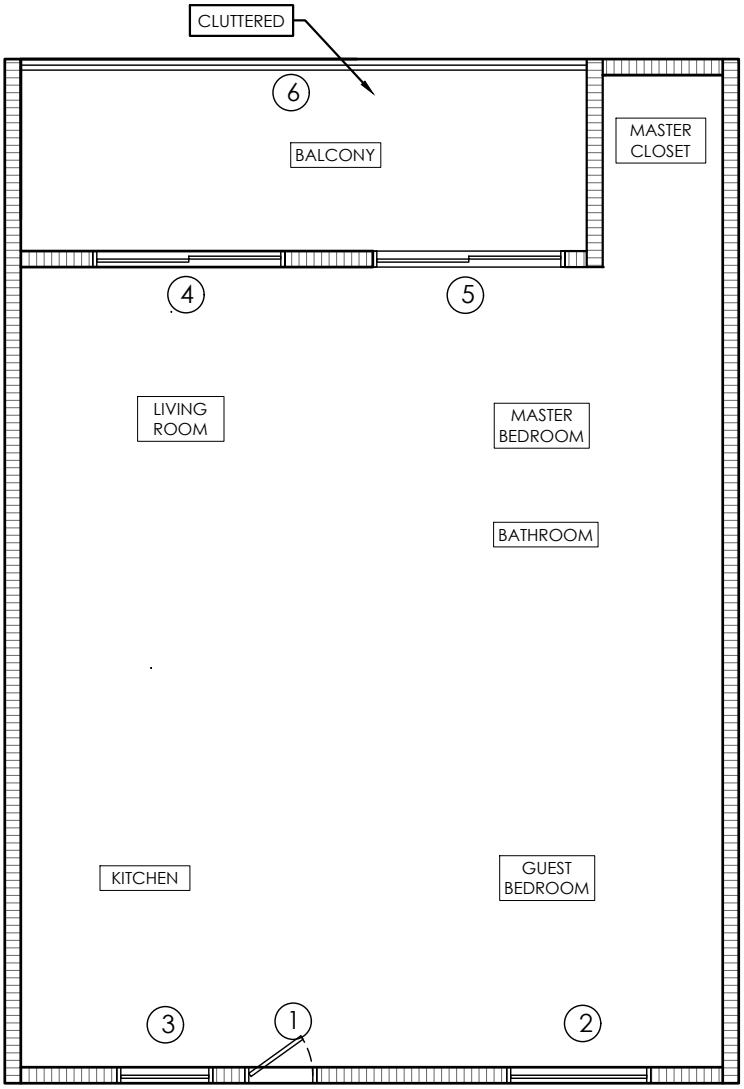
DESCRIPTION	SYM	EST. QTY.
EDGE REPAIR	E	
PARTIAL DECK REPAIR	D	
OVERHEAD REPAIR	O	
THRU DECK REPAIR	T	
STRESS CRACK REPAIR	R	
HOLLOW TILE	HT	15 SF
BEAM REPAIR	B	
COLUMN REPAIR	C	
DELAMINATED STUCCO REPAIR	S	
STUCCO CRACK REPAIR	SC	
RUST SPOTS	RS	
MISSING ELECTRICAL COVER PLATE	EC	
ABANDON FASTENER/HOLES	F	30 EA

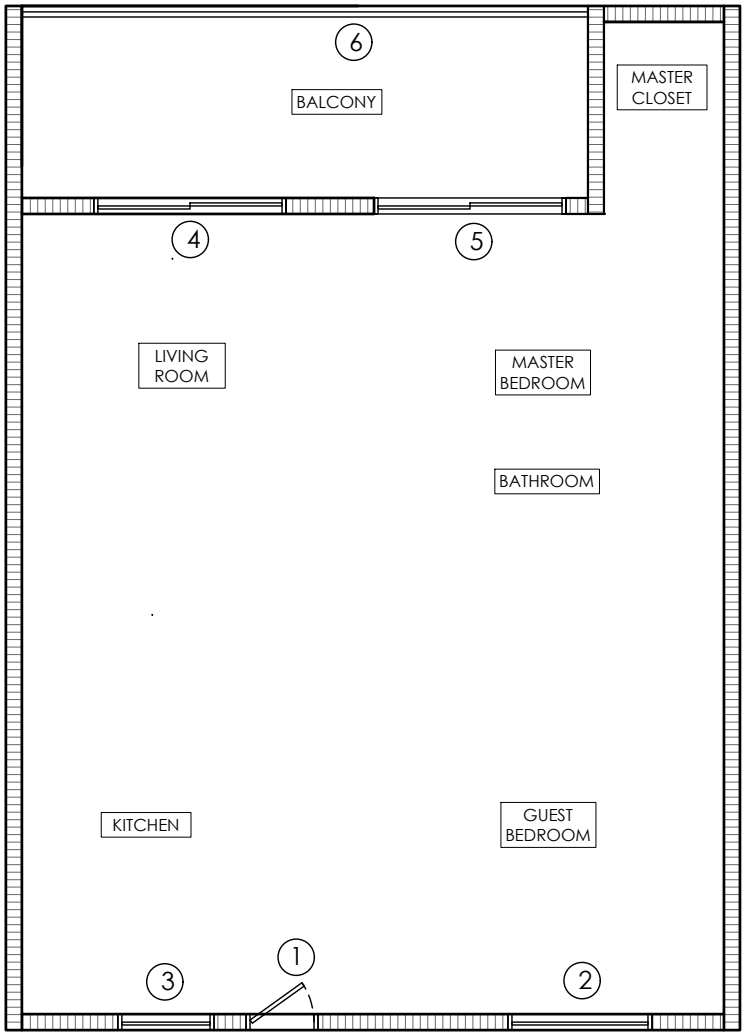
DESCRIPTION	SYM	EST, QTY.
EDGE REPAIR	E	
PARTIAL DECK REPAIR	D	
OVERHEAD REPAIR	O	
THRU DECK REPAIR	T	
STRESS CRACK REPAIR	R	
HOLLOW TILE	HT	
BEAM REPAIR	B	
COLUMN REPAIR	C	
DELAMINATED STUCCO REPAIR	S	
STUCCO CRACK REPAIR	SC	
RUST SPOTS	RS	
MISSING ELECTRICAL COVER PLATE	EC	
ABANDON FASTENER/HOLES	F	45 EA

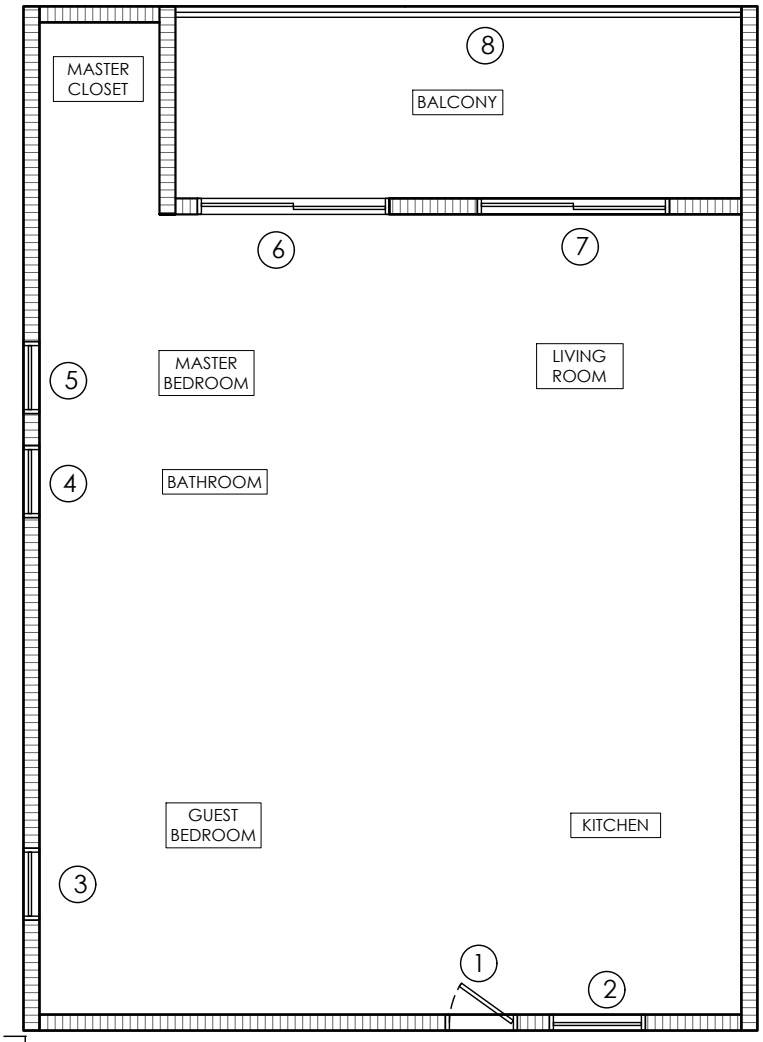
DESCRIPTION	SYM	EST, QTY.
EDGE REPAIR	E	
PARTIAL DECK REPAIR	D	
OVERHEAD REPAIR	O	
THRU DECK REPAIR	T	
STRESS CRACK REPAIR	R	
HOLLOW TILE	HT	
BEAM REPAIR	B	
COLUMN REPAIR	C	
DELAMINATED STUCCO REPAIR	S	
STUCCO CRACK REPAIR	SC	
RUST SPOTS	RS	
MISSING ELECTRICAL COVER PLATE	EC	1 EA
ABANDON FASTENER/HOLES	F

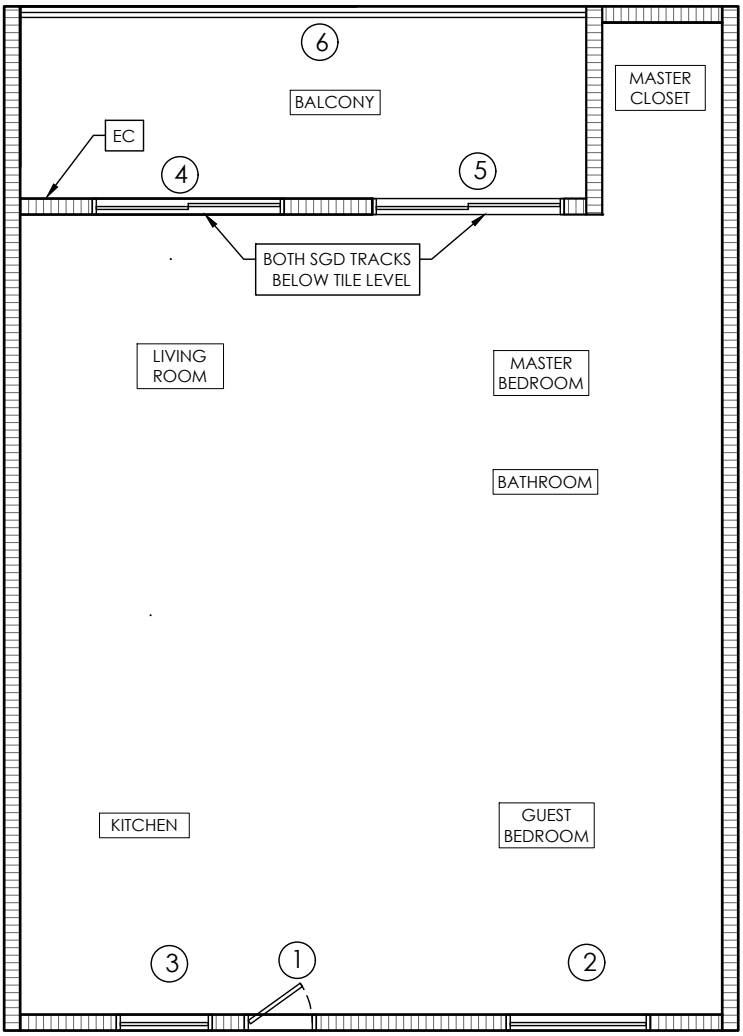
DESCRIPTION	SYM	EST, QTY.
EDGE REPAIR	E	
PARTIAL DECK REPAIR	D	
OVERHEAD REPAIR	O	
THRU DECK REPAIR	T	
STRESS CRACK REPAIR	R	
HOLLOW TILE	HT	
BEAM REPAIR	B	
COLUMN REPAIR	C	
DELAMINATED STUCCO REPAIR	S	
STUCCO CRACK REPAIR	SC	
RUST SPOTS	RS	
MISSING ELECTRICAL COVER PLATE	EC	
ABANDON FASTENER/HOLES	F	4 EA

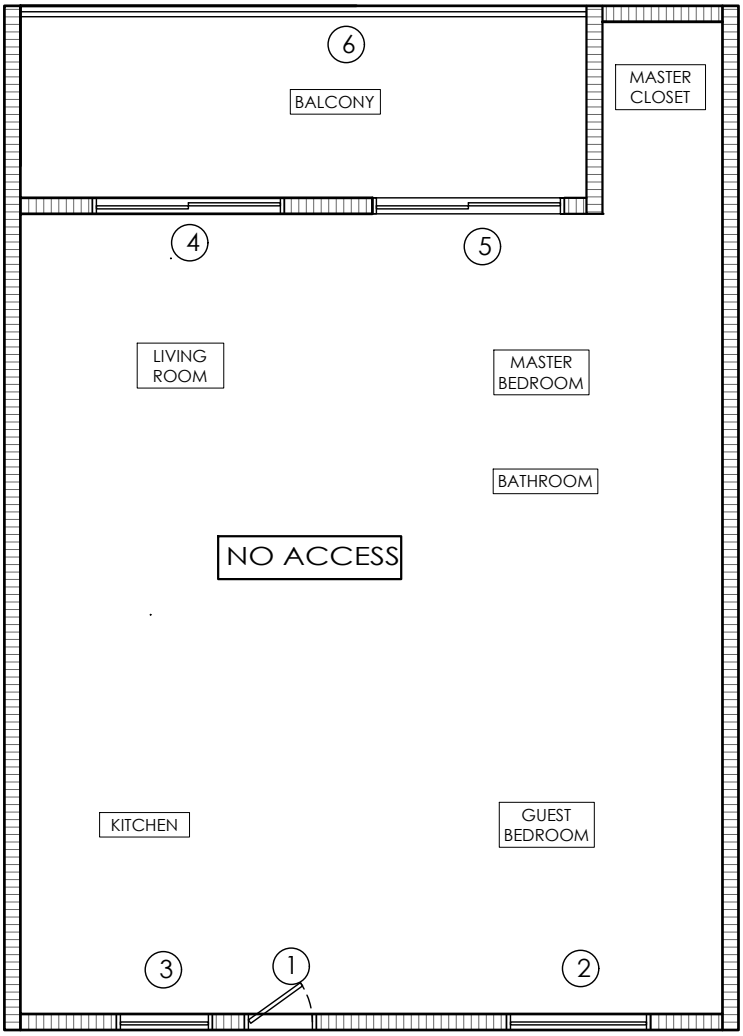
DESCRIPTION	SYM	EST, QTY.
EDGE REPAIR	E	
PARTIAL DECK REPAIR	D	
OVERHEAD REPAIR	O	
THRU DECK REPAIR	T	
STRESS CRACK REPAIR	R	
HOLLOW TILE	HT	4 SF
BEAM REPAIR	B	
COLUMN REPAIR	C	
DELAMINATED STUCCO REPAIR	S	
STUCCO CRACK REPAIR	SC	
RUST SPOTS	RS	
MISSING ELECTRICAL COVER PLATE	EC	
ABANDON FASTENER/HOLES	F

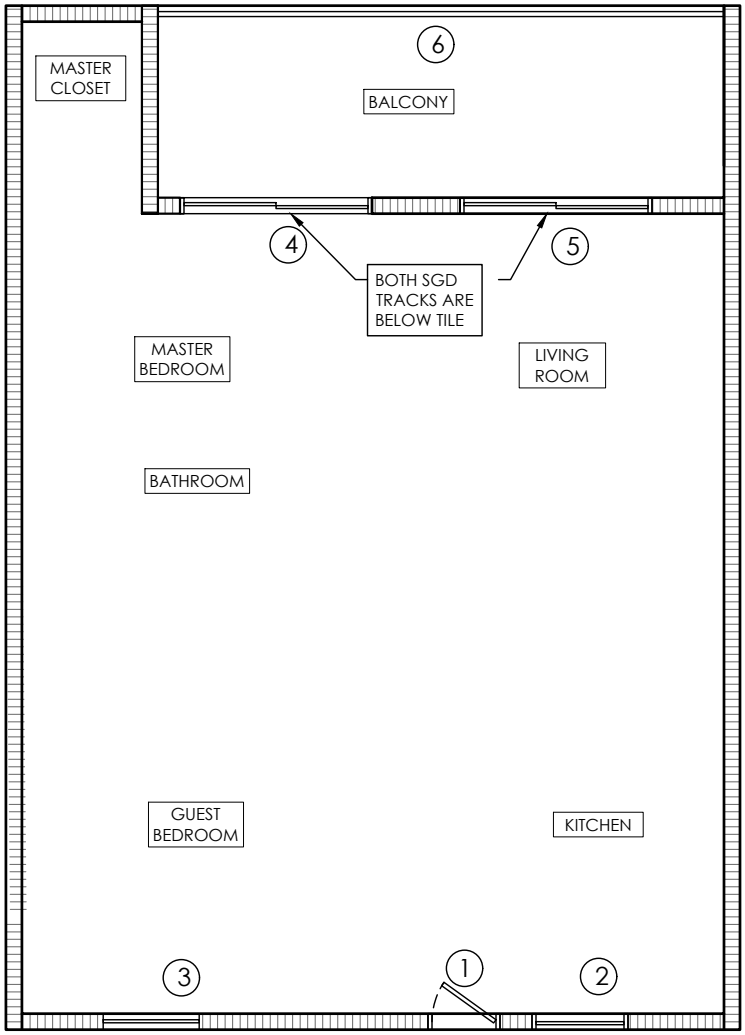
DESCRIPTION	SYM	EST. QTY.
EDGE REPAIR	E	
PARTIAL DECK REPAIR	D	
OVERHEAD REPAIR	O	
THRU DECK REPAIR	T	
STRESS CRACK REPAIR	R	
HOLLOW TILE	HT	
BEAM REPAIR	B	
COLUMN REPAIR	C	
DELAMINATED STUCCO REPAIR	S	
STUCCO CRACK REPAIR	SC	2 LF
RUST SPOTS	RS	
MISSING ELECTRICAL COVER PLATE	EC	
ABANDON FASTENER/HOLES	F

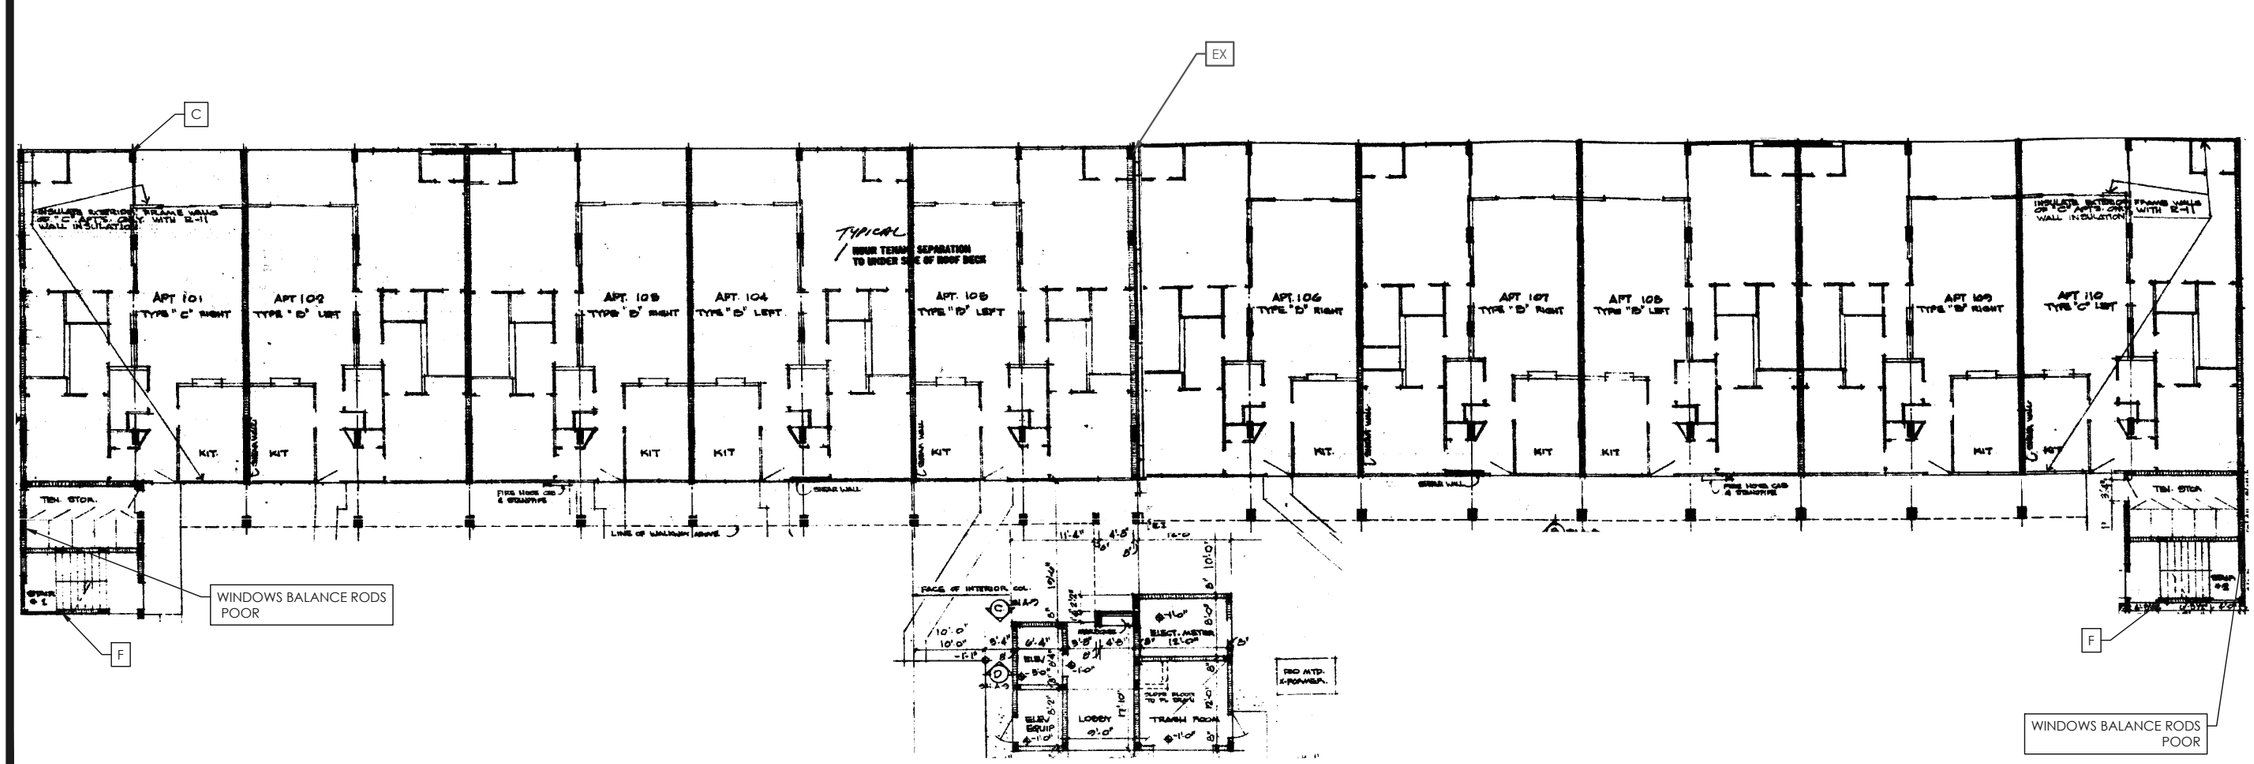
FIRST FLOOR PLAN
SCALE: NTS

ESTIMATED REPAIRS		
DESCRIPTION	SYM	EST. QTY.
EDGE REPAIR	E	
PARTIAL DECK REPAIR	D	
OVERHEAD REPAIR	O	
THRU DECK REPAIR	T	
STRESS CRACK REPAIR	R	
DELAMINATED TOPPING	DT	
BEAM REPAIR	B	
COLUMN REPAIR	C	8 CF
STUCCO REPAIR	S	
SOFFIT STUCCO REPAIR	SF	
STUCCO CRACK REPAIR	SC	
RUST SPOTS	RS	
WINDOW SILL REPAIR	SL	
POST POCKET REPAIRS	PP	
EXPANSION JOINT REPAIR	EX	
CONSTRUCT. JNT. REPAIR	CJ	
ABANDONED FASTENER/HOLES	F	4 EA

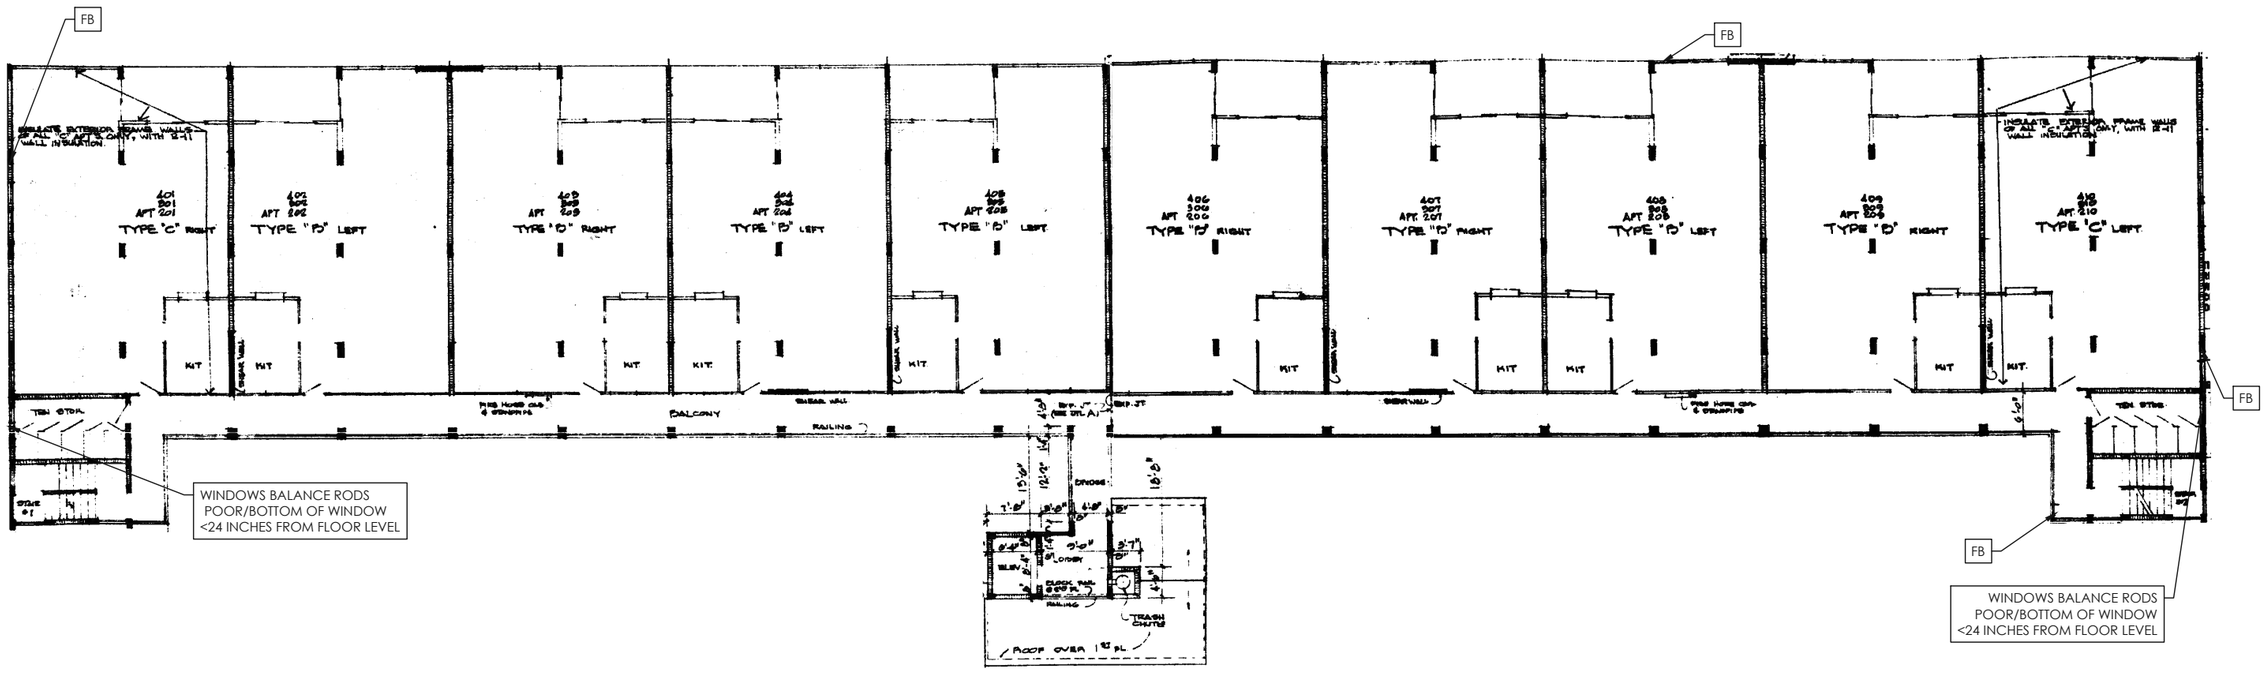
FOURTH FLOOR PLAN
SCALE: NTS

ESTIMATED REPAIRS		
DESCRIPTION	SYM	EST. QTY.
EDGE REPAIR	E	
PARTIAL DECK REPAIR	D	
OVERHEAD REPAIR	O	
THRU DECK REPAIR	T	
STRESS CRACK REPAIR	R	
DELAMINATED TOPPING	DT	
BEAM REPAIR	B	
COLUMN REPAIR	C	
STUCCO REPAIR	S	
SOFFIT STUCCO REPAIR	SF	
STUCCO CRACK REPAIR	SC	
RUST SPOTS	RS	
WINDOW SILL REPAIR	SL	
POST POCKET REPAIRS	PP	
EXPANSION JOINT REPAIR	EX	
CONSTRUCT. JNT. REPAIR	CJ	
ABANDONED FASTENER/HOLES	F	
DETERIORATED FASCIA BOARD	FB	20 LF

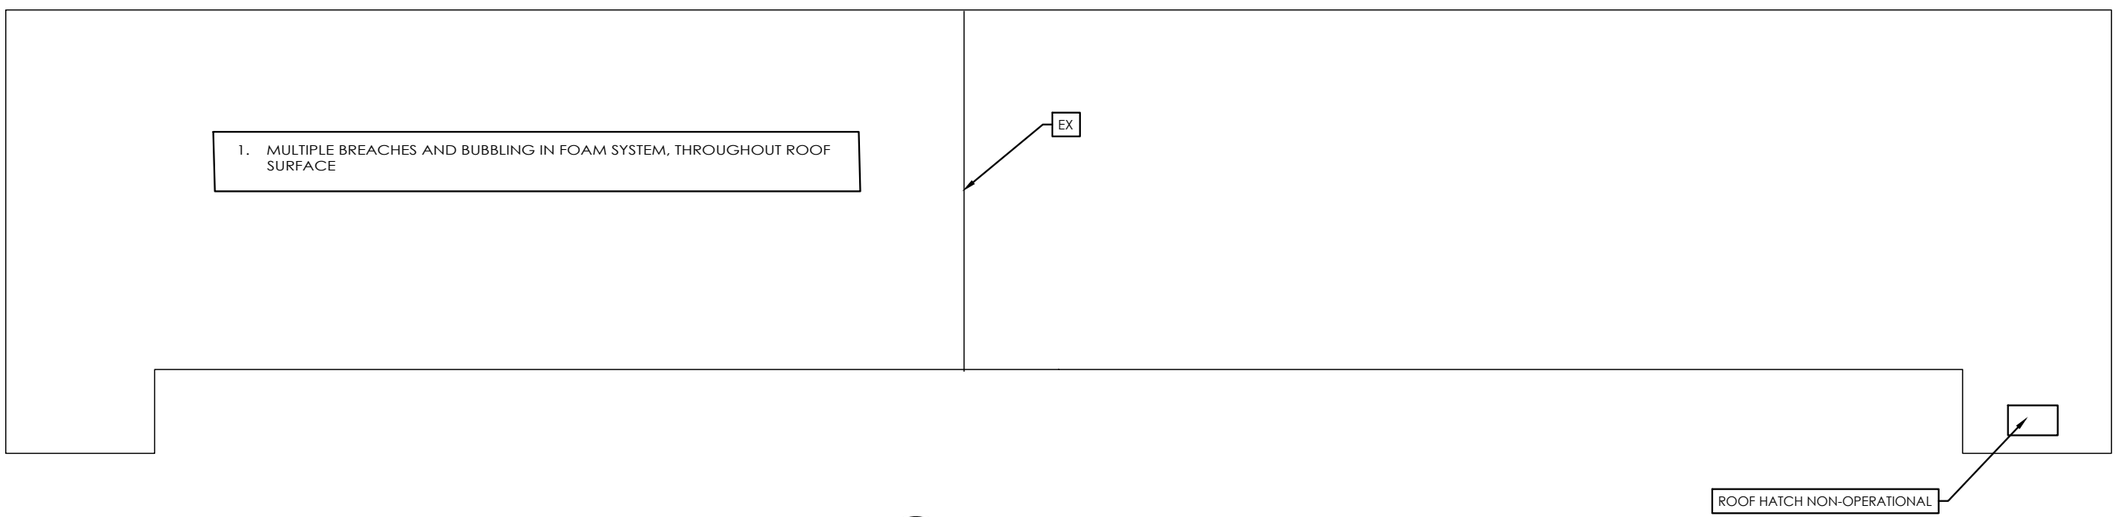
ROOF FLOOR
SCALE: NTS

1. MULTIPLE BREACHES AND BUBBLING IN FOAM SYSTEM, THROUGHOUT ROOF SURFACE

13. All flat roof systems should be fully replaced. The structural slabs should be inspected prior to the new roof systems being stalled. Stucco repairs will be required on parapet walls. A/C unit stands might require replacement to meet current roofing codes.

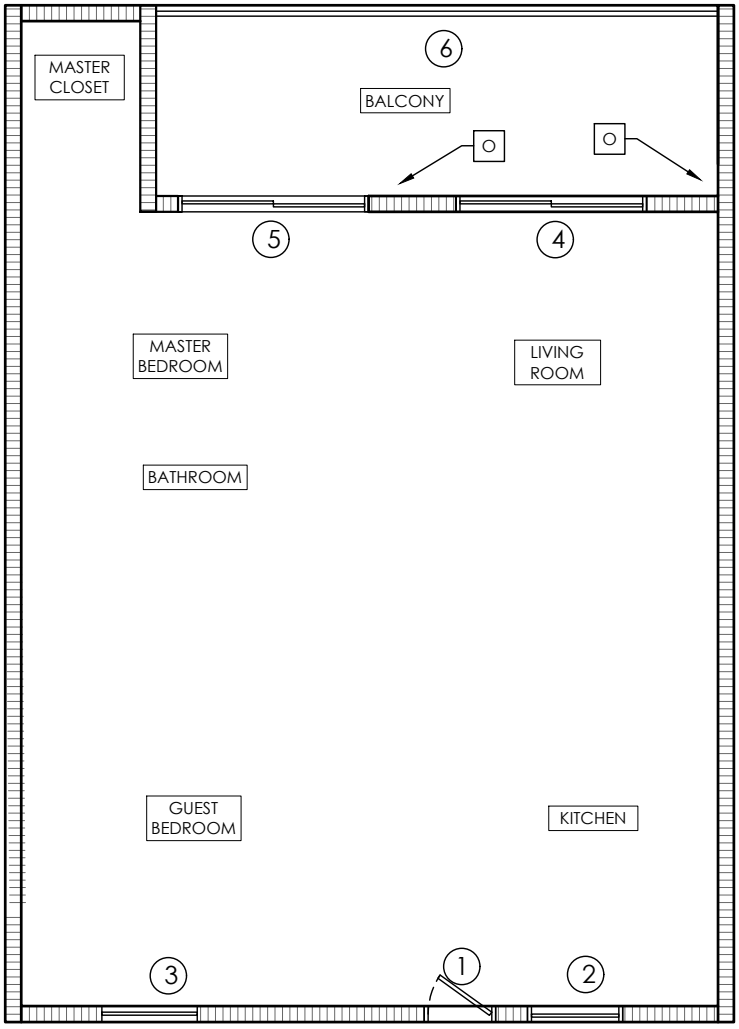
FLOOR PLAN
SCALE: 1/8" = 1'-0"

DESCRIPTION	SYM	EST. QTY.
EDGE REPAIR	E	
PARTIAL DECK REPAIR	D	
OVERHEAD REPAIR	O	12 SF
THRU DECK REPAIR	T	
STRESS CRACK REPAIR	R	
HOLLOW TILE	HT	
BEAM REPAIR	B	
COLUMN REPAIR	C	
DELAMINATED STUCCO REPAIR	S	
STUCCO CRACK REPAIR	SC	
RUST SPOTS	RS	
MISSING ELECTRICAL COVER PLATE	EC	
ABANDON FASTENER/HOLES	F

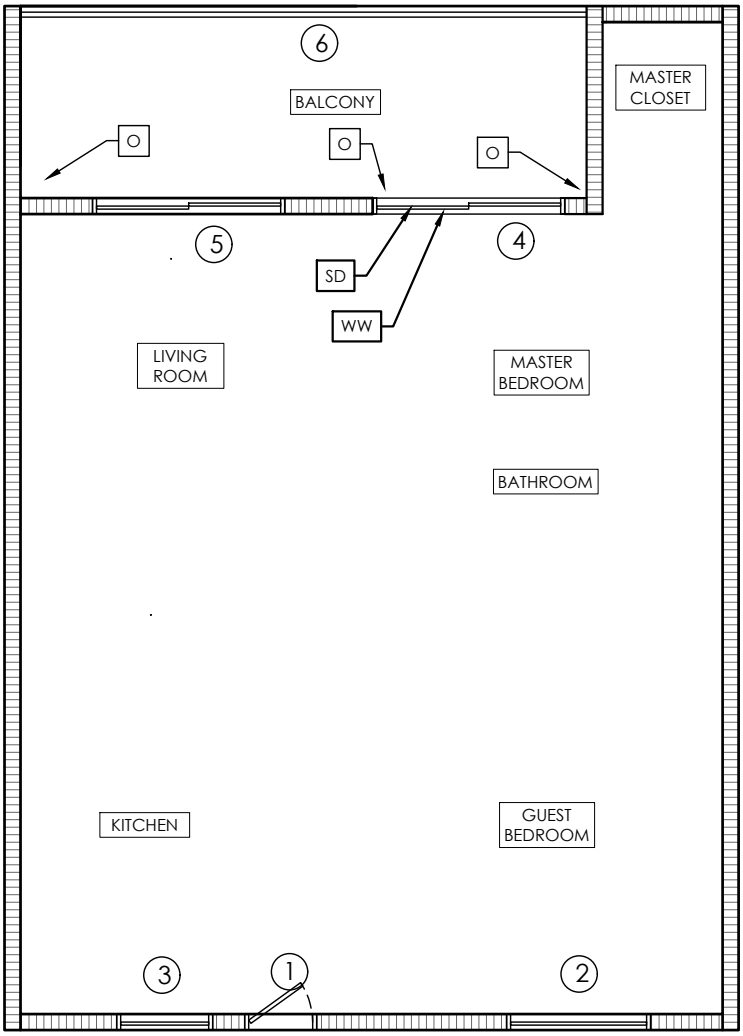
FLOOR PLAN
SCALE: 1/8" = 1'-0"

DESCRIPTION	SYM	EST. QTY.
EDGE REPAIR	E	
PARTIAL DECK REPAIR	D	
OVERHEAD REPAIR	O	11 SF
THRU DECK REPAIR	T	
STRESS CRACK REPAIR	R	
HOLLOW TILE	HT	10 SF
BEAM REPAIR	B	
COLUMN REPAIR	C	
DELAMINATED STUCCO REPAIR	S	
STUCCO CRACK REPAIR	SC	
RUST SPOTS	RS	
MISSING ELECTRICAL COVER PLATE	EC	
ABANDON FASTENER/HOLES	F	10 EA

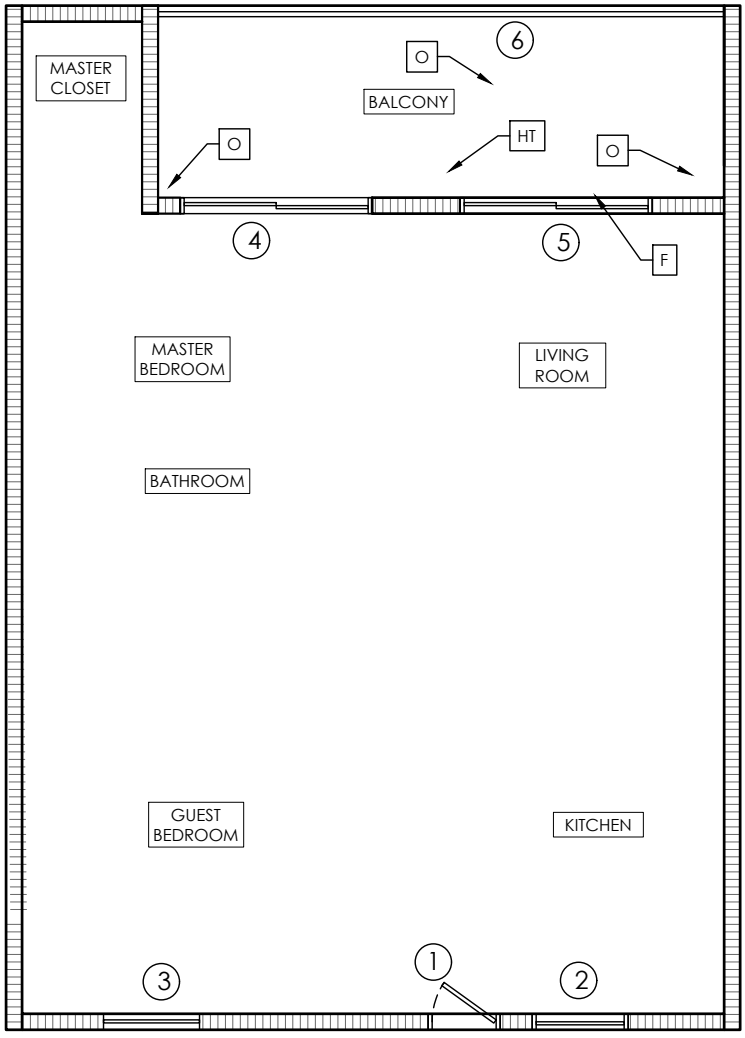
FLOOR PLAN
SCALE: 1/8" = 1'-0"

DESCRIPTION	SYM	EST. QTY.
EDGE REPAIR	E	
PARTIAL DECK REPAIR	D	
OVERHEAD REPAIR	O	6 SF
THRU DECK REPAIR	T	
STRESS CRACK REPAIR	R	
HOLLOW TILE	HT	2 SF
BEAM REPAIR	B	
COLUMN REPAIR	C	
DELAMINATED STUCCO REPAIR	S	
STUCCO CRACK REPAIR	SC	
RUST SPOTS	RS	
MISSING ELECTRICAL COVER PLATE	EC	
ABANDON FASTENER/HOLES	F
