HUNTINGTON LAKES SECTION 4
BUILDING 36

BUILDINGS STRUCTURAL PHASE TWO
MILESTONE INSPECTION REPORT

SEPTEMBER 2024

Re: Milestone Inspections
Huntington Lakes Section Four
7281 Amberly Lane – Building 36
Delray Beach, Florida 33446

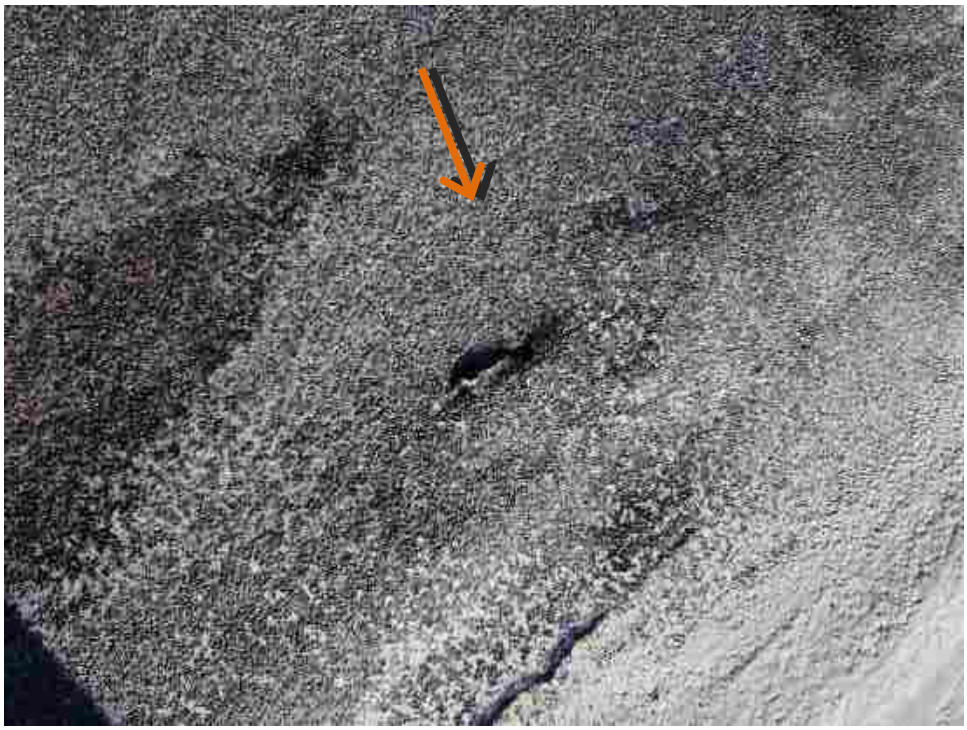
7. The Property Appraiser did not identify the roofing system, however all roof areas and portions of parapet walls appear to be covered in a spray foam. This foam has delaminated in many areas and the roof appears to have extensive patch repairs. Large and small areas of ponding water and breaching were observed throughout the flat roof areas. The roof appears to be reaching the end of its useful live.

Figure 12: Damaged roofing membrane

13. All flat roof systems should be fully replaced. The structural slabs should be inspected prior to the new roof systems being stalled. Stucco repairs will be required on parapet walls. A/C unit stands might require replacement to meet current roofing codes. Damaged fascia boards should be repaired at this time.

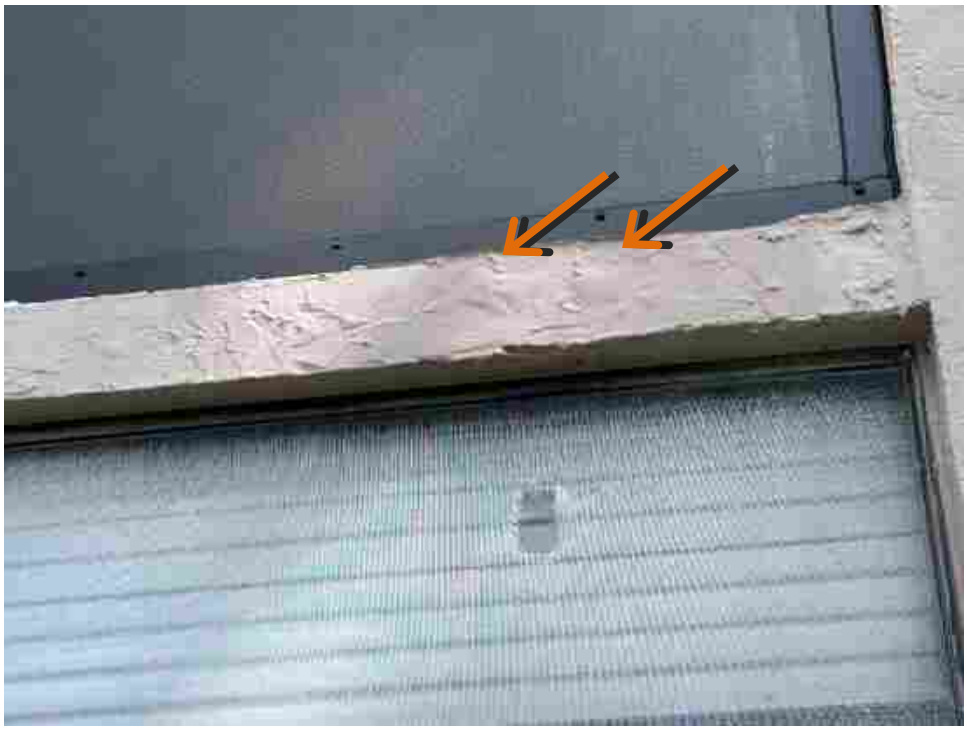
Figure 49: Bubbling paint at slab edge

12. Exterior wall coatings should continue to be maintained and painting projects should be performed every 8 to 10 years. The project should include the preparation, priming and painting of all slab edges, ceiling areas, and all vertical stucco surfaces. Additionally, all exterior window and door perimeter seals should be re-caulked or removed and replaced if deteriorated. Any exterior metal doors should also be painted to prolong their aesthetic life expectancy.

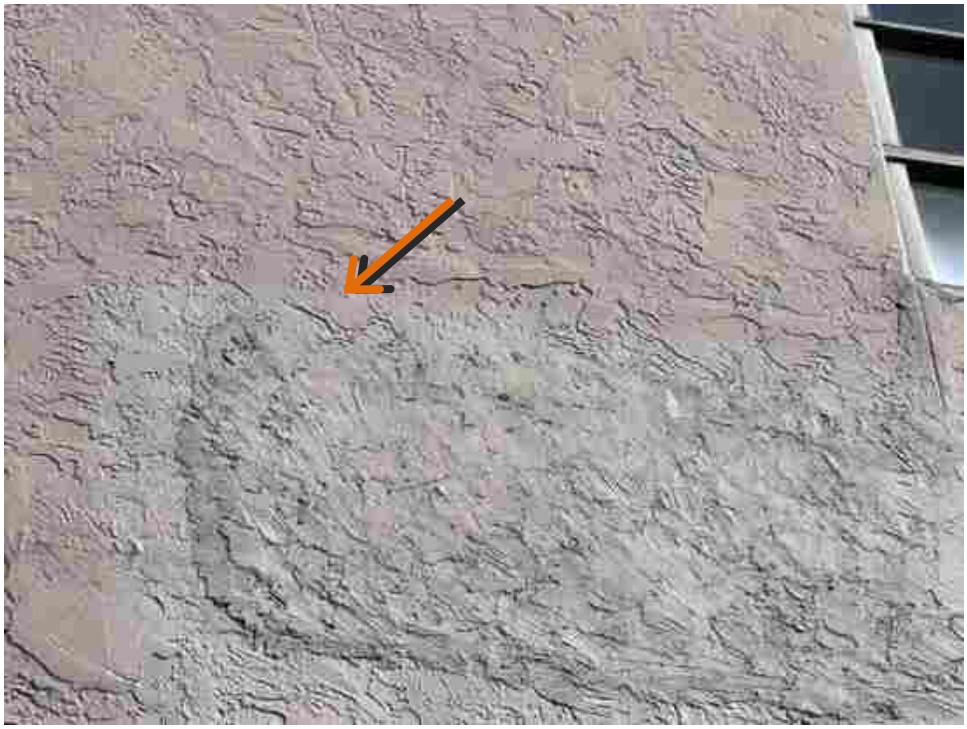
Figure 50: Failing previous repair at exterior wall

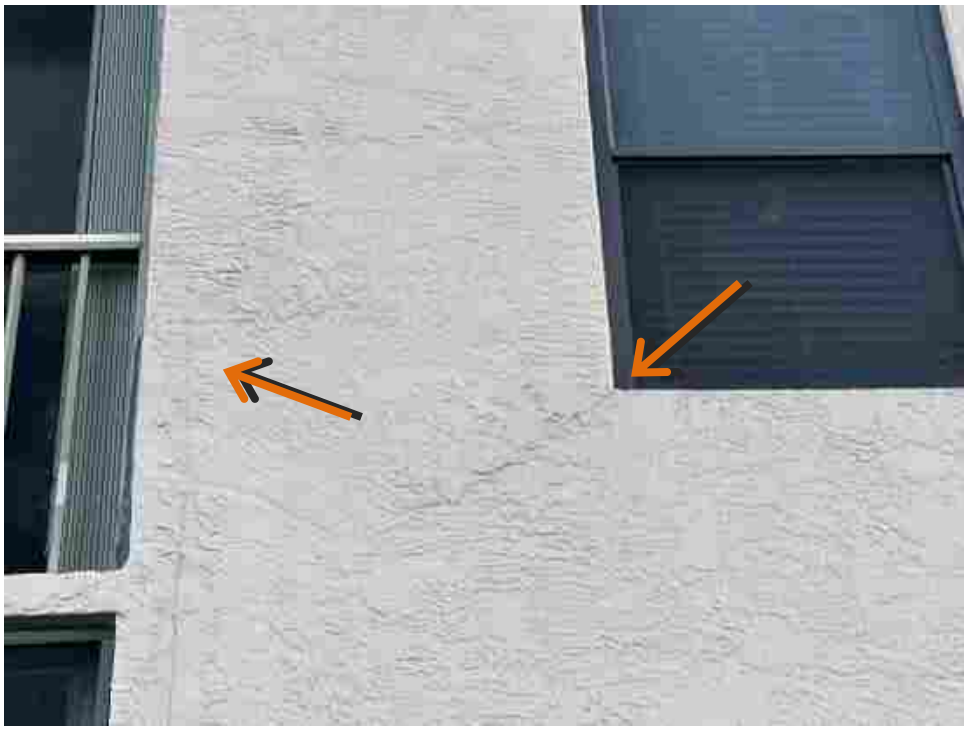
12. Many areas of stucco delamination and stucco cracking were observed on the masonry walls but were often found on the slab edges. Rust spots were also observed along some of the slab edges.
13. Some column spalling were observed at the elevator tower and catwalk areas.
14. Paint bubbling and delamination was observed occasionally.
15. In general, the stair tower structures, and stair systems were in fair condition.
16. Abandoned fasteners were found throughout the building envelope as well as unsealed holes where fasteners were once installed.
17. Some areas of the vertical expansion joint were failing at the front and back of the building. Cover plates were installed at the expansion joints on the catwalks, inhibiting inspection of the horizontal expansion joints.
18. Rotted wood fascia was observed along the lobby roof areas.

Figure 51: Stucco cracks

8. The Association should plan to replace the existing balcony enclosures and picket railings with new code-compliant railings.
9. Delaminated stucco should be removed from any concrete or masonry surfaces. New stucco should be applied to match existing. Cracks in the stucco on vertical and horizontal surfaces should be sealed. If cracks exceed 1/16” in width, the cracks should be routed in a “V” shape before sealing. Cracking between poured concrete elements and concrete blocks might require mesh reinforcement to prevent future cracking.

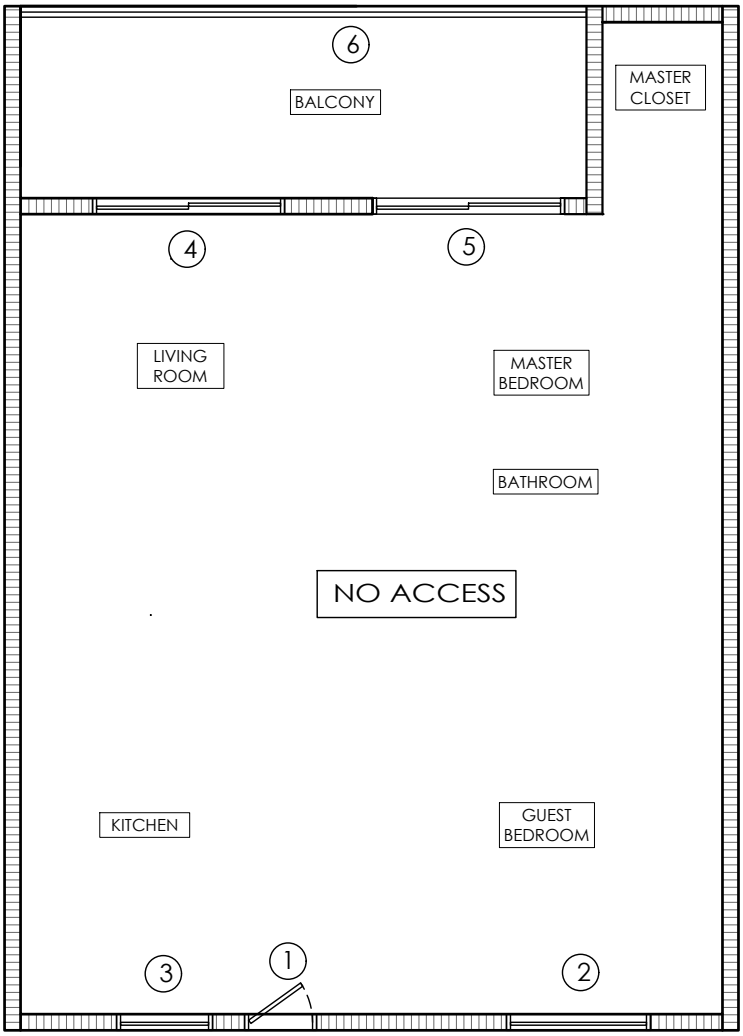
FLOOR PLAN
SCALE: 1/8" = 1'-0"

DESCRIPTION	SYM	EST, QTY.
EDGE REPAIR	E	
PARTIAL DECK REPAIR	D	
OVERHEAD REPAIR	O	
THRU DECK REPAIR	T	
STRESS CRACK REPAIR	R	
HOLLOW TILE	HT	
BEAM REPAIR	B	
COLUMN REPAIR	C	
DELAMINATED STUCCO REPAIR	S	10 LF
STUCCO CRACK REPAIR	SC	
RUST SPOTS	RS	
MISSING ELECTRICAL COVER PLATE	EC	
ABANDON FASTENER/HOLES	F

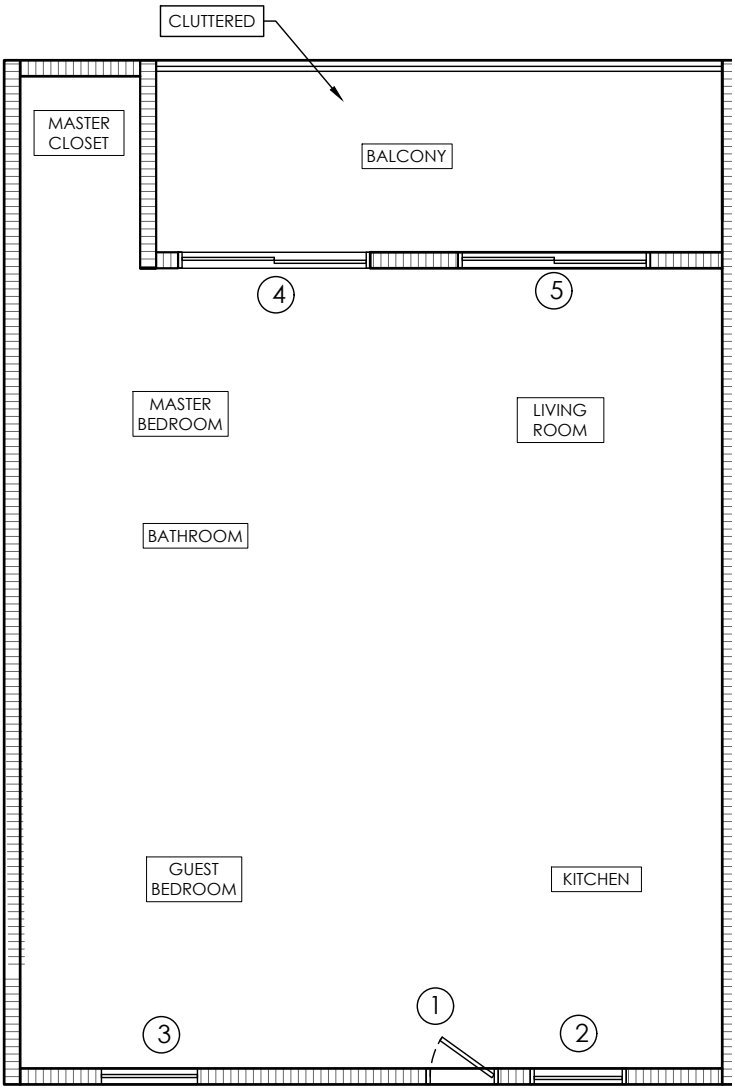
FLOOR PLAN
SCALE: 1/8" = 1'-0"

DESCRIPTION	SYM	EST, QTY.
EDGE REPAIR	E	
PARTIAL DECK REPAIR	D	
OVERHEAD REPAIR	O	2 SF
THRU DECK REPAIR	T	
STRESS CRACK REPAIR	R	
HOLLOW TILE	HT	
BEAM REPAIR	B	
COLUMN REPAIR	C	
DELAMINATED STUCCO REPAIR	S	
STUCCO CRACK REPAIR	SC	
RUST SPOTS	RS	
MISSING ELECTRICAL COVER PLATE	EC	
ABANDON FASTENER/HOLES	F

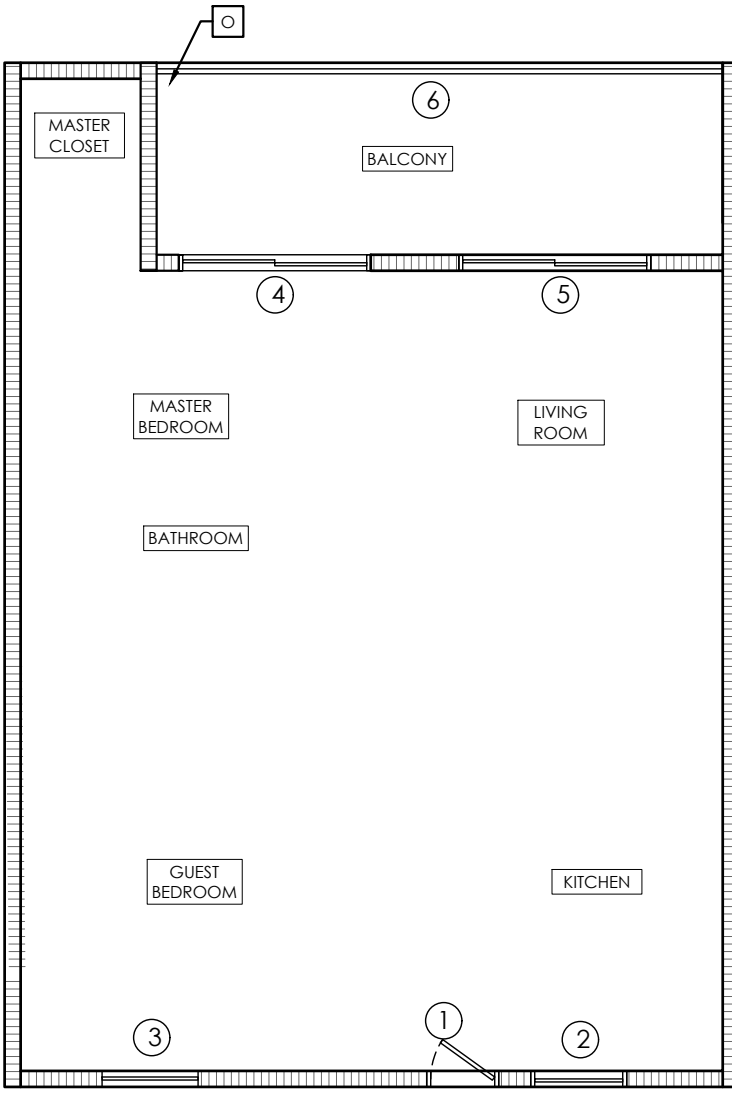
FLOOR PLAN
SCALE: 1/8" = 1'-0"

DESCRIPTION	SYM	EST, QTY.
EDGE REPAIR	E	
PARTIAL DECK REPAIR	D	
OVERHEAD REPAIR	O	
THRU DECK REPAIR	T	
STRESS CRACK REPAIR	R	
HOLLOW TILE	HT	
BEAM REPAIR	B	
COLUMN REPAIR	C	
DELAMINATED STUCCO REPAIR	S	3 SF
STUCCO CRACK REPAIR	SC	
RUST SPOTS	RS	
MISSING ELECTRICAL COVER PLATE	EC	
ABANDON FASTENER/HOLES	F

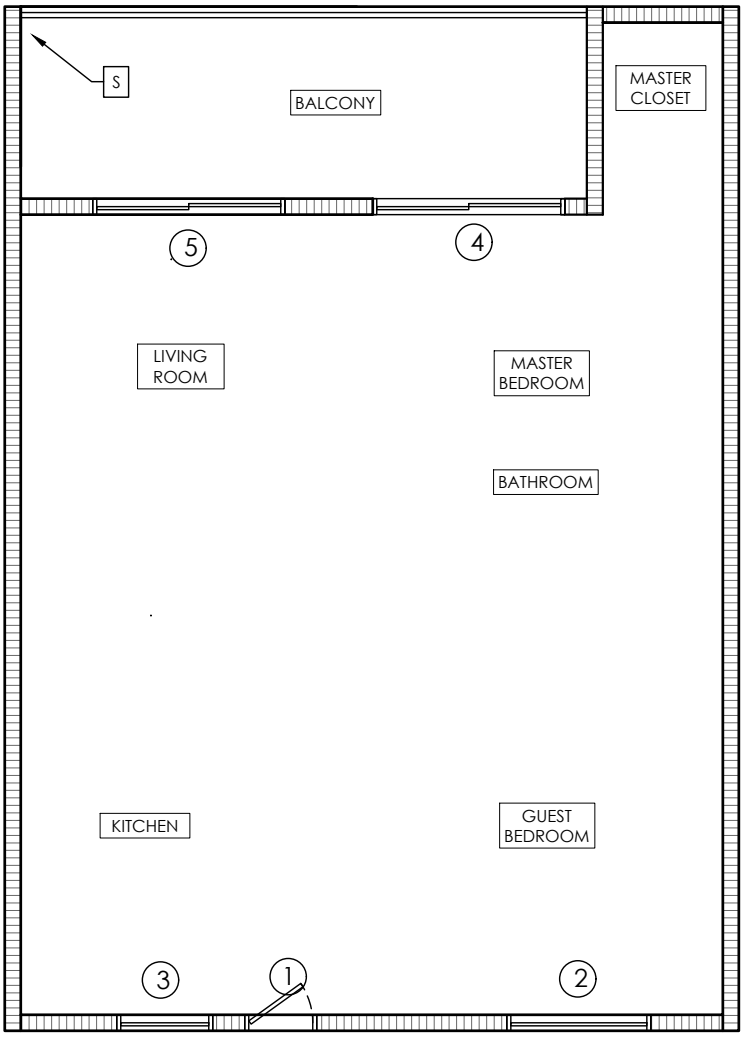
FLOOR PLAN
SCALE: 1/8" = 1'-0"

DESCRIPTION	SYM	EST, QTY.
EDGE REPAIR	E	
PARTIAL DECK REPAIR	D	
OVERHEAD REPAIR	O	
THRU DECK REPAIR	T	
STRESS CRACK REPAIR	R	
HOLLOW TILE	HT	
BEAM REPAIR	B	
COLUMN REPAIR	C	
DELAMINATED STUCCO REPAIR	S	10 SF
STUCCO CRACK REPAIR	SC	
RUST SPOTS	RS	
MISSING ELECTRICAL COVER PLATE	EC	
ABANDON FASTENER/HOLES	F

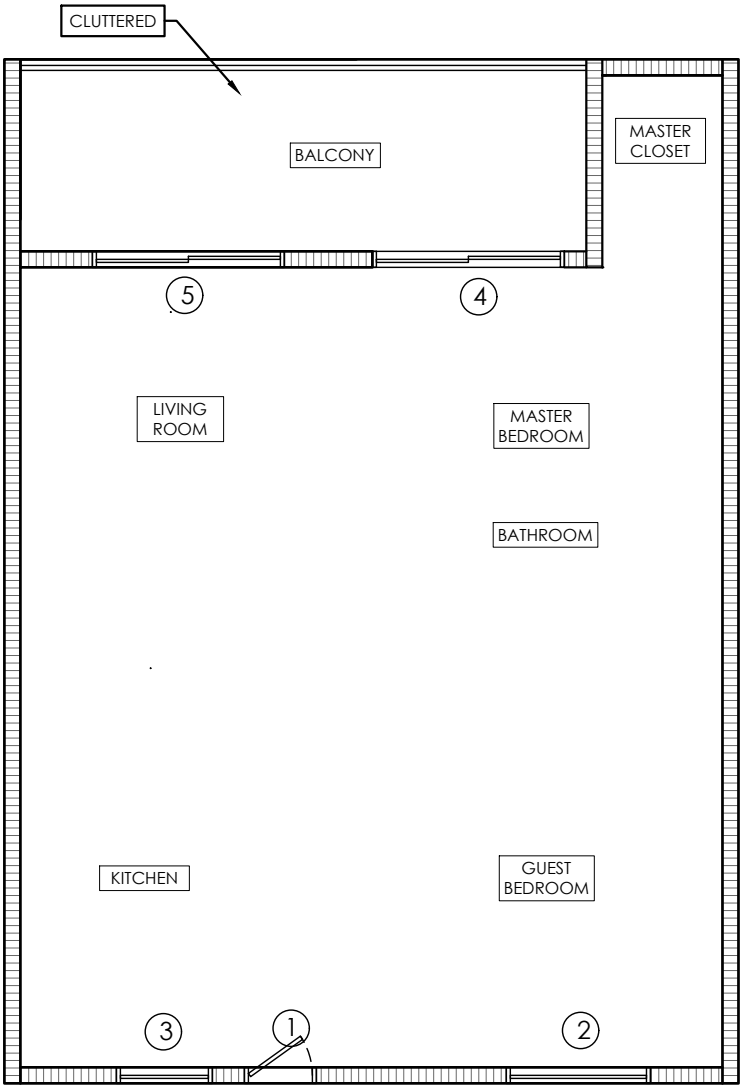
FLOOR PLAN
SCALE: 1/8" = 1'-0"

DESCRIPTION	SYM	EST. QTY.
EDGE REPAIR	E	
PARTIAL DECK REPAIR	D	
OVERHEAD REPAIR	O	
THRU DECK REPAIR	T	
STRESS CRACK REPAIR	R	
HOLLOW TILE	HT	10 SF
BEAM REPAIR	B	
COLUMN REPAIR	C	
DELAMINATED STUCCO REPAIR	S	
STUCCO CRACK REPAIR	SC	
RUST SPOTS	RS	
MISSING ELECTRICAL COVER PLATE	EC	
ABANDON FASTENER/HOLES	F

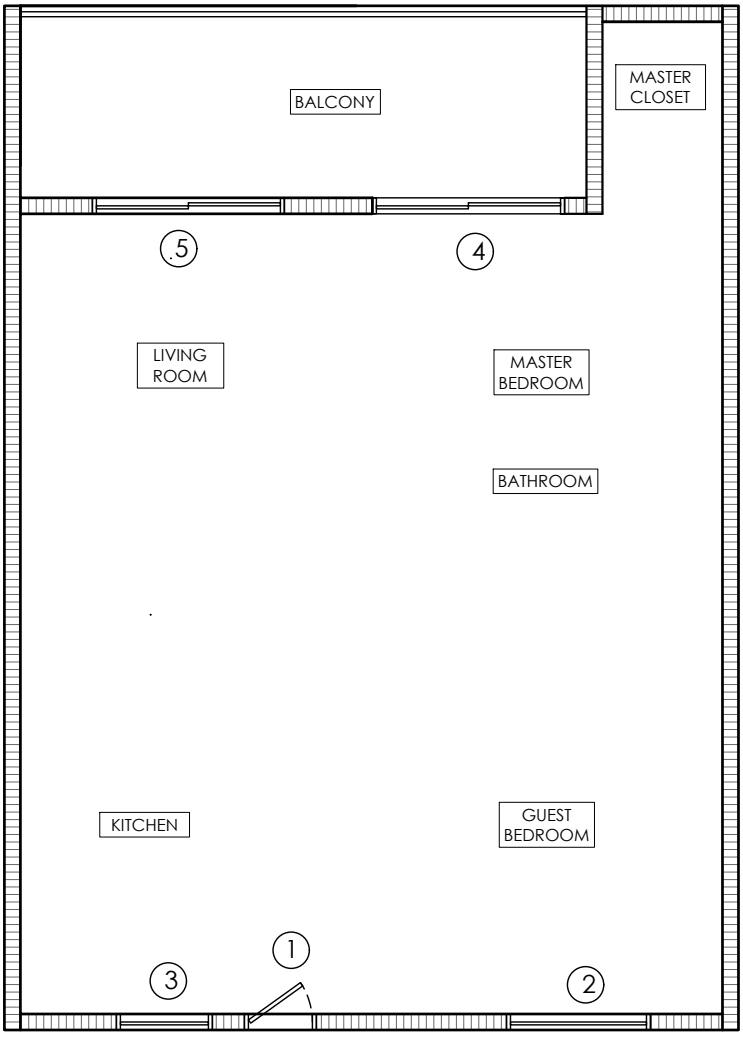
FLOOR PLAN
SCALE: 1/8" = 1'-0"

DESCRIPTION	SYM	EST. QTY.
EDGE REPAIR	E	
PARTIAL DECK REPAIR	D	
OVERHEAD REPAIR	O	10 SF
THRU DECK REPAIR	T	
STRESS CRACK REPAIR	R	
HOLLOW TILE	HT	
BEAM REPAIR	B	
COLUMN REPAIR	C	
DELAMINATED STUCCO REPAIR	S	
STUCCO CRACK REPAIR	SC	
RUST SPOTS	RS	
MISSING ELECTRICAL COVER PLATE	EC	
ABANDON FASTENER/HOLES	F

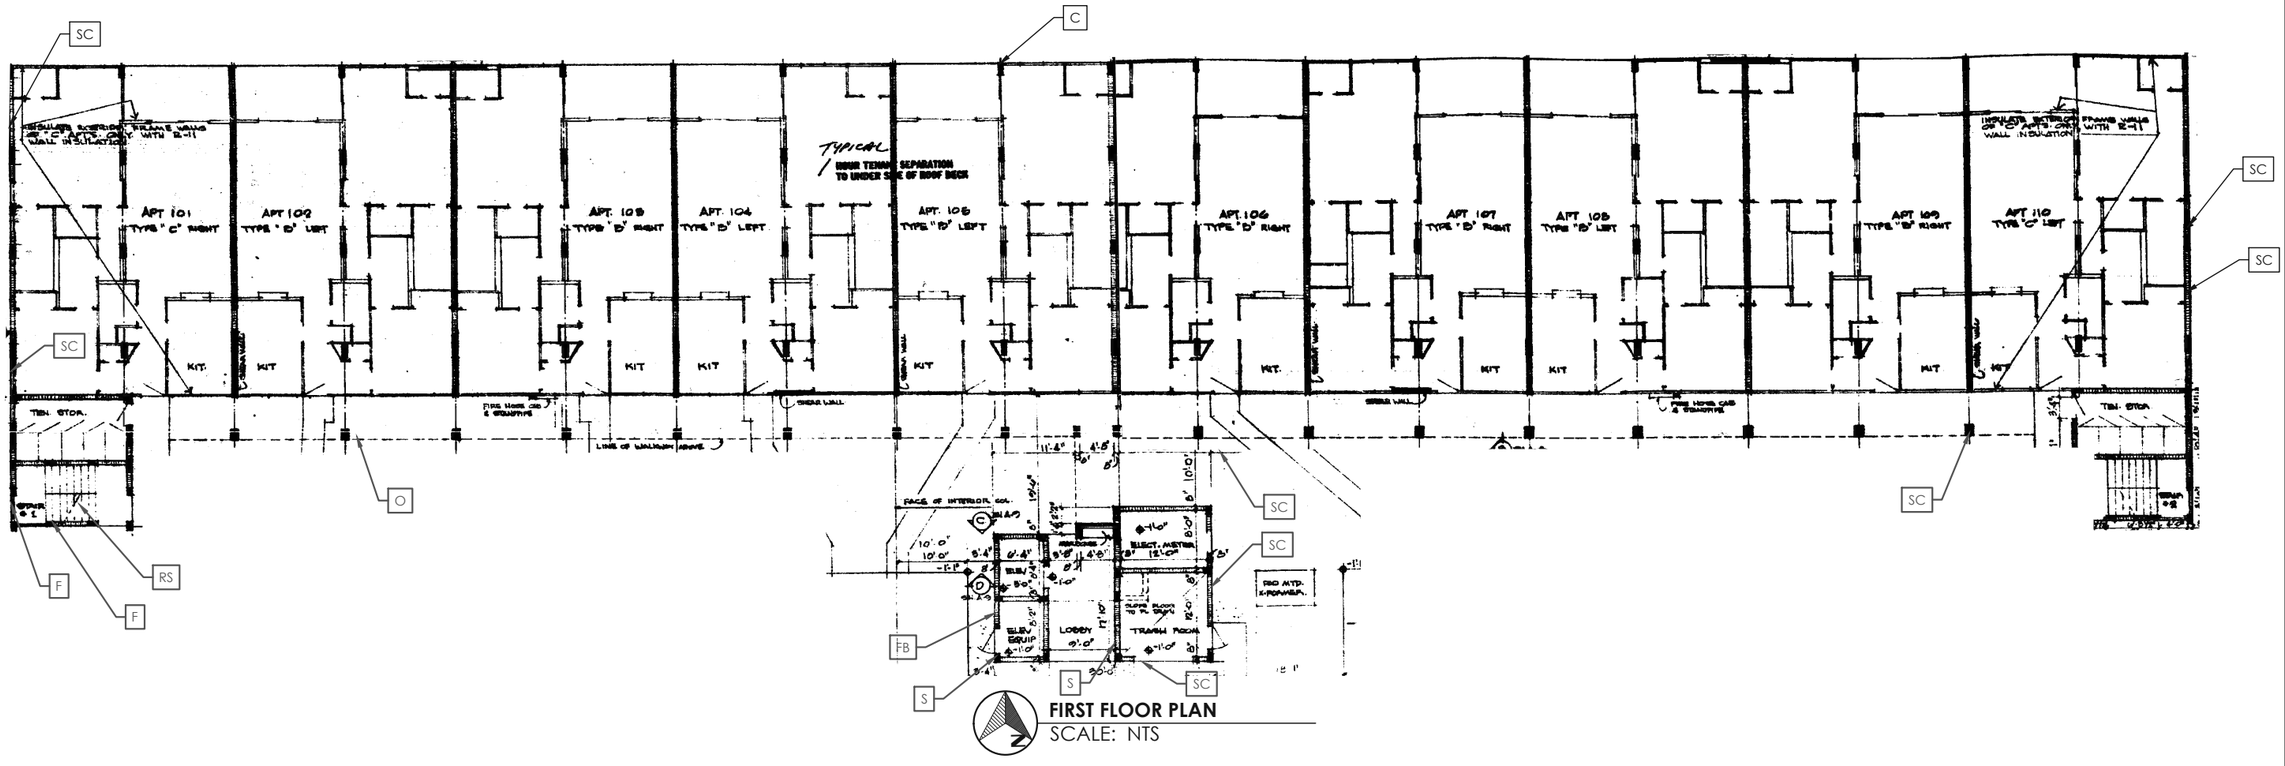
FIRST FLOOR PLAN
SCALE: NTS

ESTIMATED REPAIRS		
DESCRIPTION	SYM	EST. QTY.
EDGE REPAIR	E	
PARTIAL DECK REPAIR	D	
OVERHEAD REPAIR	O	2 SF
THRU DECK REPAIR	T	
STRESS CRACK REPAIR	R	
DELAMINATED TOPPING	DT	
BEAM REPAIR	B	
COLUMN REPAIR	C	5 CF
STUCCO REPAIR	S	6 SF
SOFFIT STUCCO REPAIR	SF	
STUCCO CRACK REPAIR	SC	35 LF
RUST SPOTS	RS	1 EA
WINDOW SILL REPAIR	SL	
POST POCKET REPAIRS	PP	
EXPANSION JOINT REPAIR	EX	
CONSTRUCT. JNT. REPAIR	CJ	
ABANDONED FASTENER/HOLES	F	8 EA
DETERIORATED FASCIA BOARD	FB	8 LF

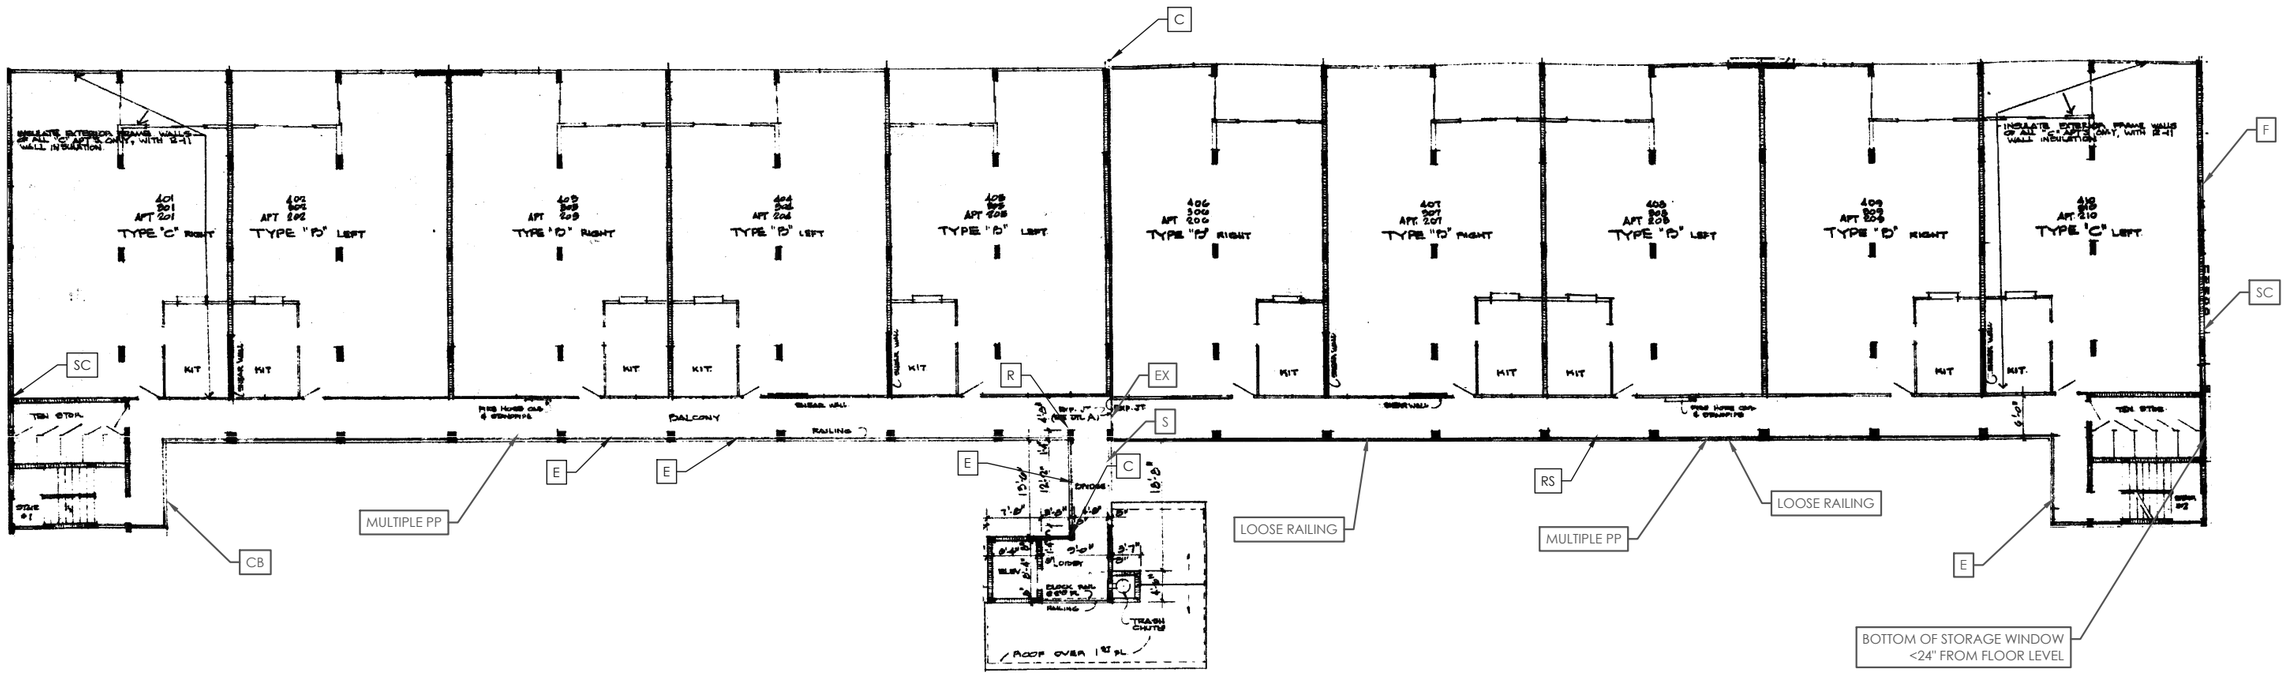
SECOND FLOOR PLAN
SCALE: NTS

ESTIMATED REPAIRS		
DESCRIPTION	SYM	EST. QTY.
EDGE REPAIR	E	8 LF
PARTIAL DECK REPAIR	D	
OVERHEAD REPAIR	O	
THRU DECK REPAIR	T	
STRESS CRACK REPAIR	R	4 LF
DELAMINATED TOPPING	DT	
BEAM REPAIR	B	
COLUMN REPAIR	C	6 CF
STUCCO REPAIR	S	2 SF
SOFFIT STUCCO REPAIR	SF	
STUCCO CRACK REPAIR	SC	10 LF
RUST SPOTS	RS	1 EA
WINDOW SILL REPAIR	SL	
POST POCKET REPAIRS	PP	52 EA
EXPANSION JOINT REPAIR	EX	5 LF
CONSTRUCT. JNT. REPAIR	CJ	
ABANDONED FASTENER/HOLES	F	4 EA
CORRODED RAIL BRACKETS	CB	2 EA

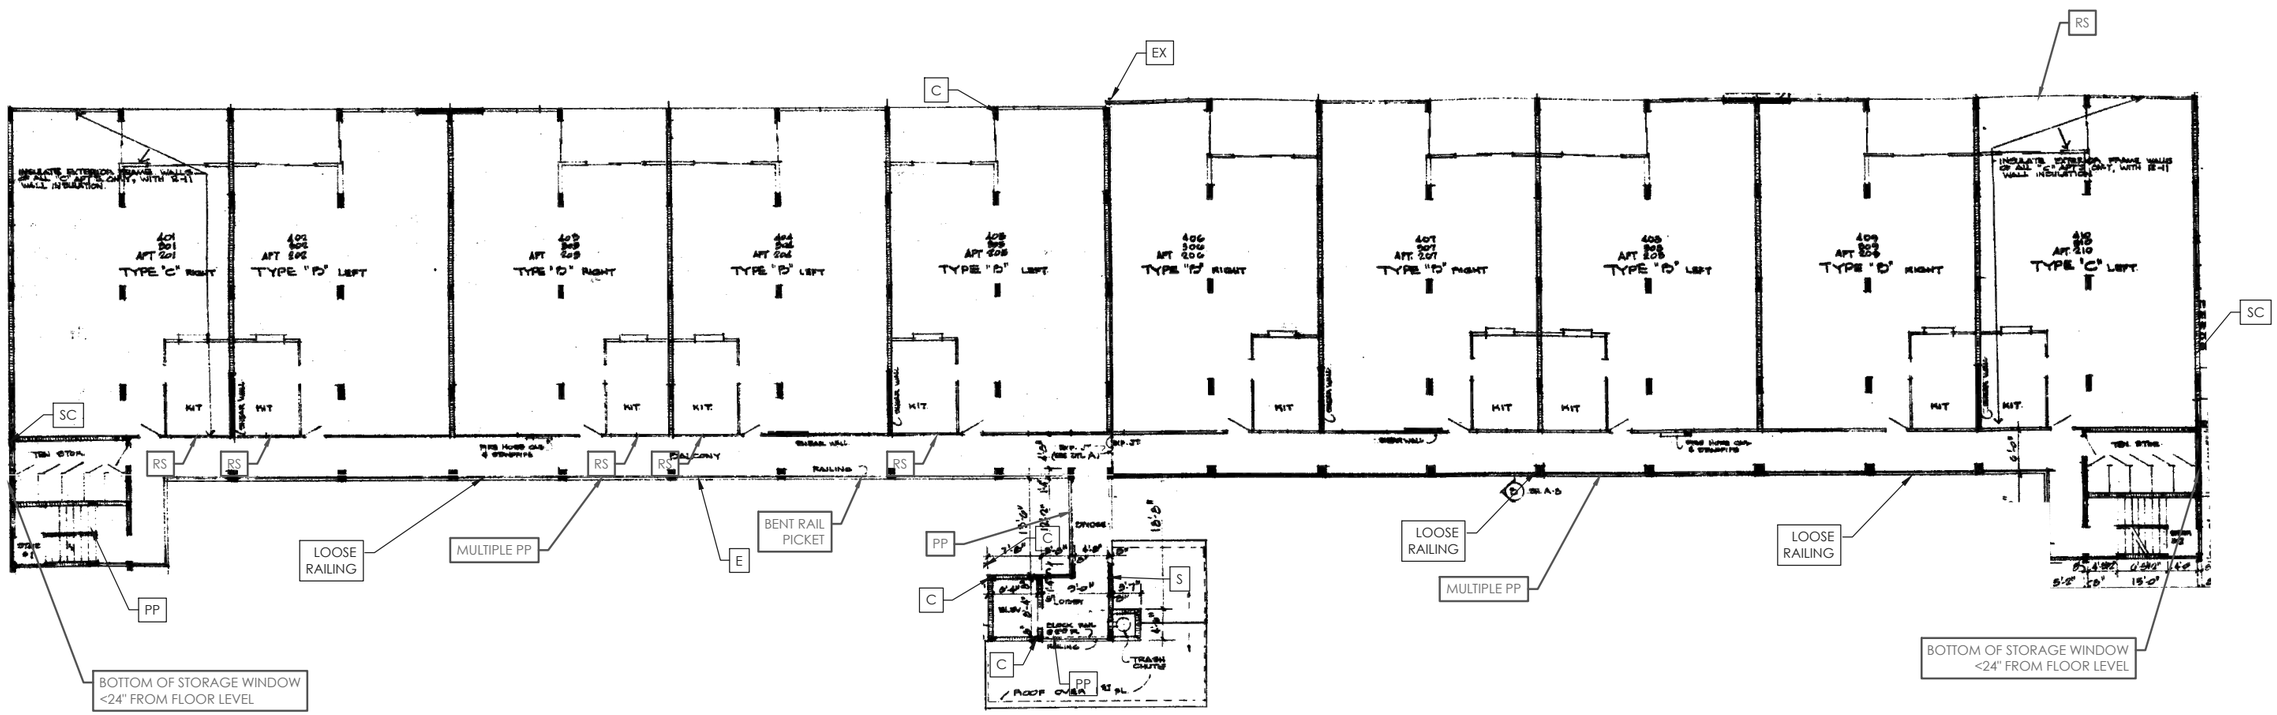
THIRD FLOOR PLAN
SCALE: NTS

ESTIMATED REPAIRS		
DESCRIPTION	SYM	EST. QTY.
EDGE REPAIR	E	1 LF
PARTIAL DECK REPAIR	D	
OVERHEAD REPAIR	O	
THRU DECK REPAIR	T	
STRESS CRACK REPAIR	R	
DELAMINATED TOPPING	DT	
BEAM REPAIR	B	
COLUMN REPAIR	C	10 CF
STUCCO REPAIR	S	2 SF
SOFFIT STUCCO REPAIR	SF	
STUCCO CRACK REPAIR	SC	10 LF
RUST SPOTS	RS	6 EA
WINDOW SILL REPAIR	SL	
POST POCKET REPAIRS	PP	70 EA
EXPANSION JOINT REPAIR	EX	13 LF
CONSTRUCT. JNT. REPAIR	CJ	
ABANDONED FASTENER/HOLES	F

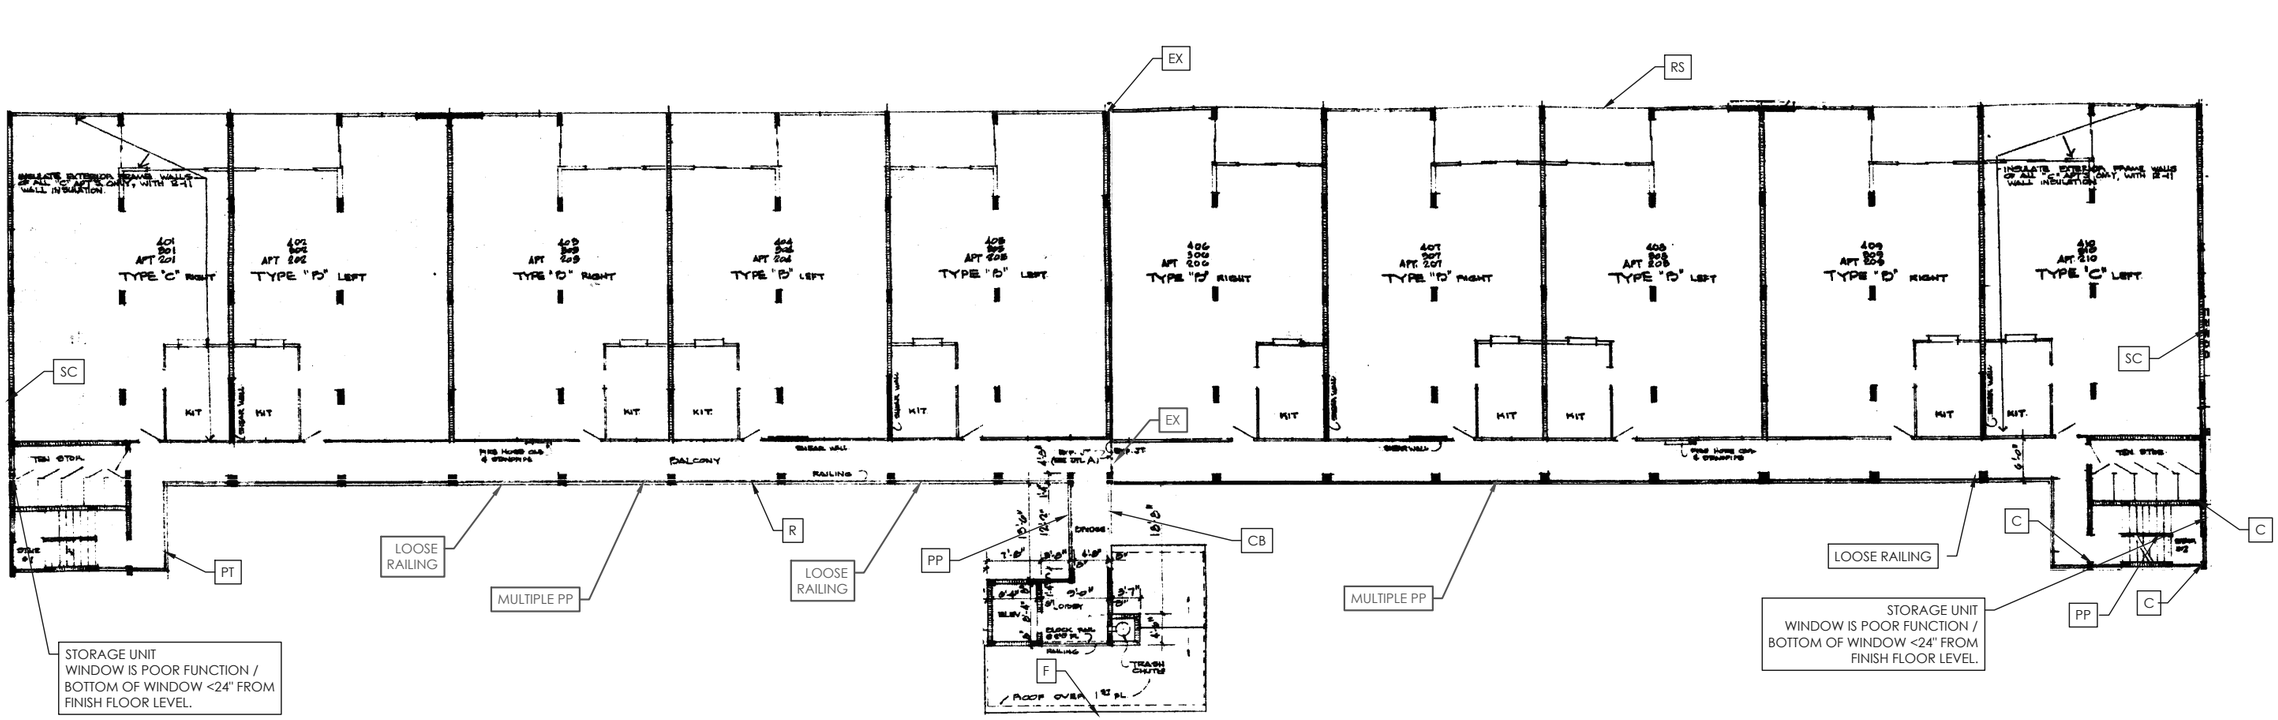
FOURTH FLOOR PLAN
SCALE: NTS

ESTIMATED REPAIRS		
DESCRIPTION	SYM	EST. QTY.
EDGE REPAIR	E	
PARTIAL DECK REPAIR	D	
OVERHEAD REPAIR	O	
THRU DECK REPAIR	T	
STRESS CRACK REPAIR	R	5 LF
DELAMINATED TOPPING	DT	
BEAM REPAIR	B	
COLUMN REPAIR	C	4 CF
STUCCO REPAIR	S	
SOFFIT STUCCO REPAIR	SF	
STUCCO CRACK REPAIR	SC	10 LF
RUST SPOTS	RS	1 EA
WINDOW SILL REPAIR	SL	
POST POCKET REPAIRS	PP	59 EA
EXPANSION JOINT REPAIR	EX	13 LF
CONSTRUCT. JNT. REPAIR	CJ	
ABANDONED FASTENER/HOLES	F	4 EA
POST TENSION ANCHOR REPAIR	PT	1 EA
