CITIZENS BUILDING TYPE II AND III MITIGATION INSPECTION FORM

WIND LOSS MITIGATION INFORMATION				
PREMISES #		SUBJECT OF INSURANCE:	**HUNTINGTON LAKES SECTION FOUR**	POLICY #:
BUILDING#:	**35**	PROPERTY ADDRESS:	**7301 AMBERLY LN, DELRAY BEACH FL 33446**	
# STORIES	**4**	BUILDING DESCRIPTION:		
BUILDING TYPE:	**II (4 to 6 stories)**

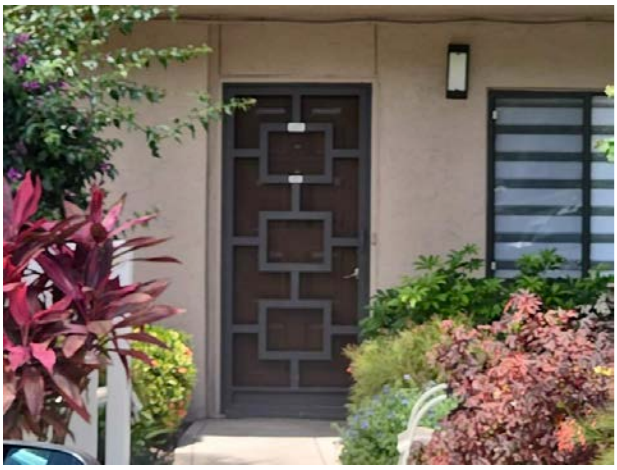
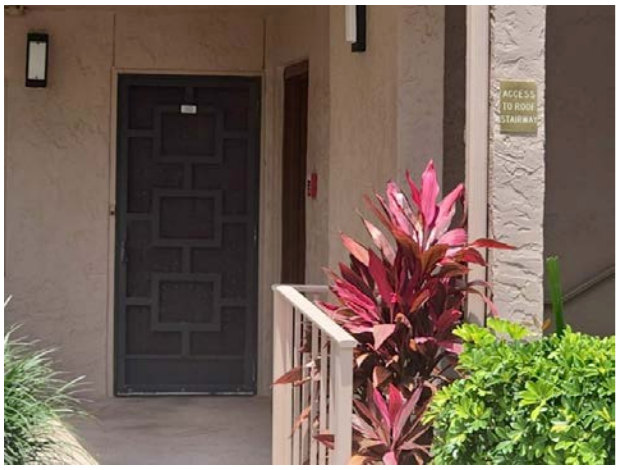
NON GLAZED OPENINGS

Inspector Notes / Comments:
Roof permit #B-2010-020234-0000
...Multiple glazed and non glazed openings are non impact rated and unprotected or have unverified protection...Recommended individual unit inspection for further credits...Shingle mansard portion of roof is not part of main roof and is not considered when determining roof characteristics and credits with carrier
